27 BLEECKER STREET - PROPOSED SIDEWALK VAULT REPAIRS - DOCKET NUMBER #17-3280

DRAFT

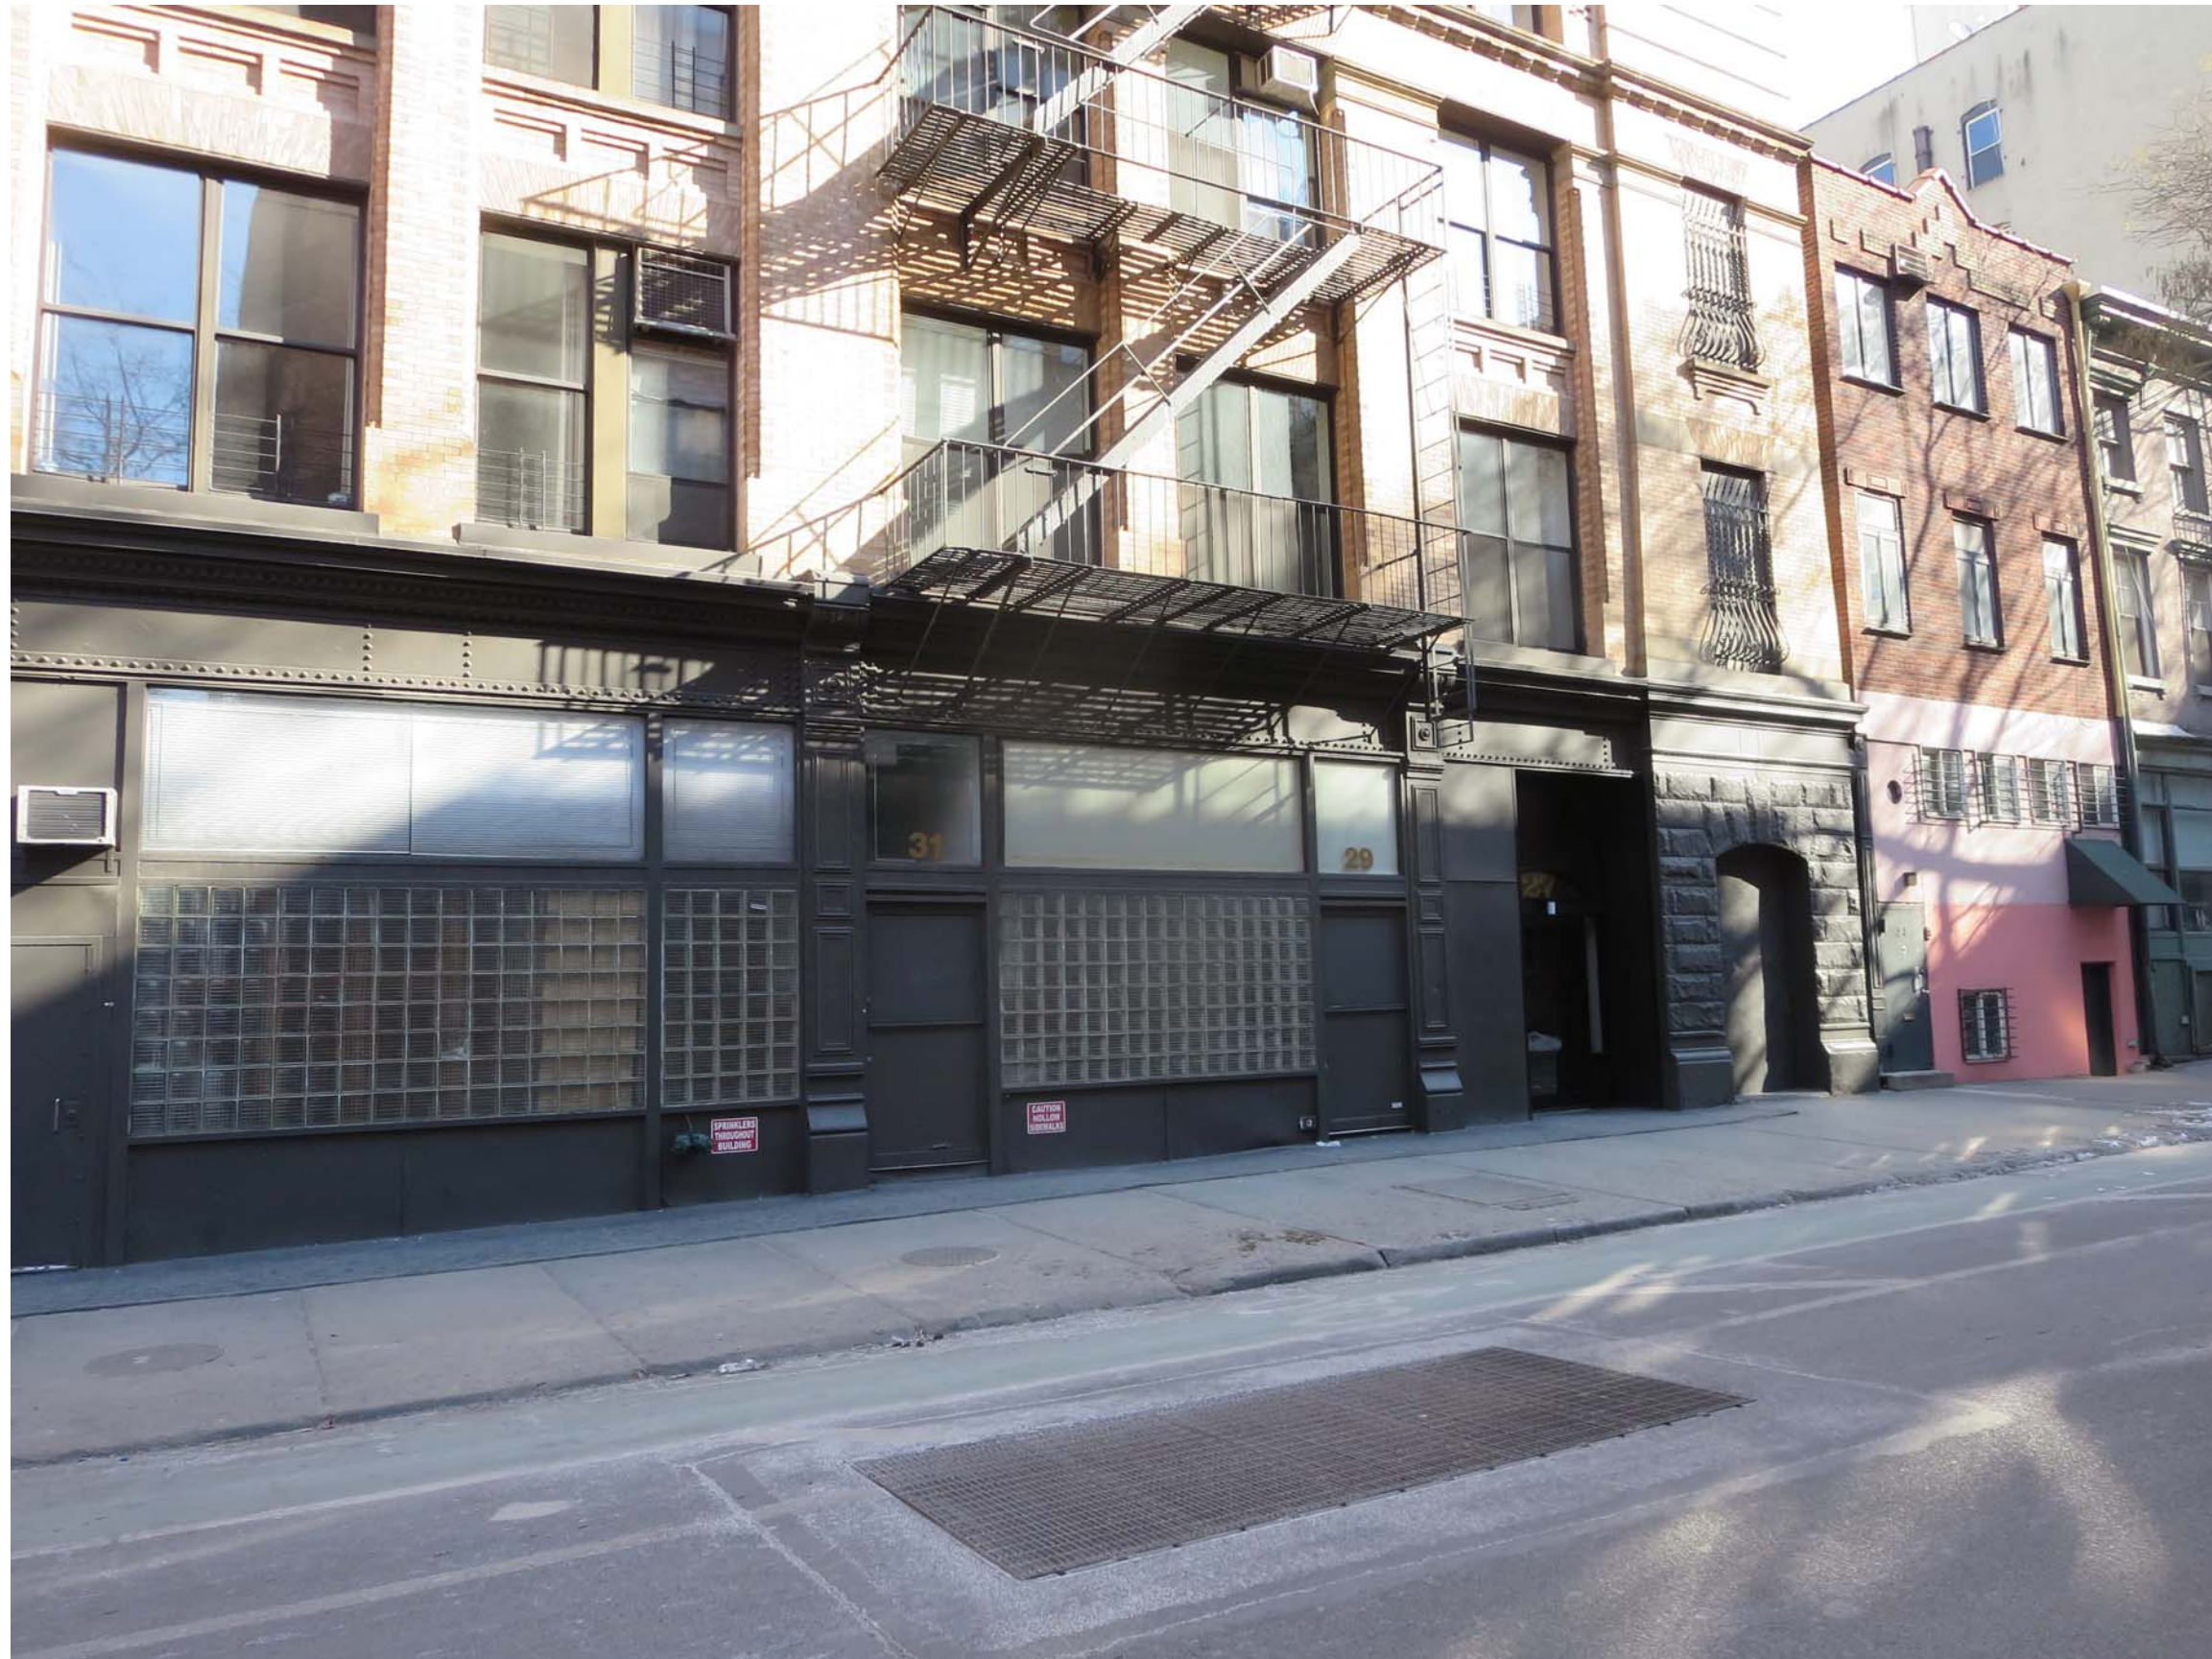
EXISTING CONDITIONS PRIOR TO INVESTIGATION

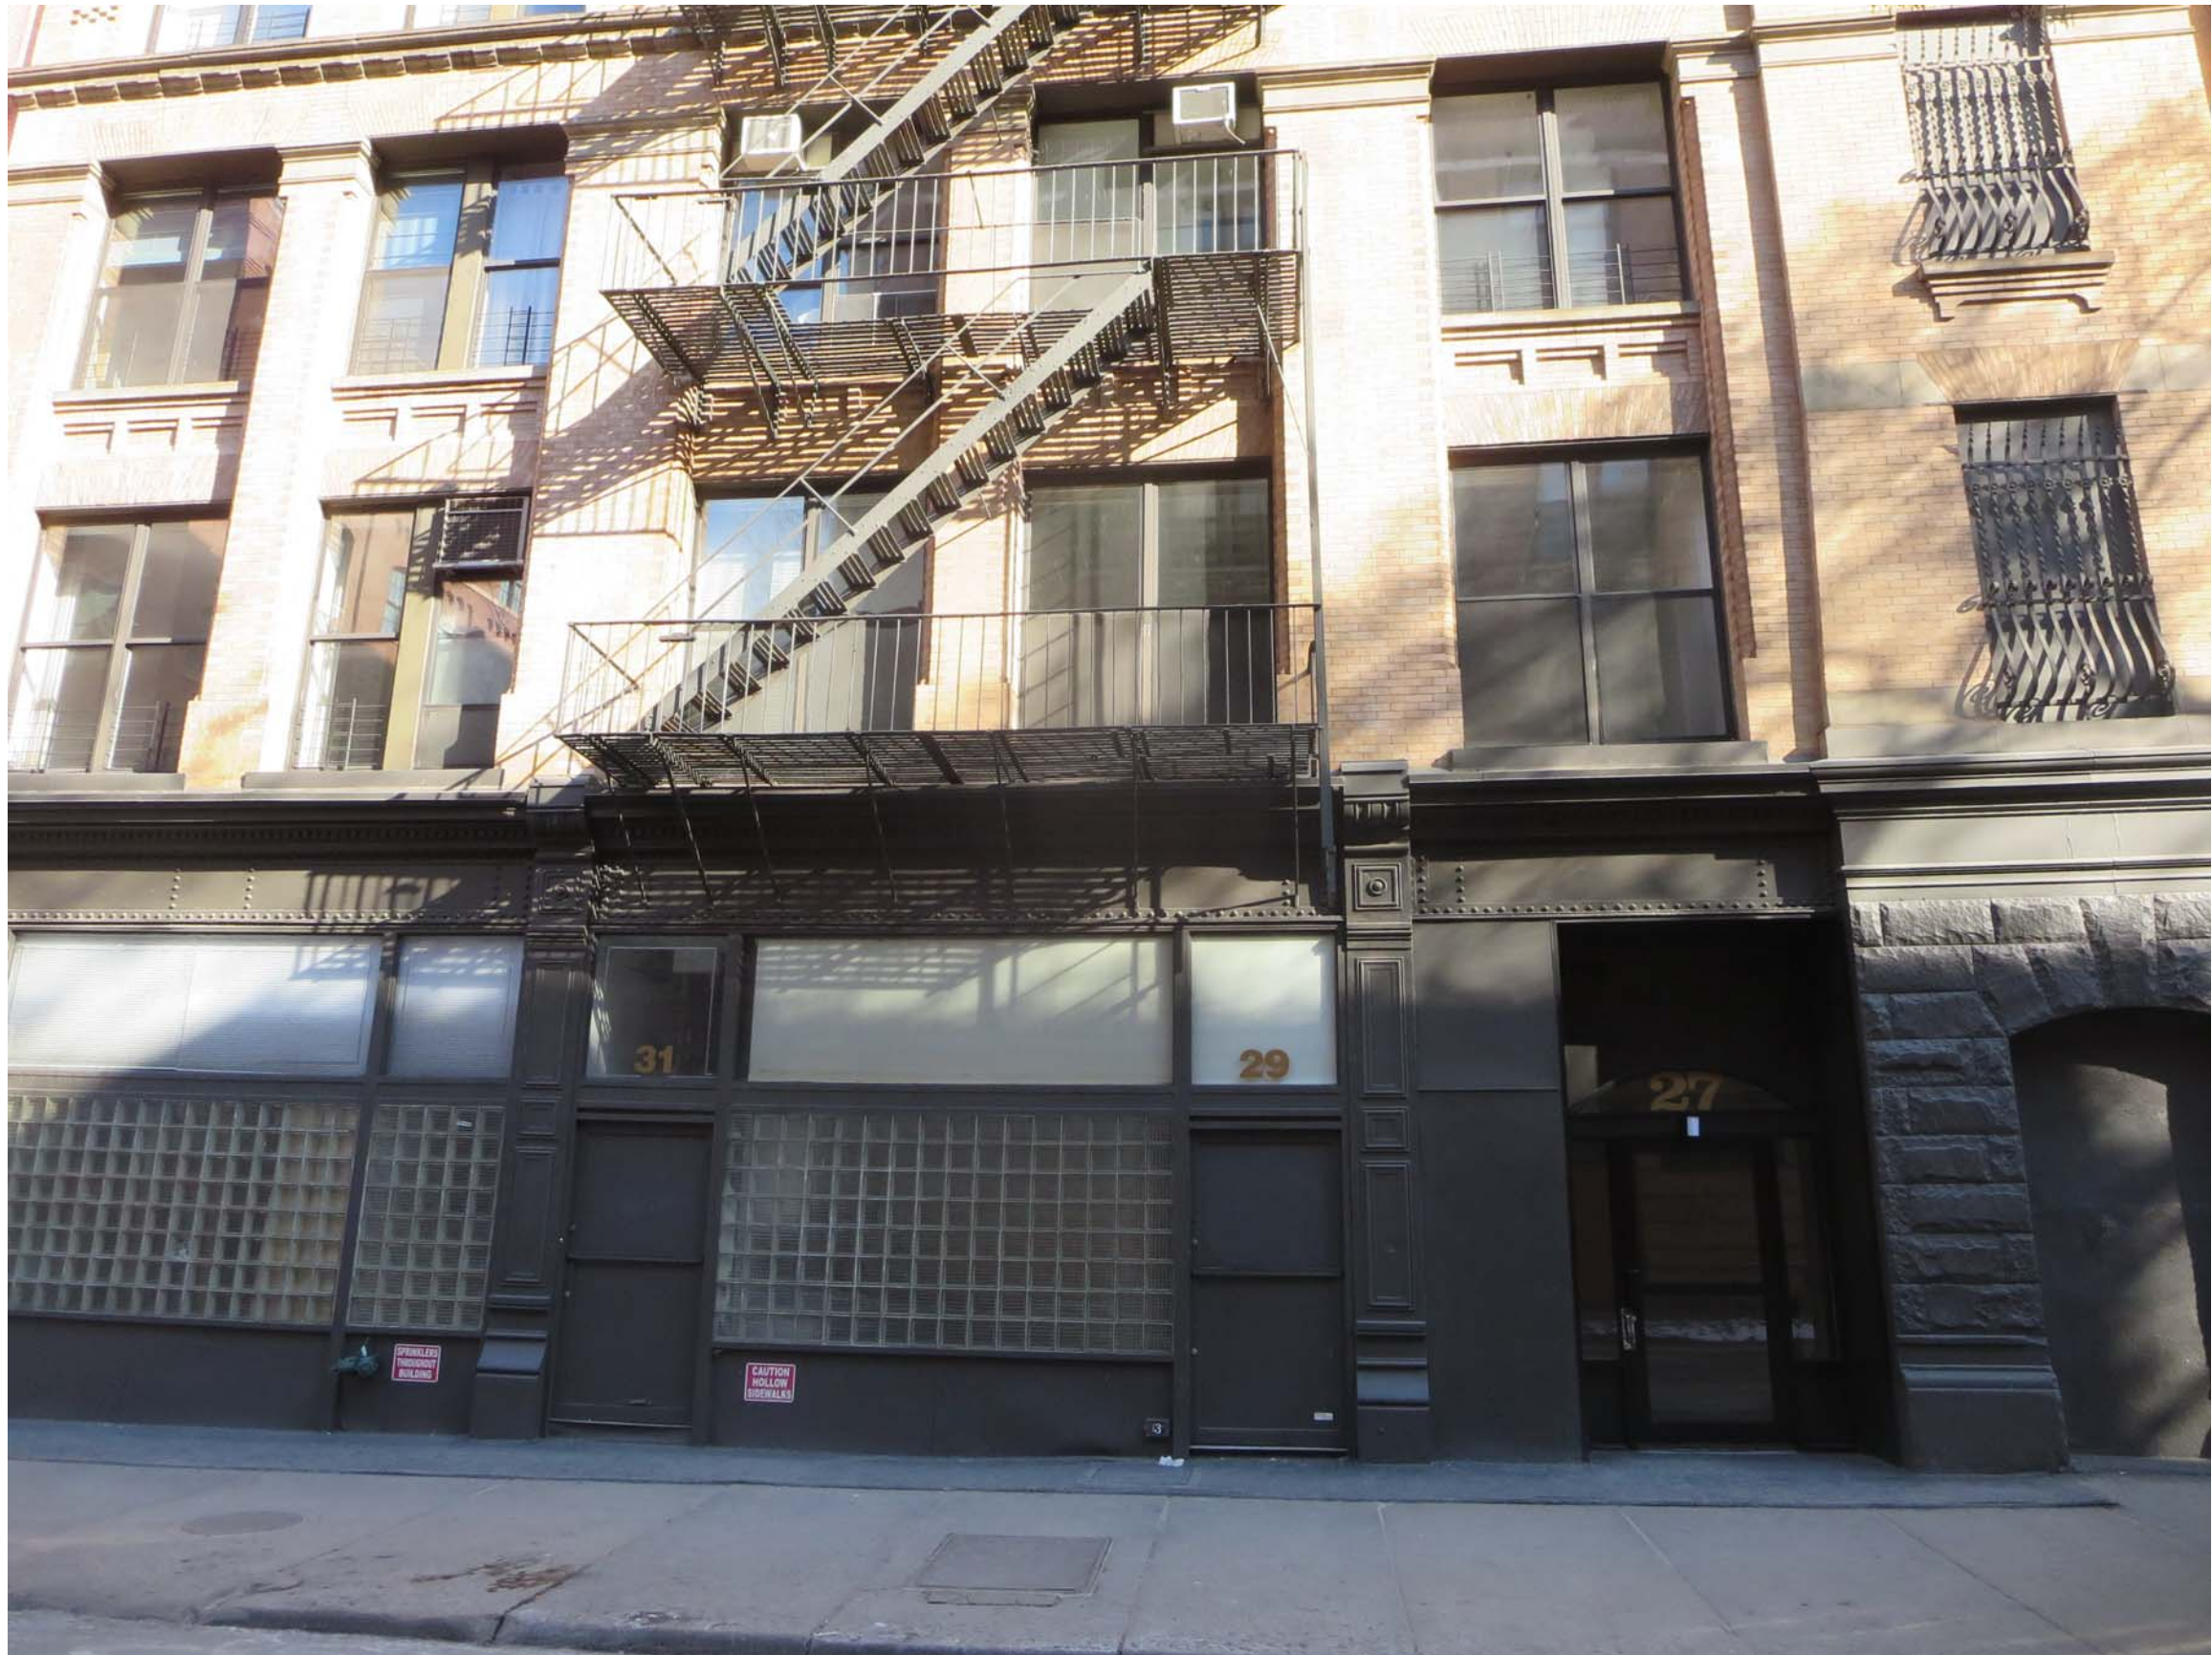
EXISTING CONDITIONS PRIOR TO INVESTIGATION

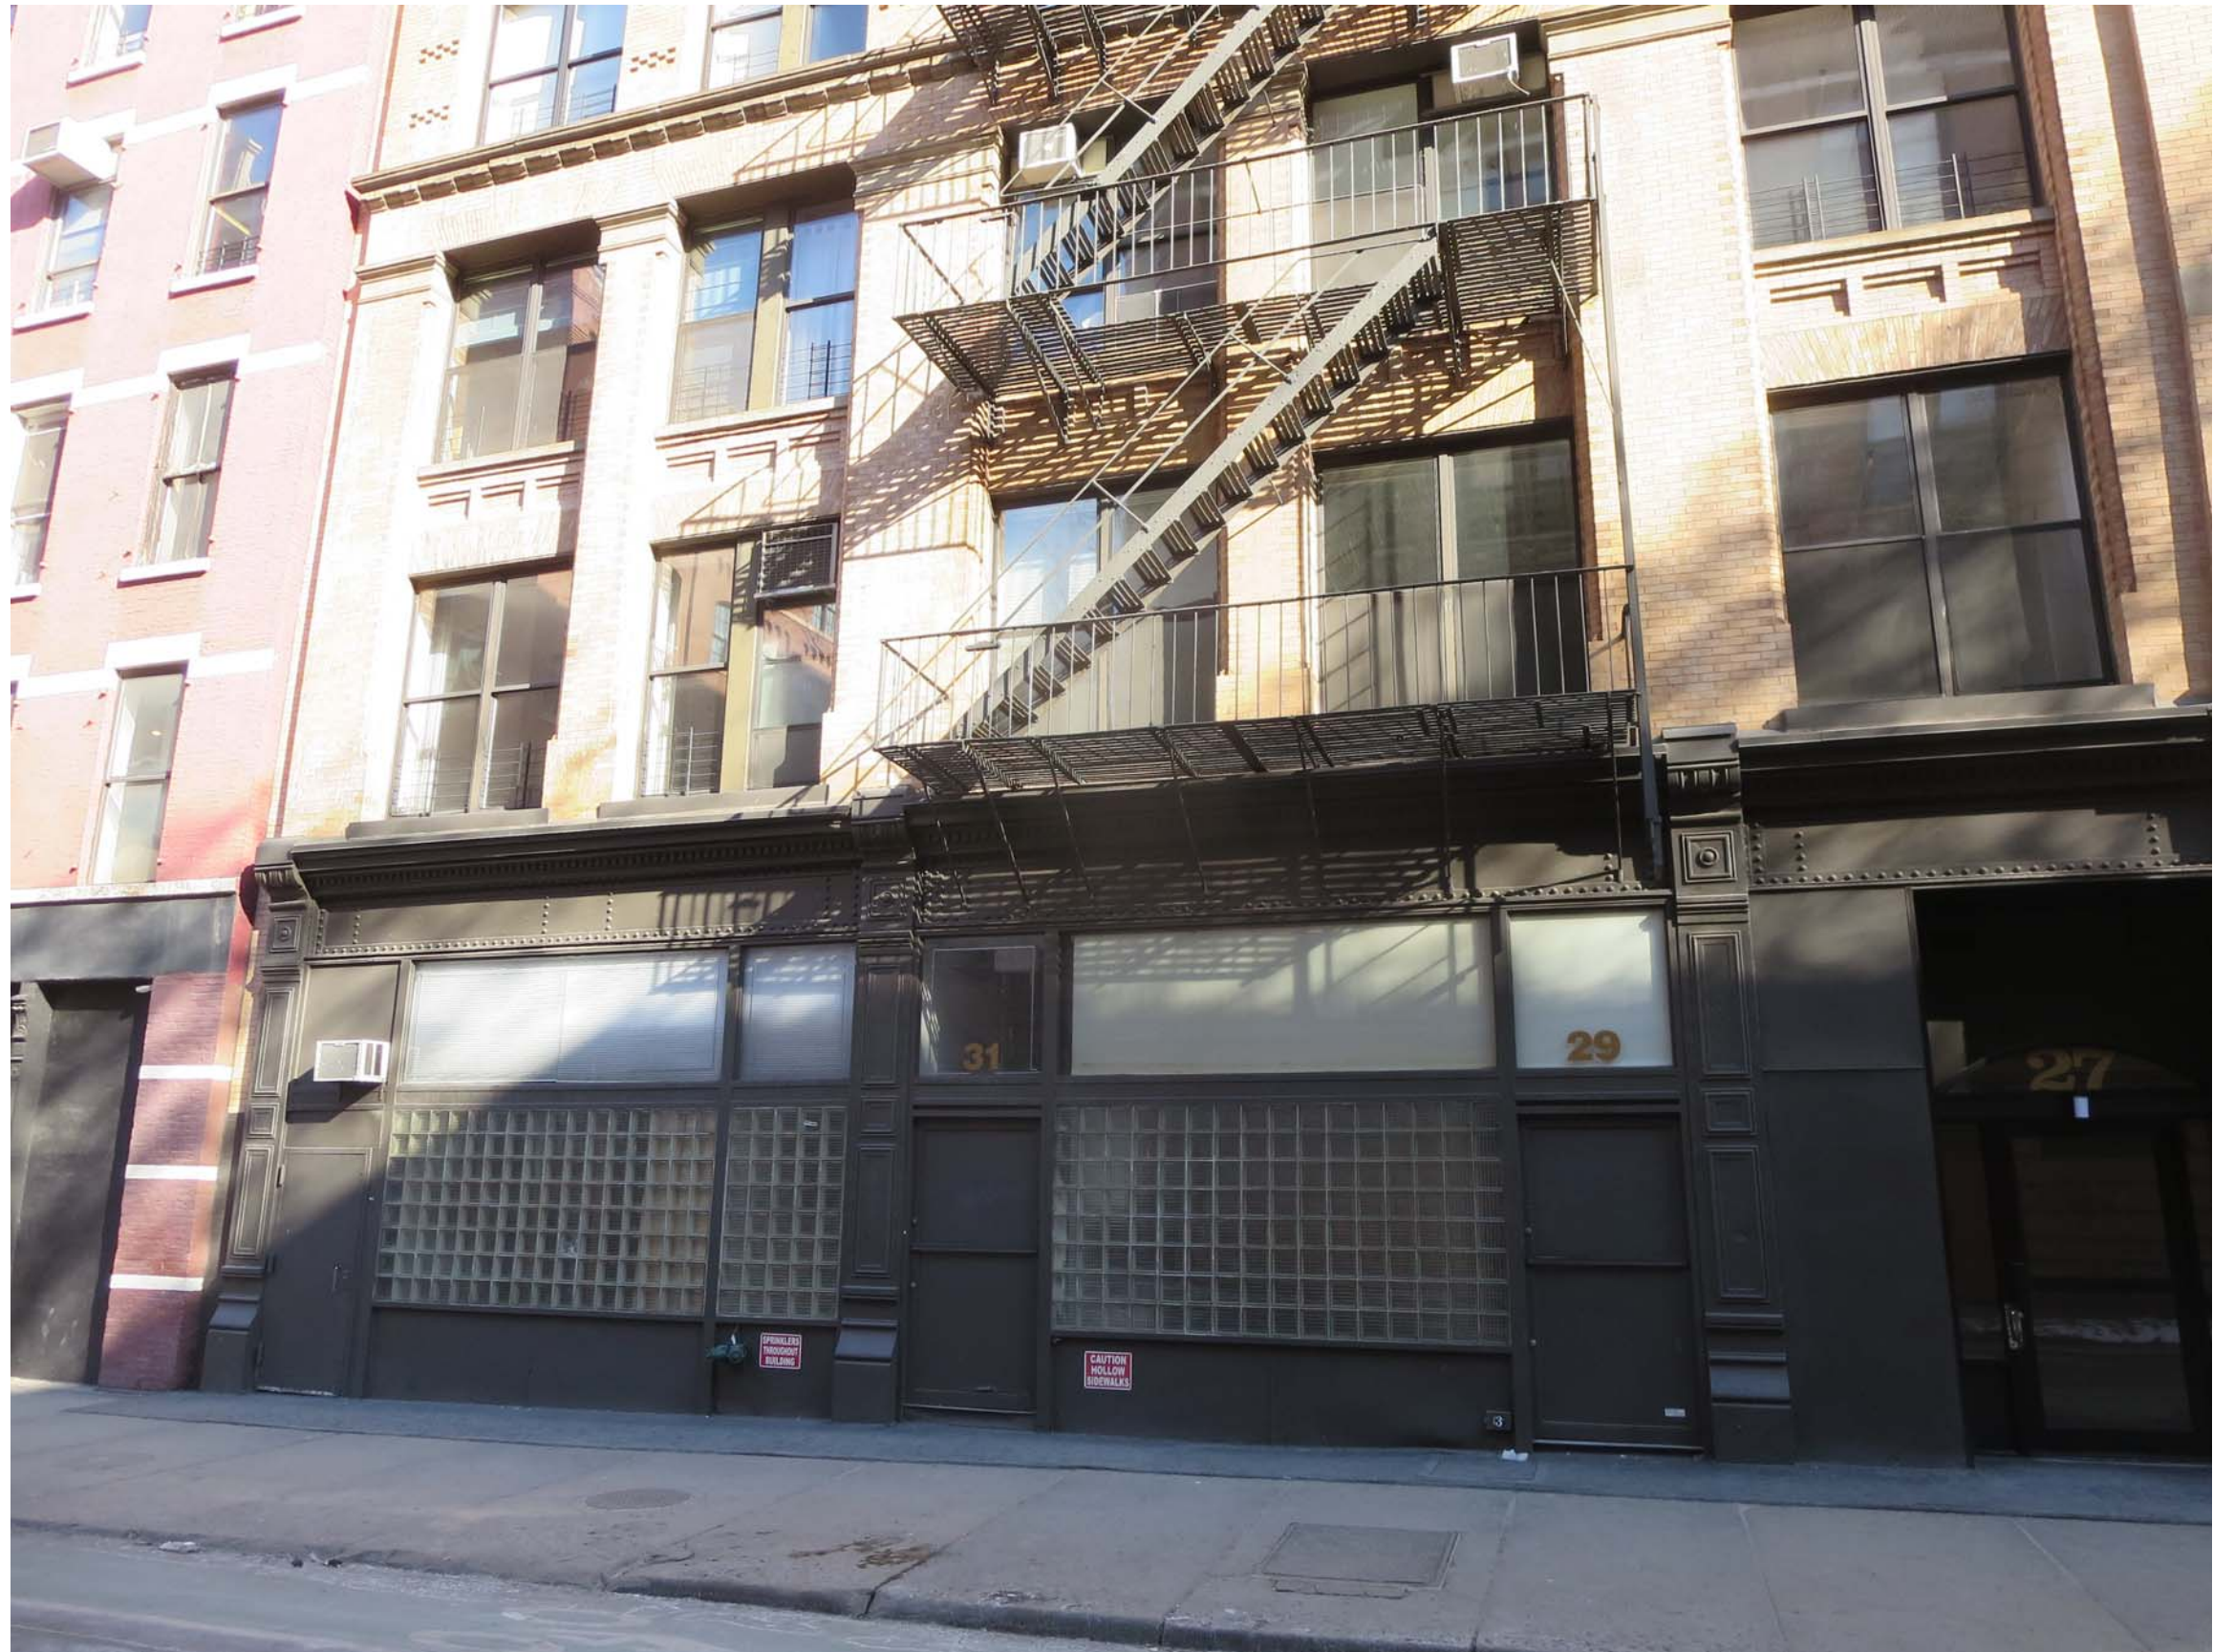
EXISTING CONDITIONS PRIOR TO INVESTIGATION

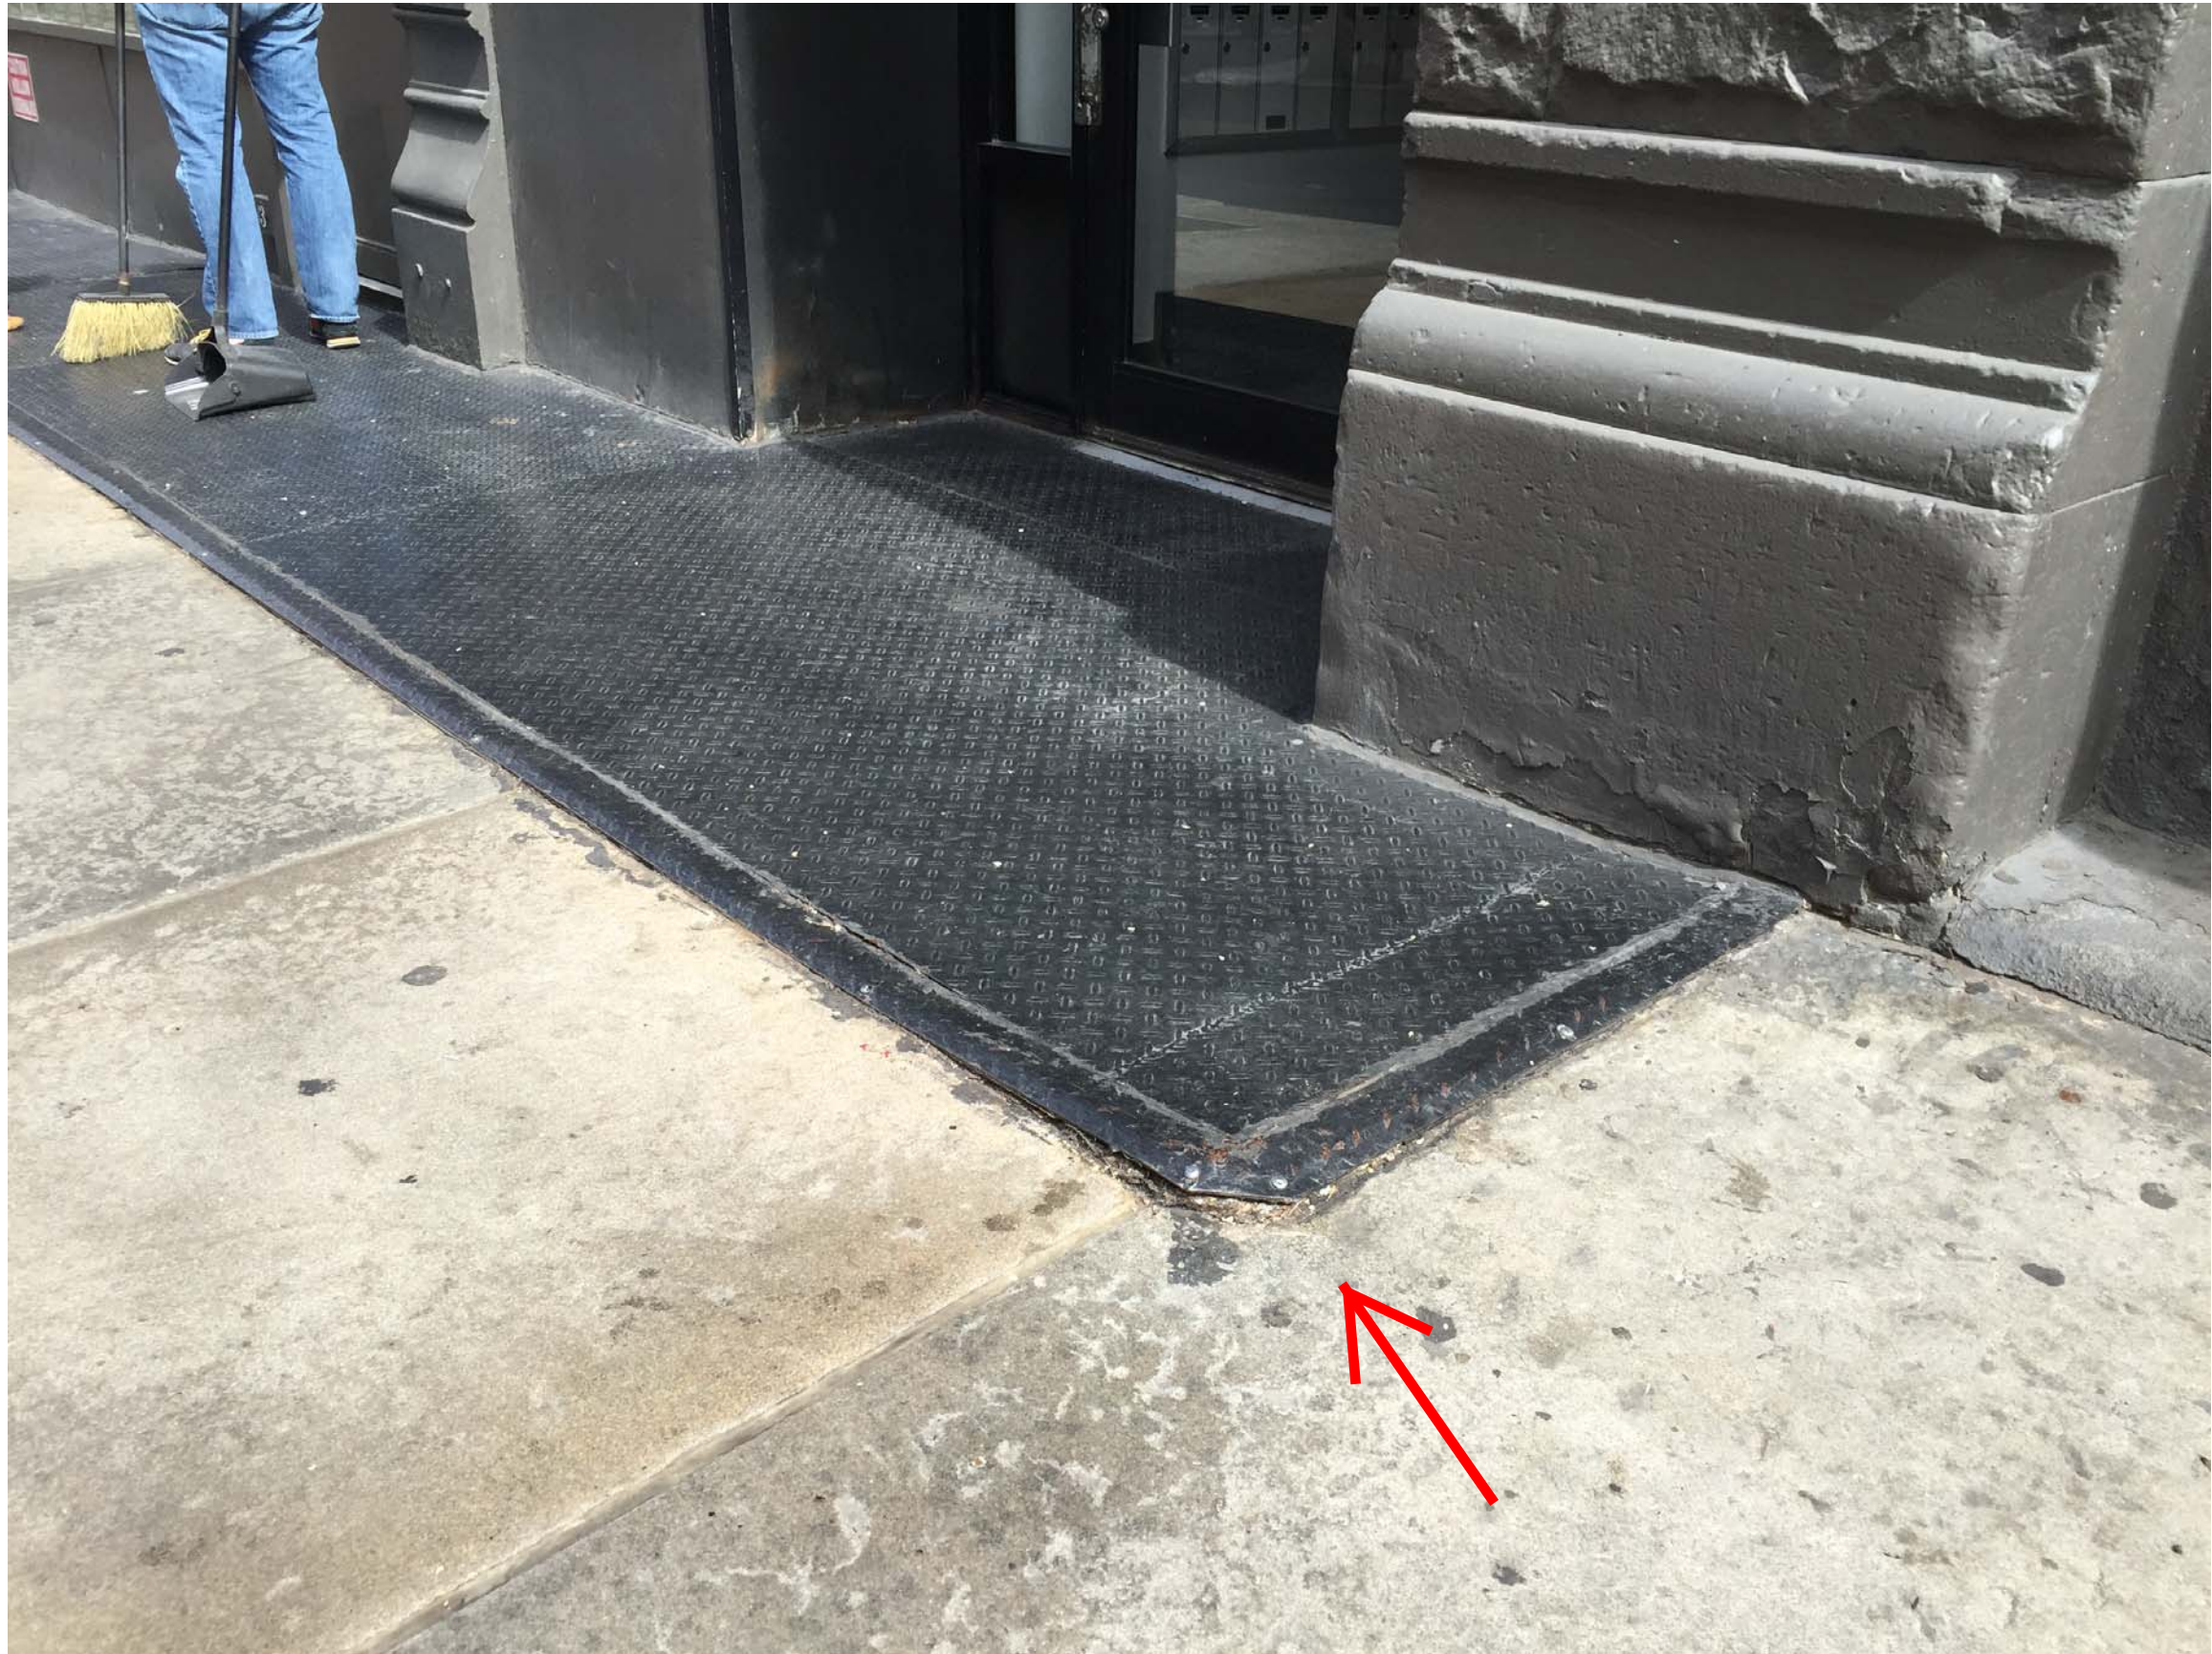
DEFECTIVE STEEL PLATES LIFTED AT THE TRIM

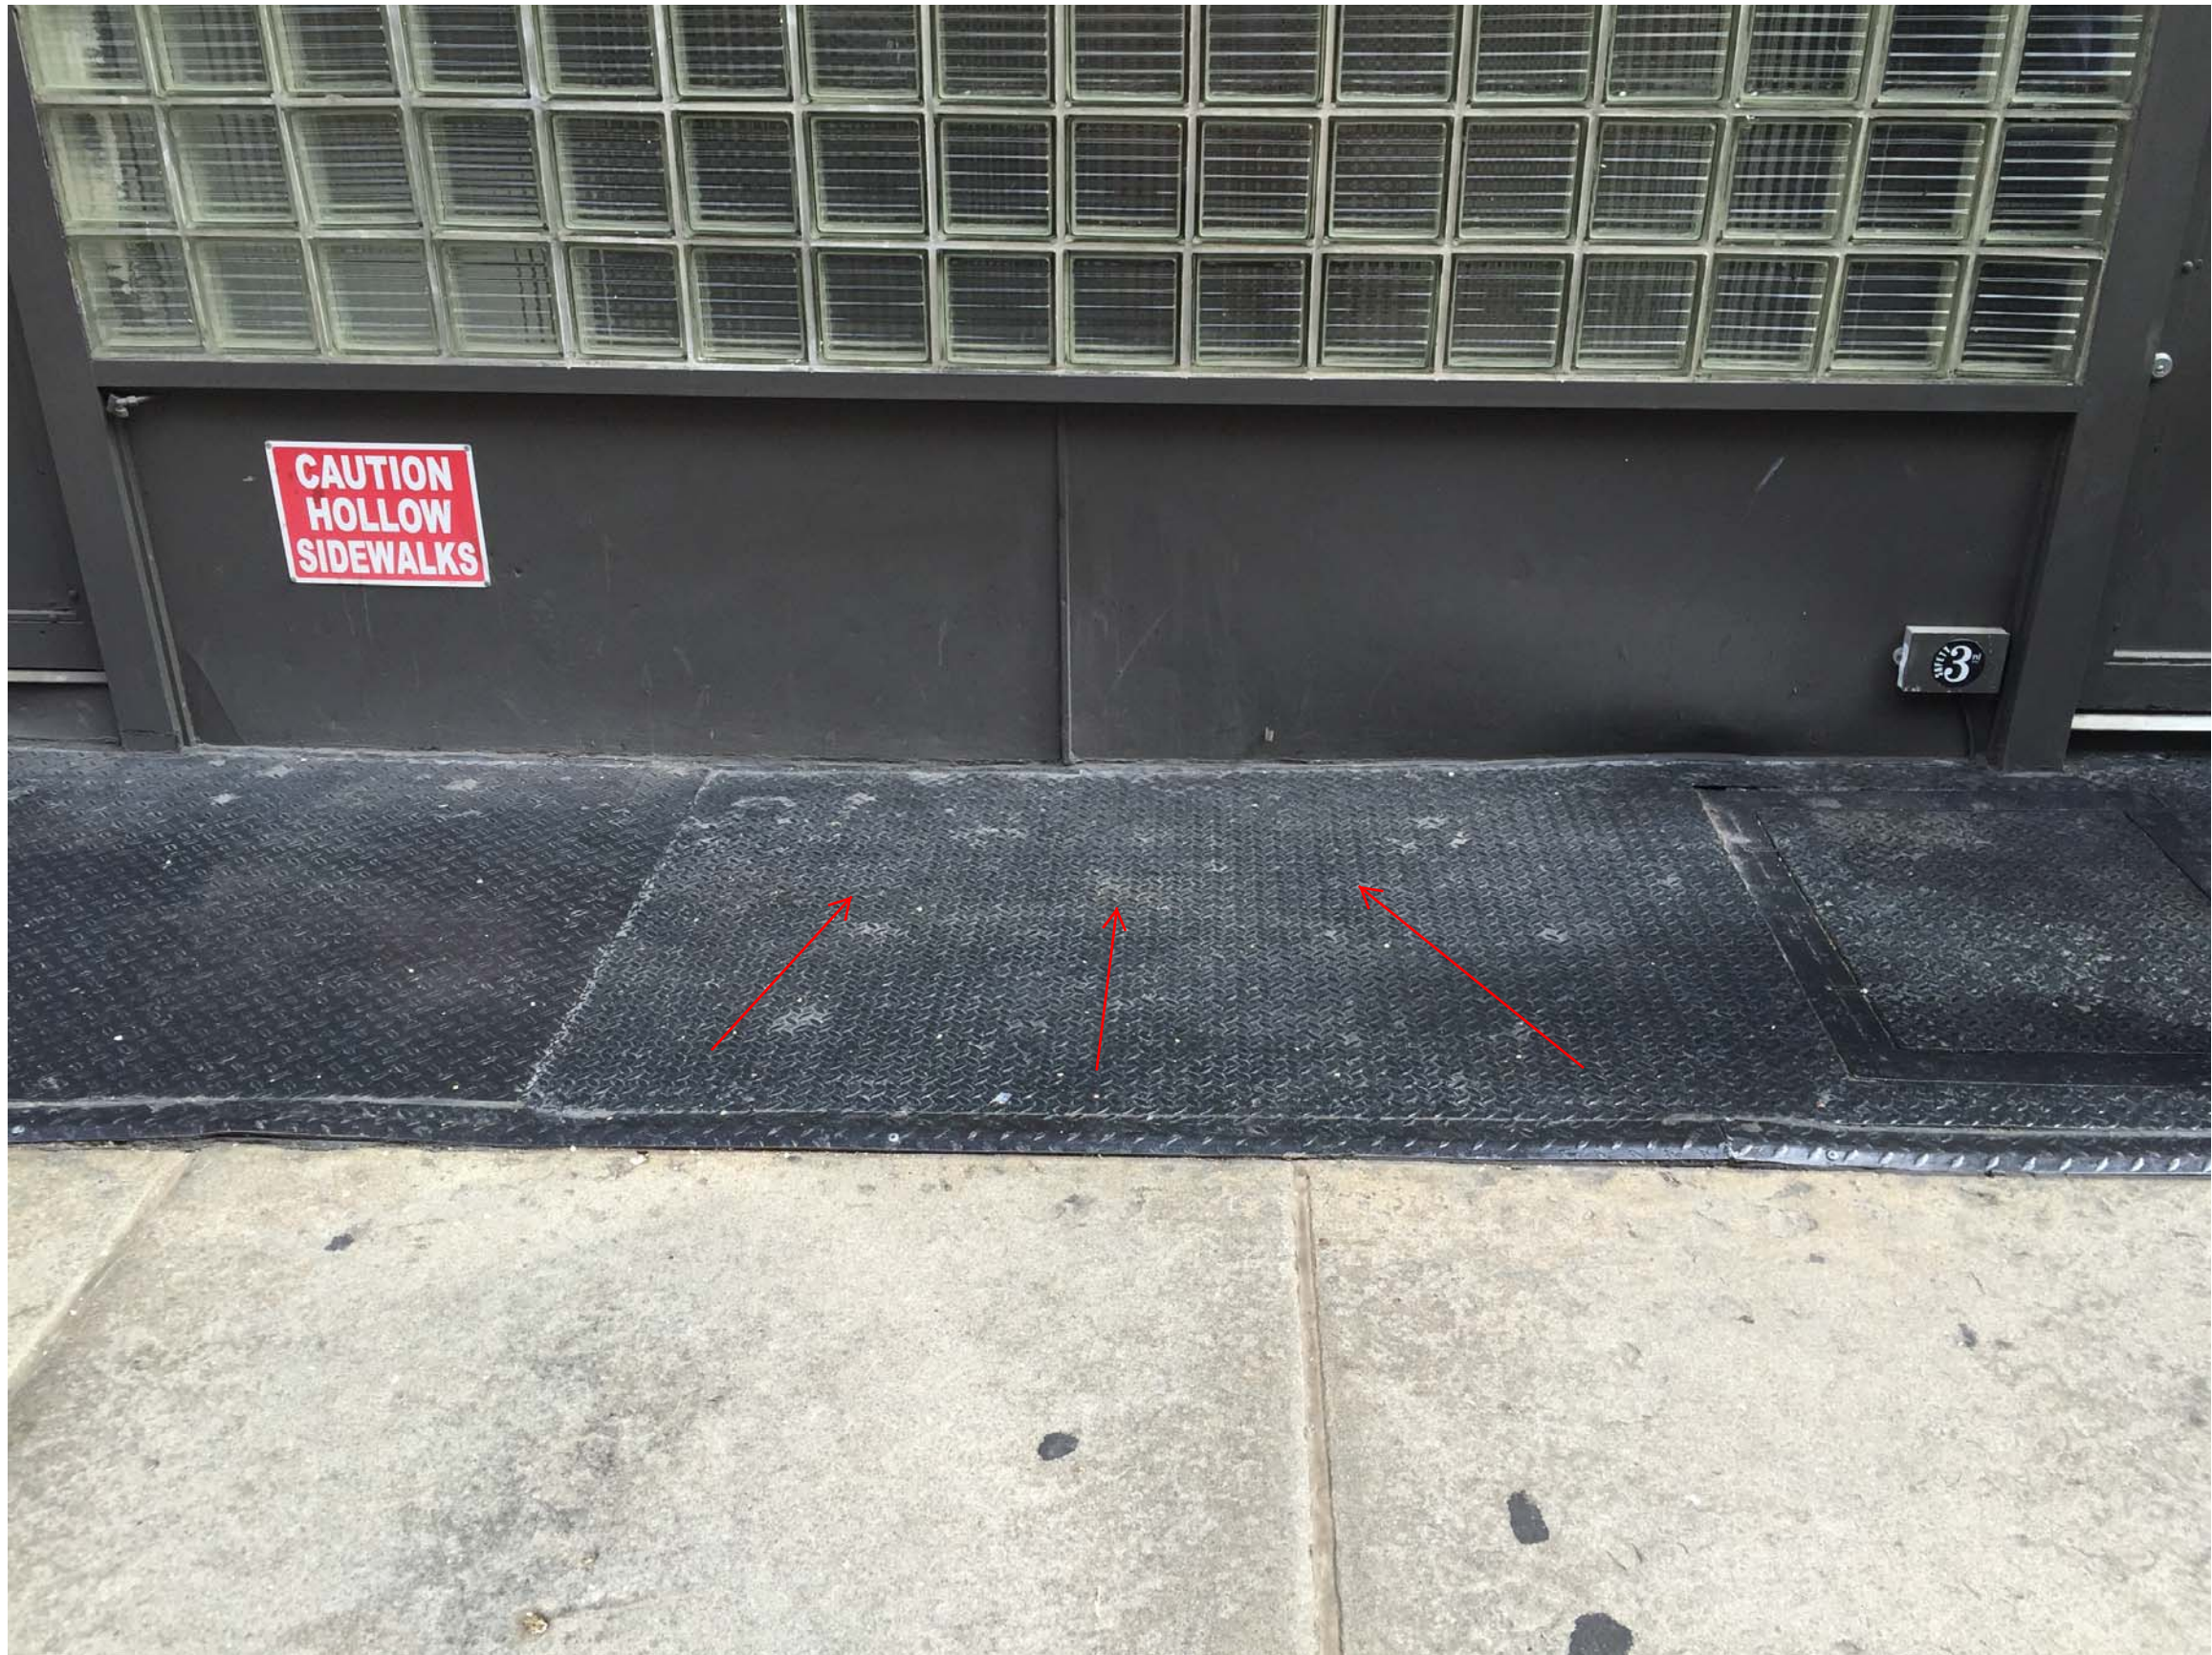
BOWED STEEL PLATING ALLOWING WATER TO POOL AND INFILTRATE

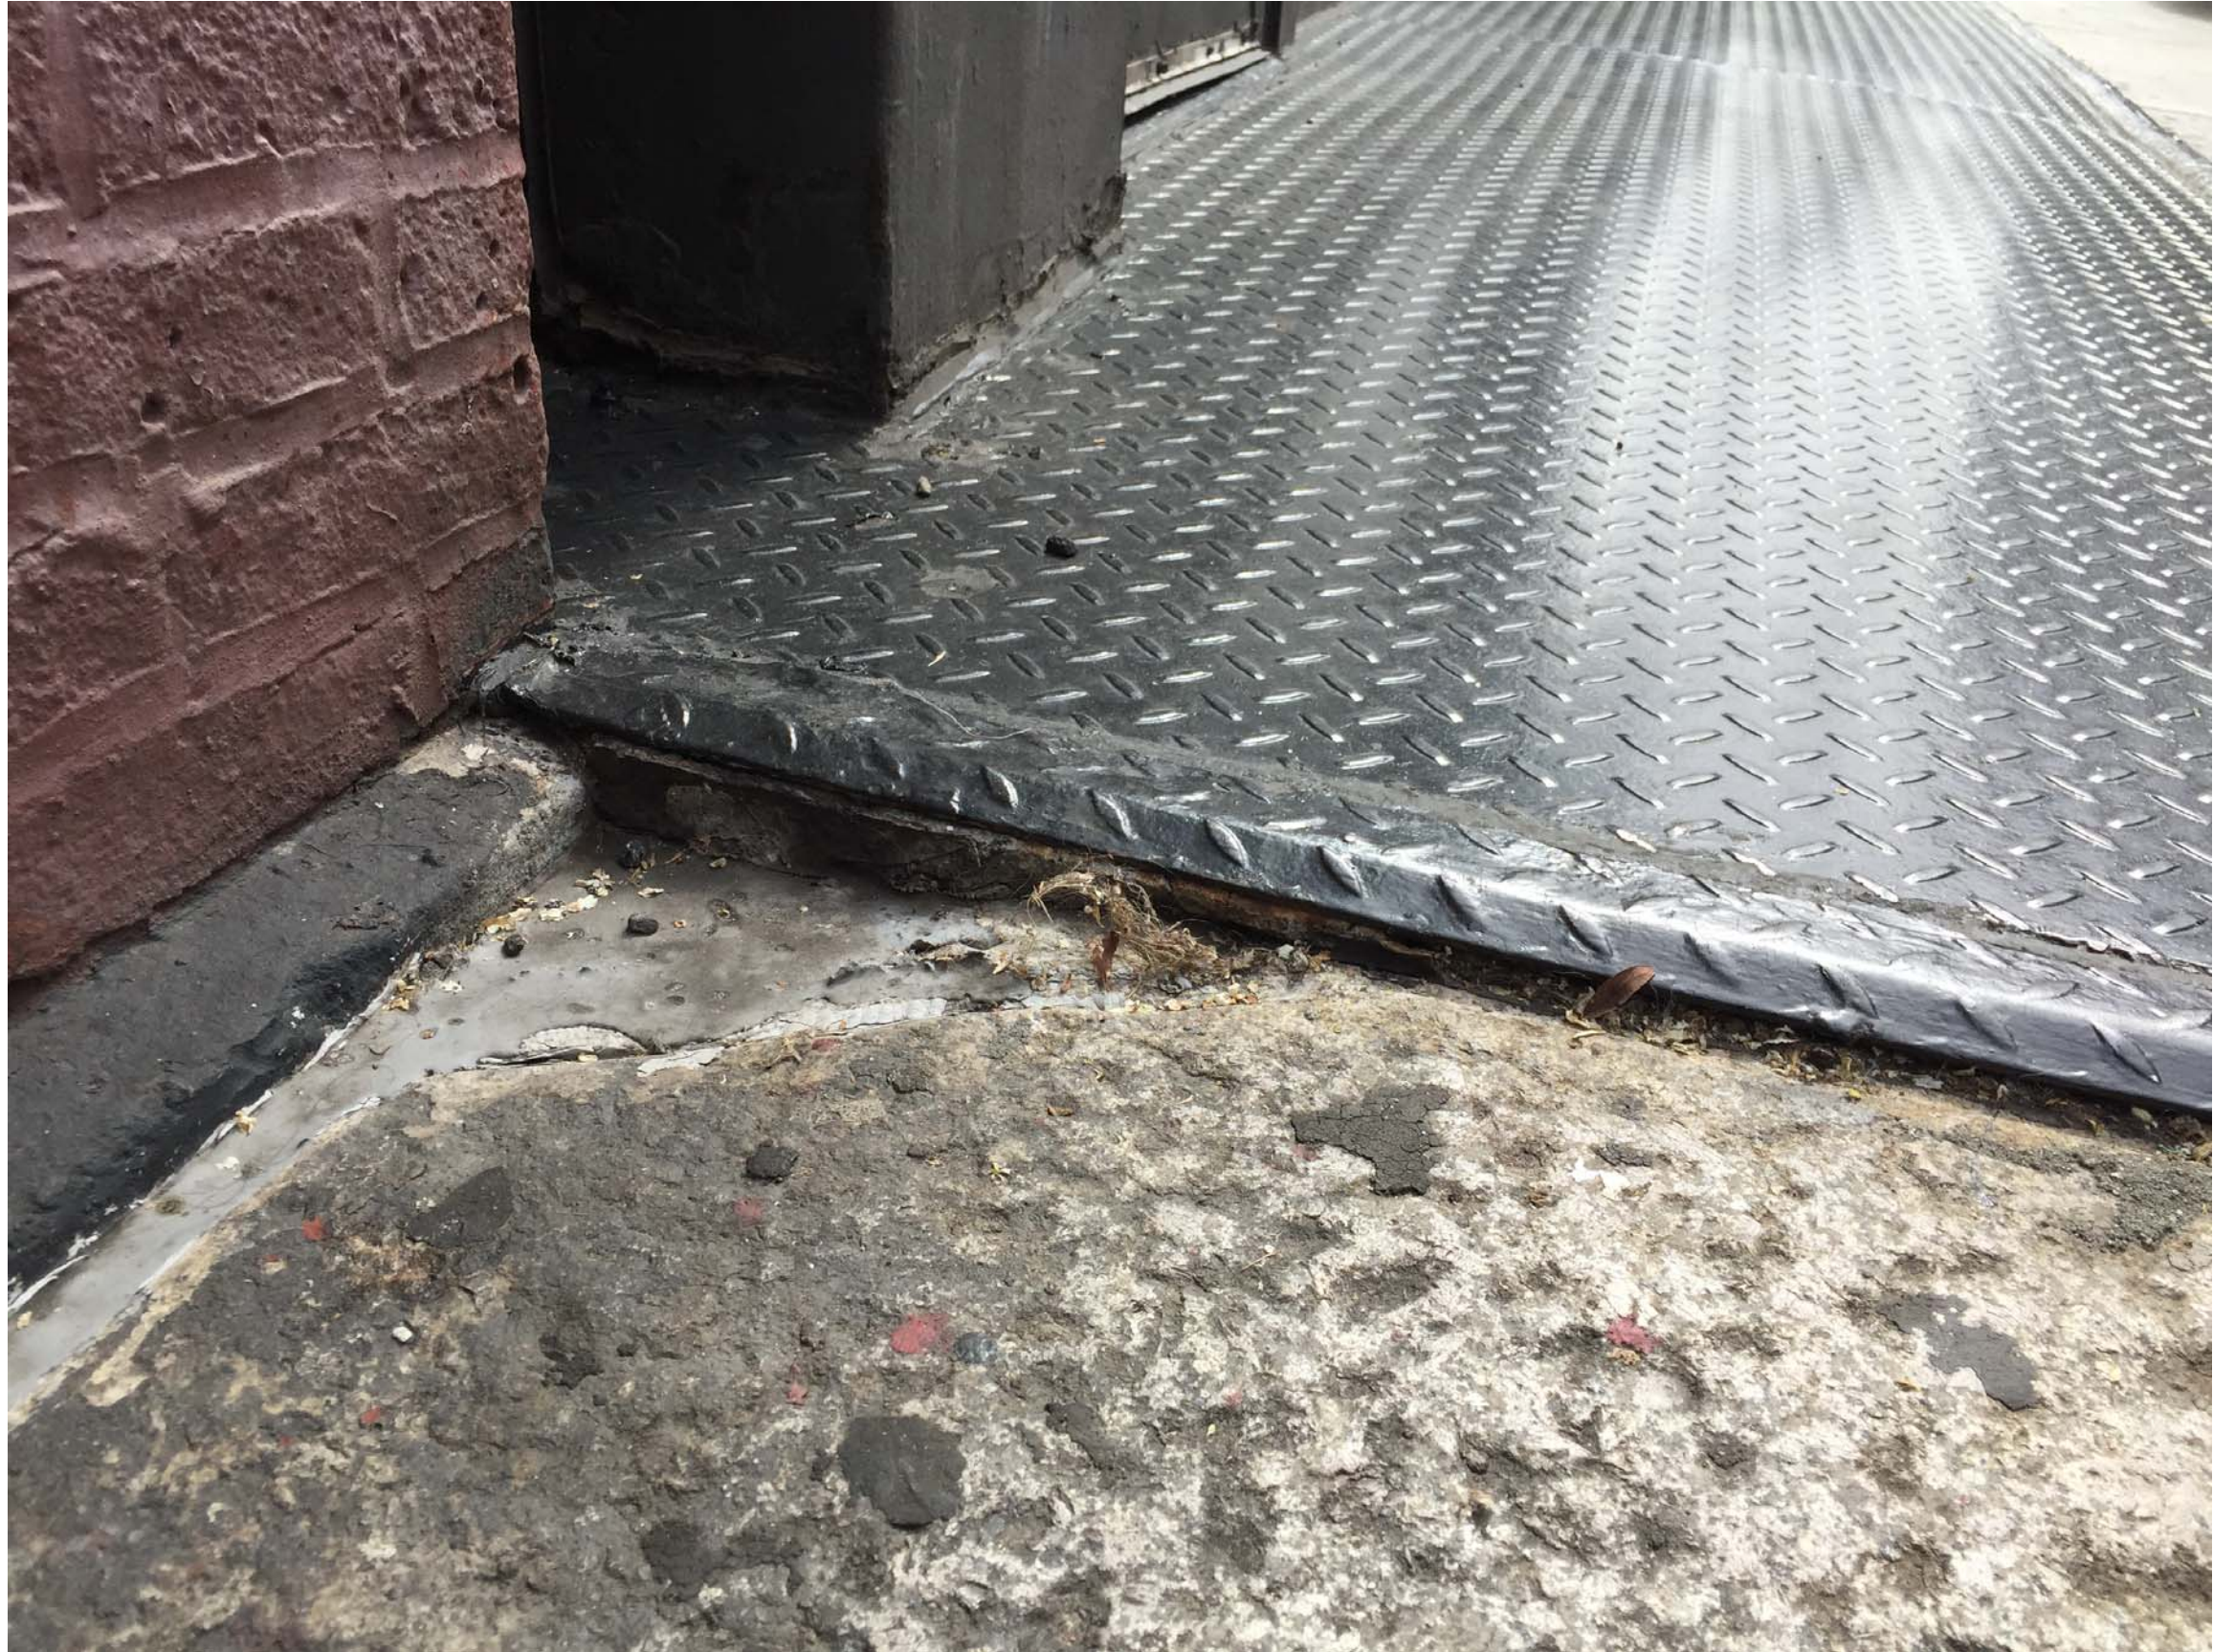
STEEL PLATE CONDITIONS AT THE PERIMETER TRIMMING
