27 BLEECKER STREET - PROPOSED SIDEWALK VAULT REPAIRS - DOCKET NUMBER #17-3280

DRAFT

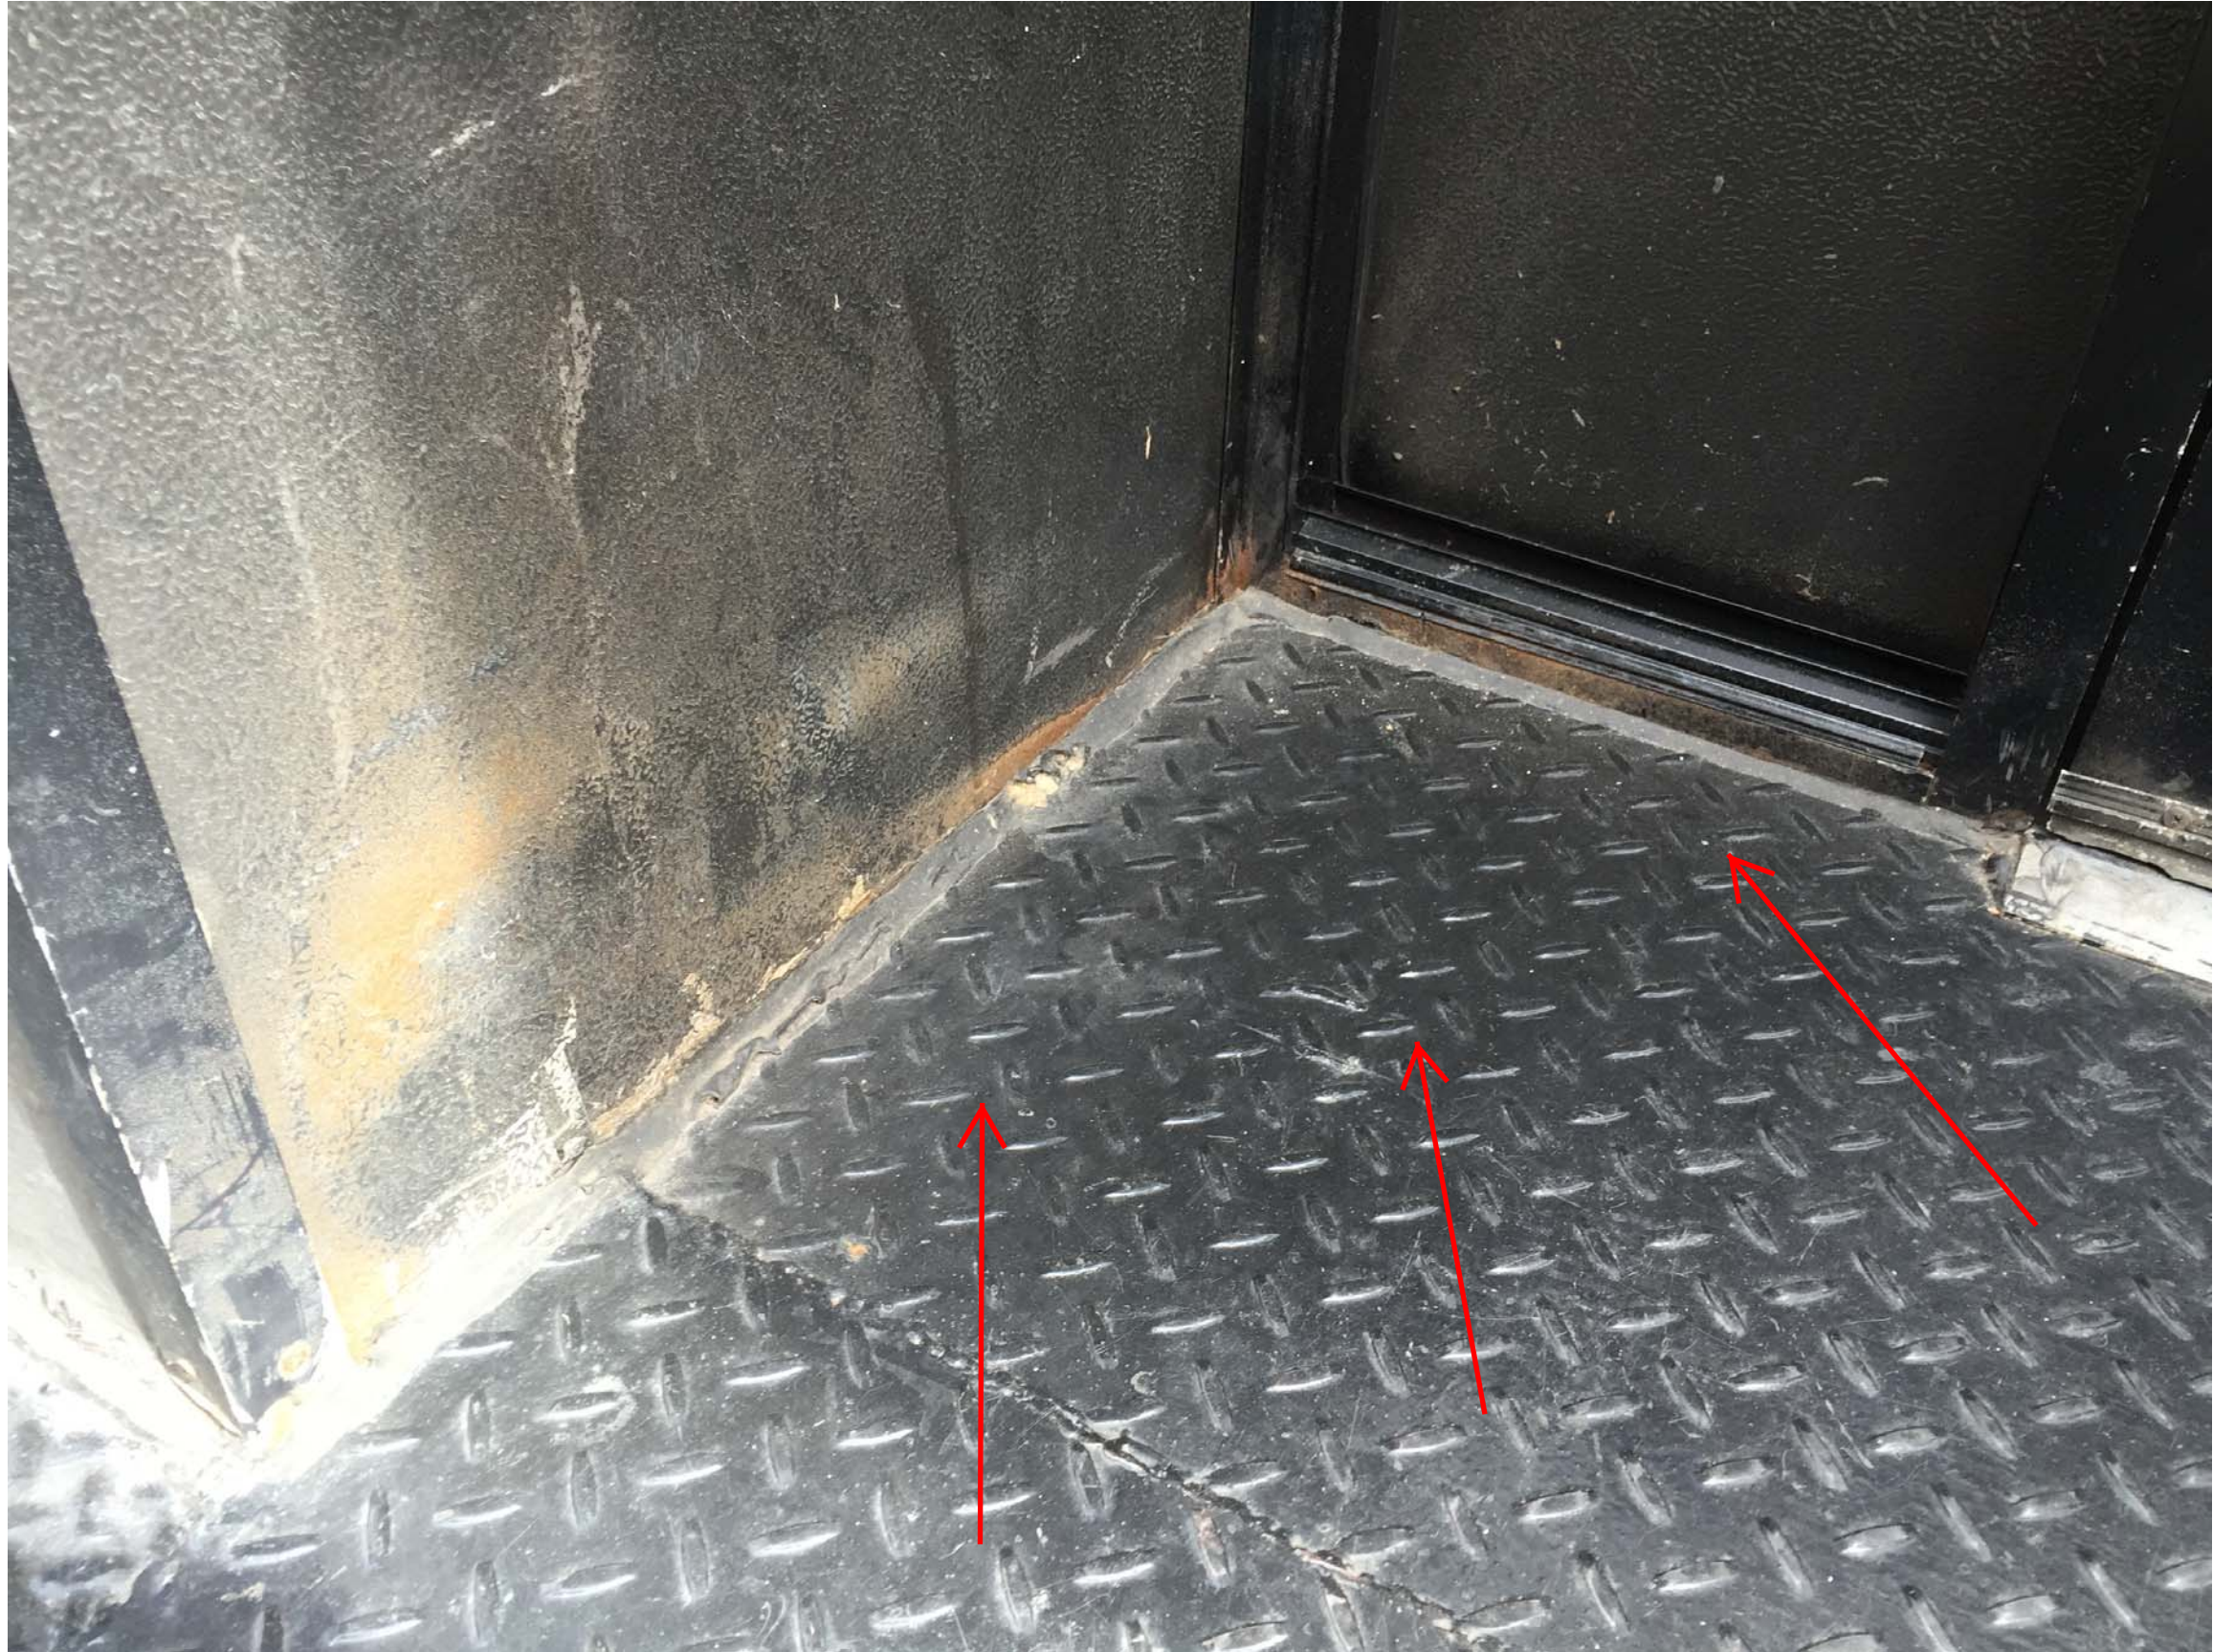
BACK PITCHED PLATING CAUSING WAER INFILTRATION INTO BUILDING ENTRANCE

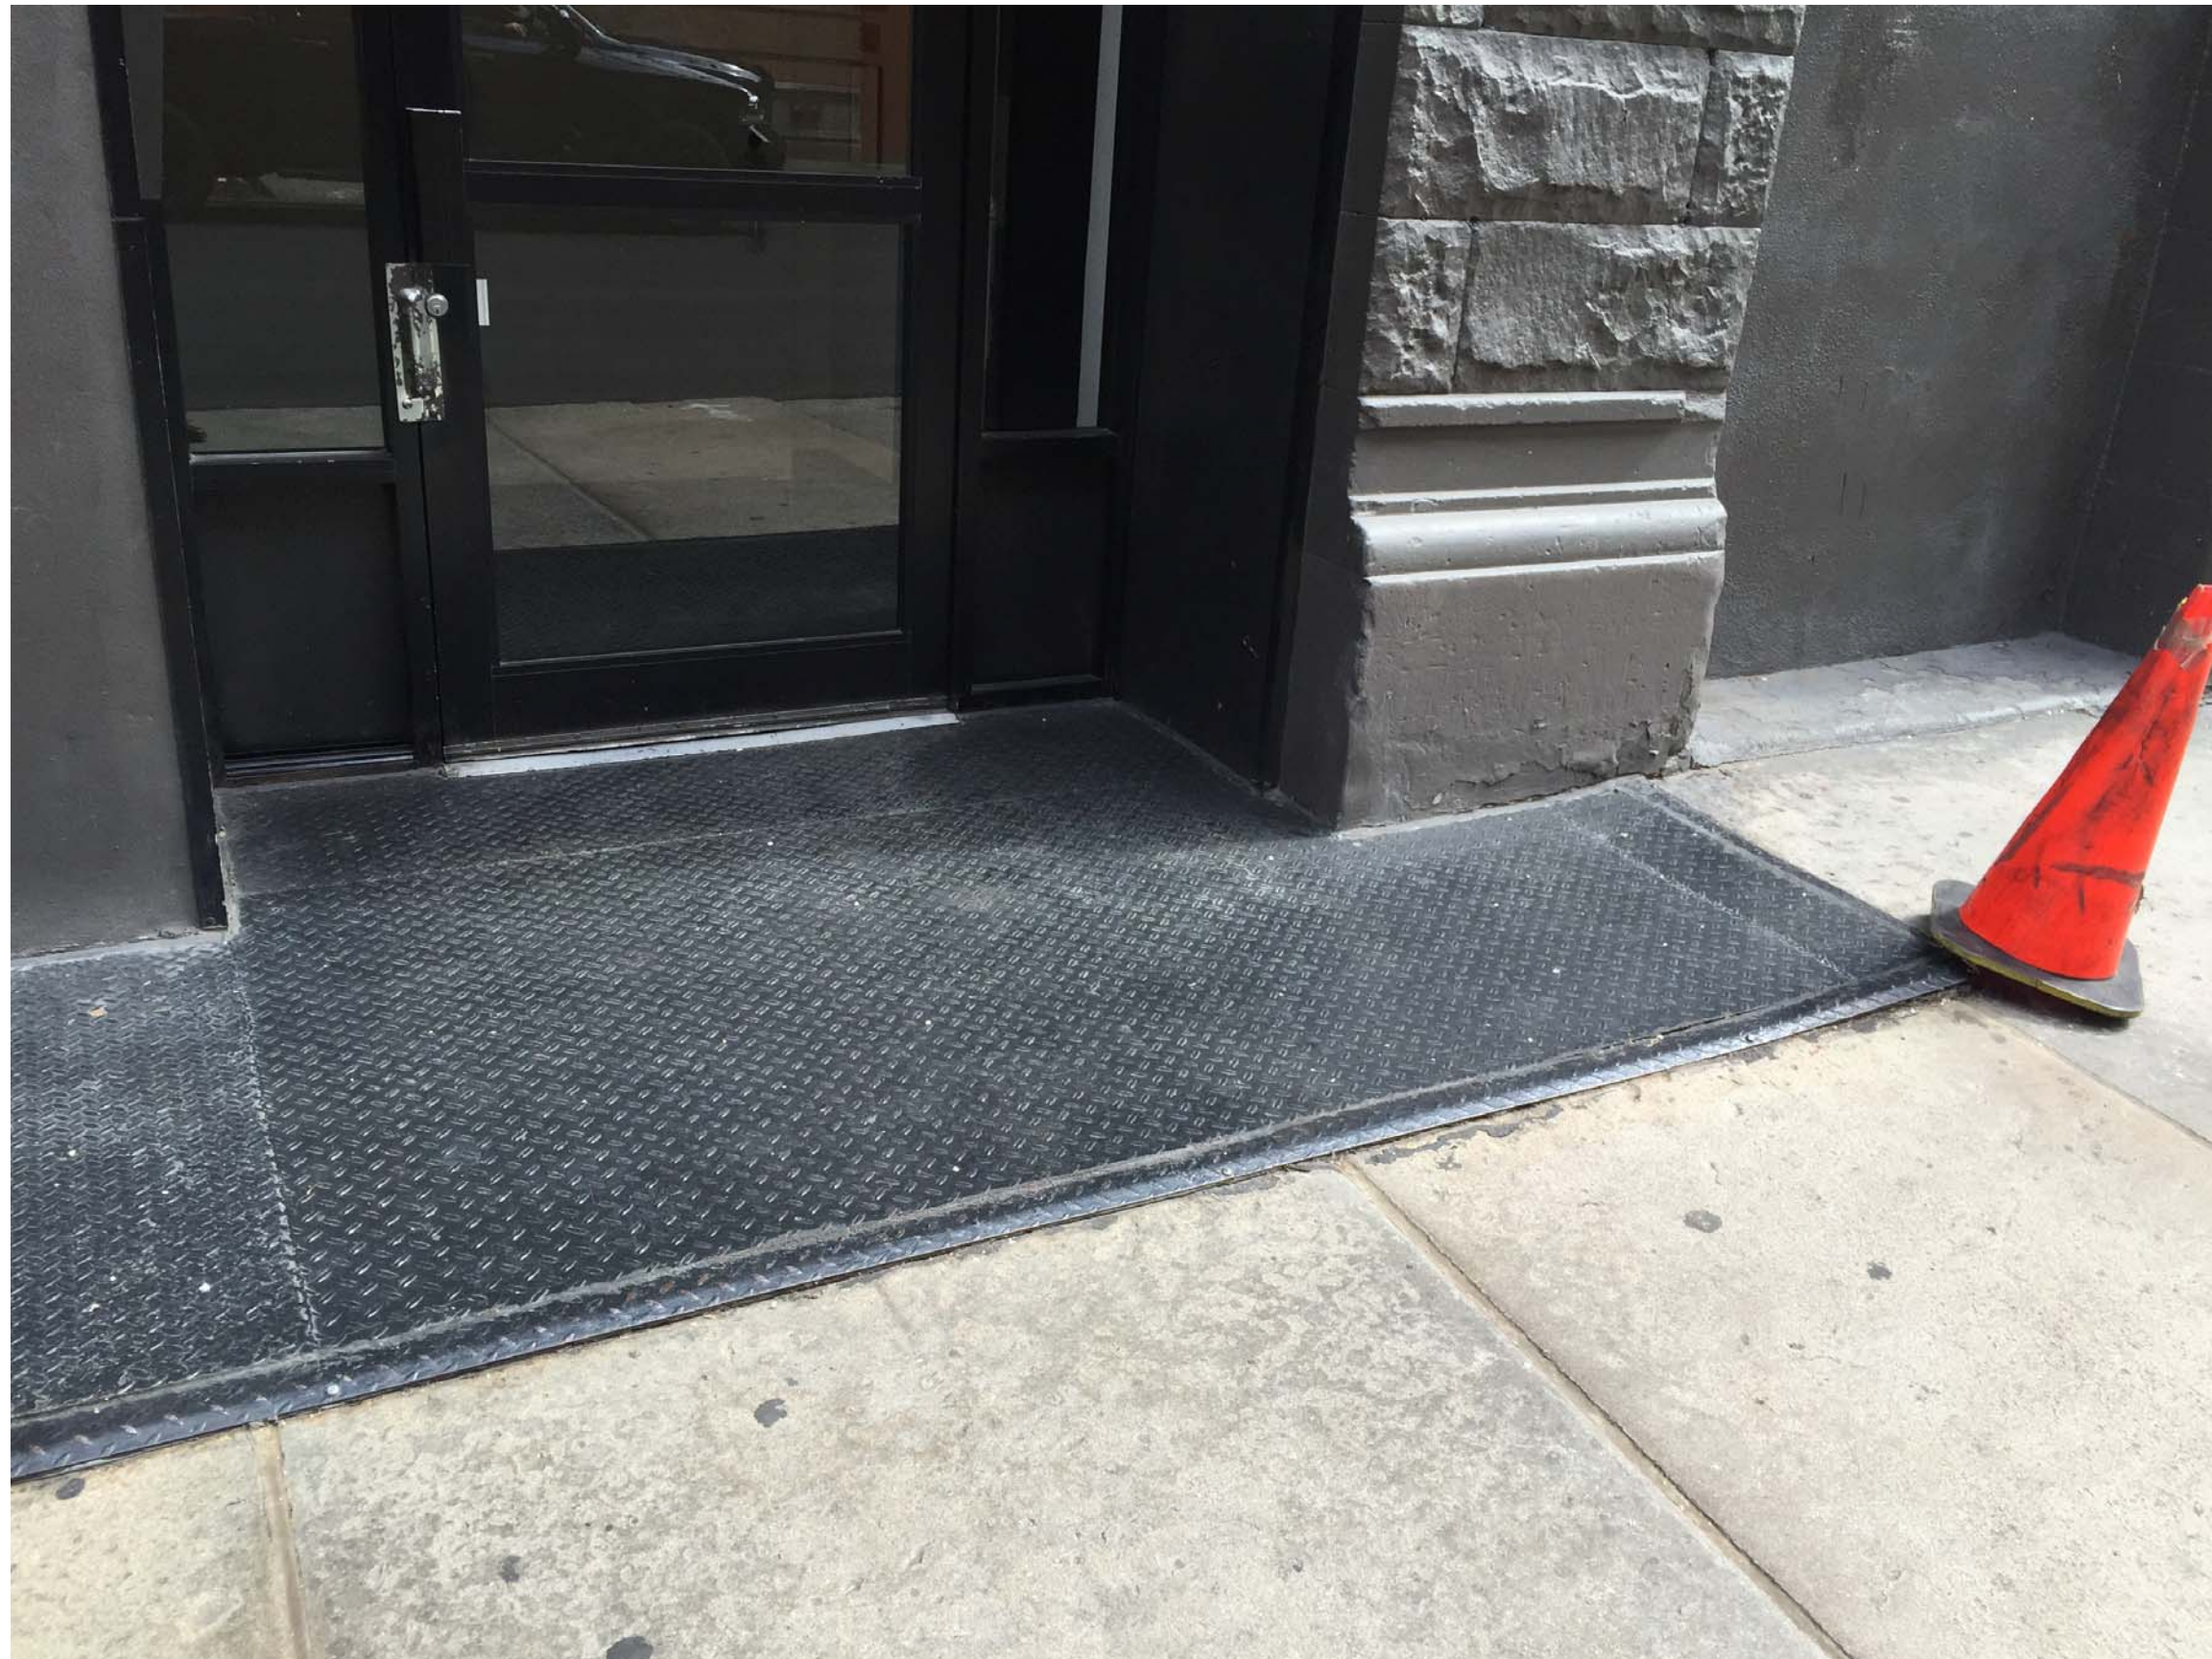
PRECAUTIONARY MEASURES FOR TRIP HAZARD CAUSED BY THE DAMAGE

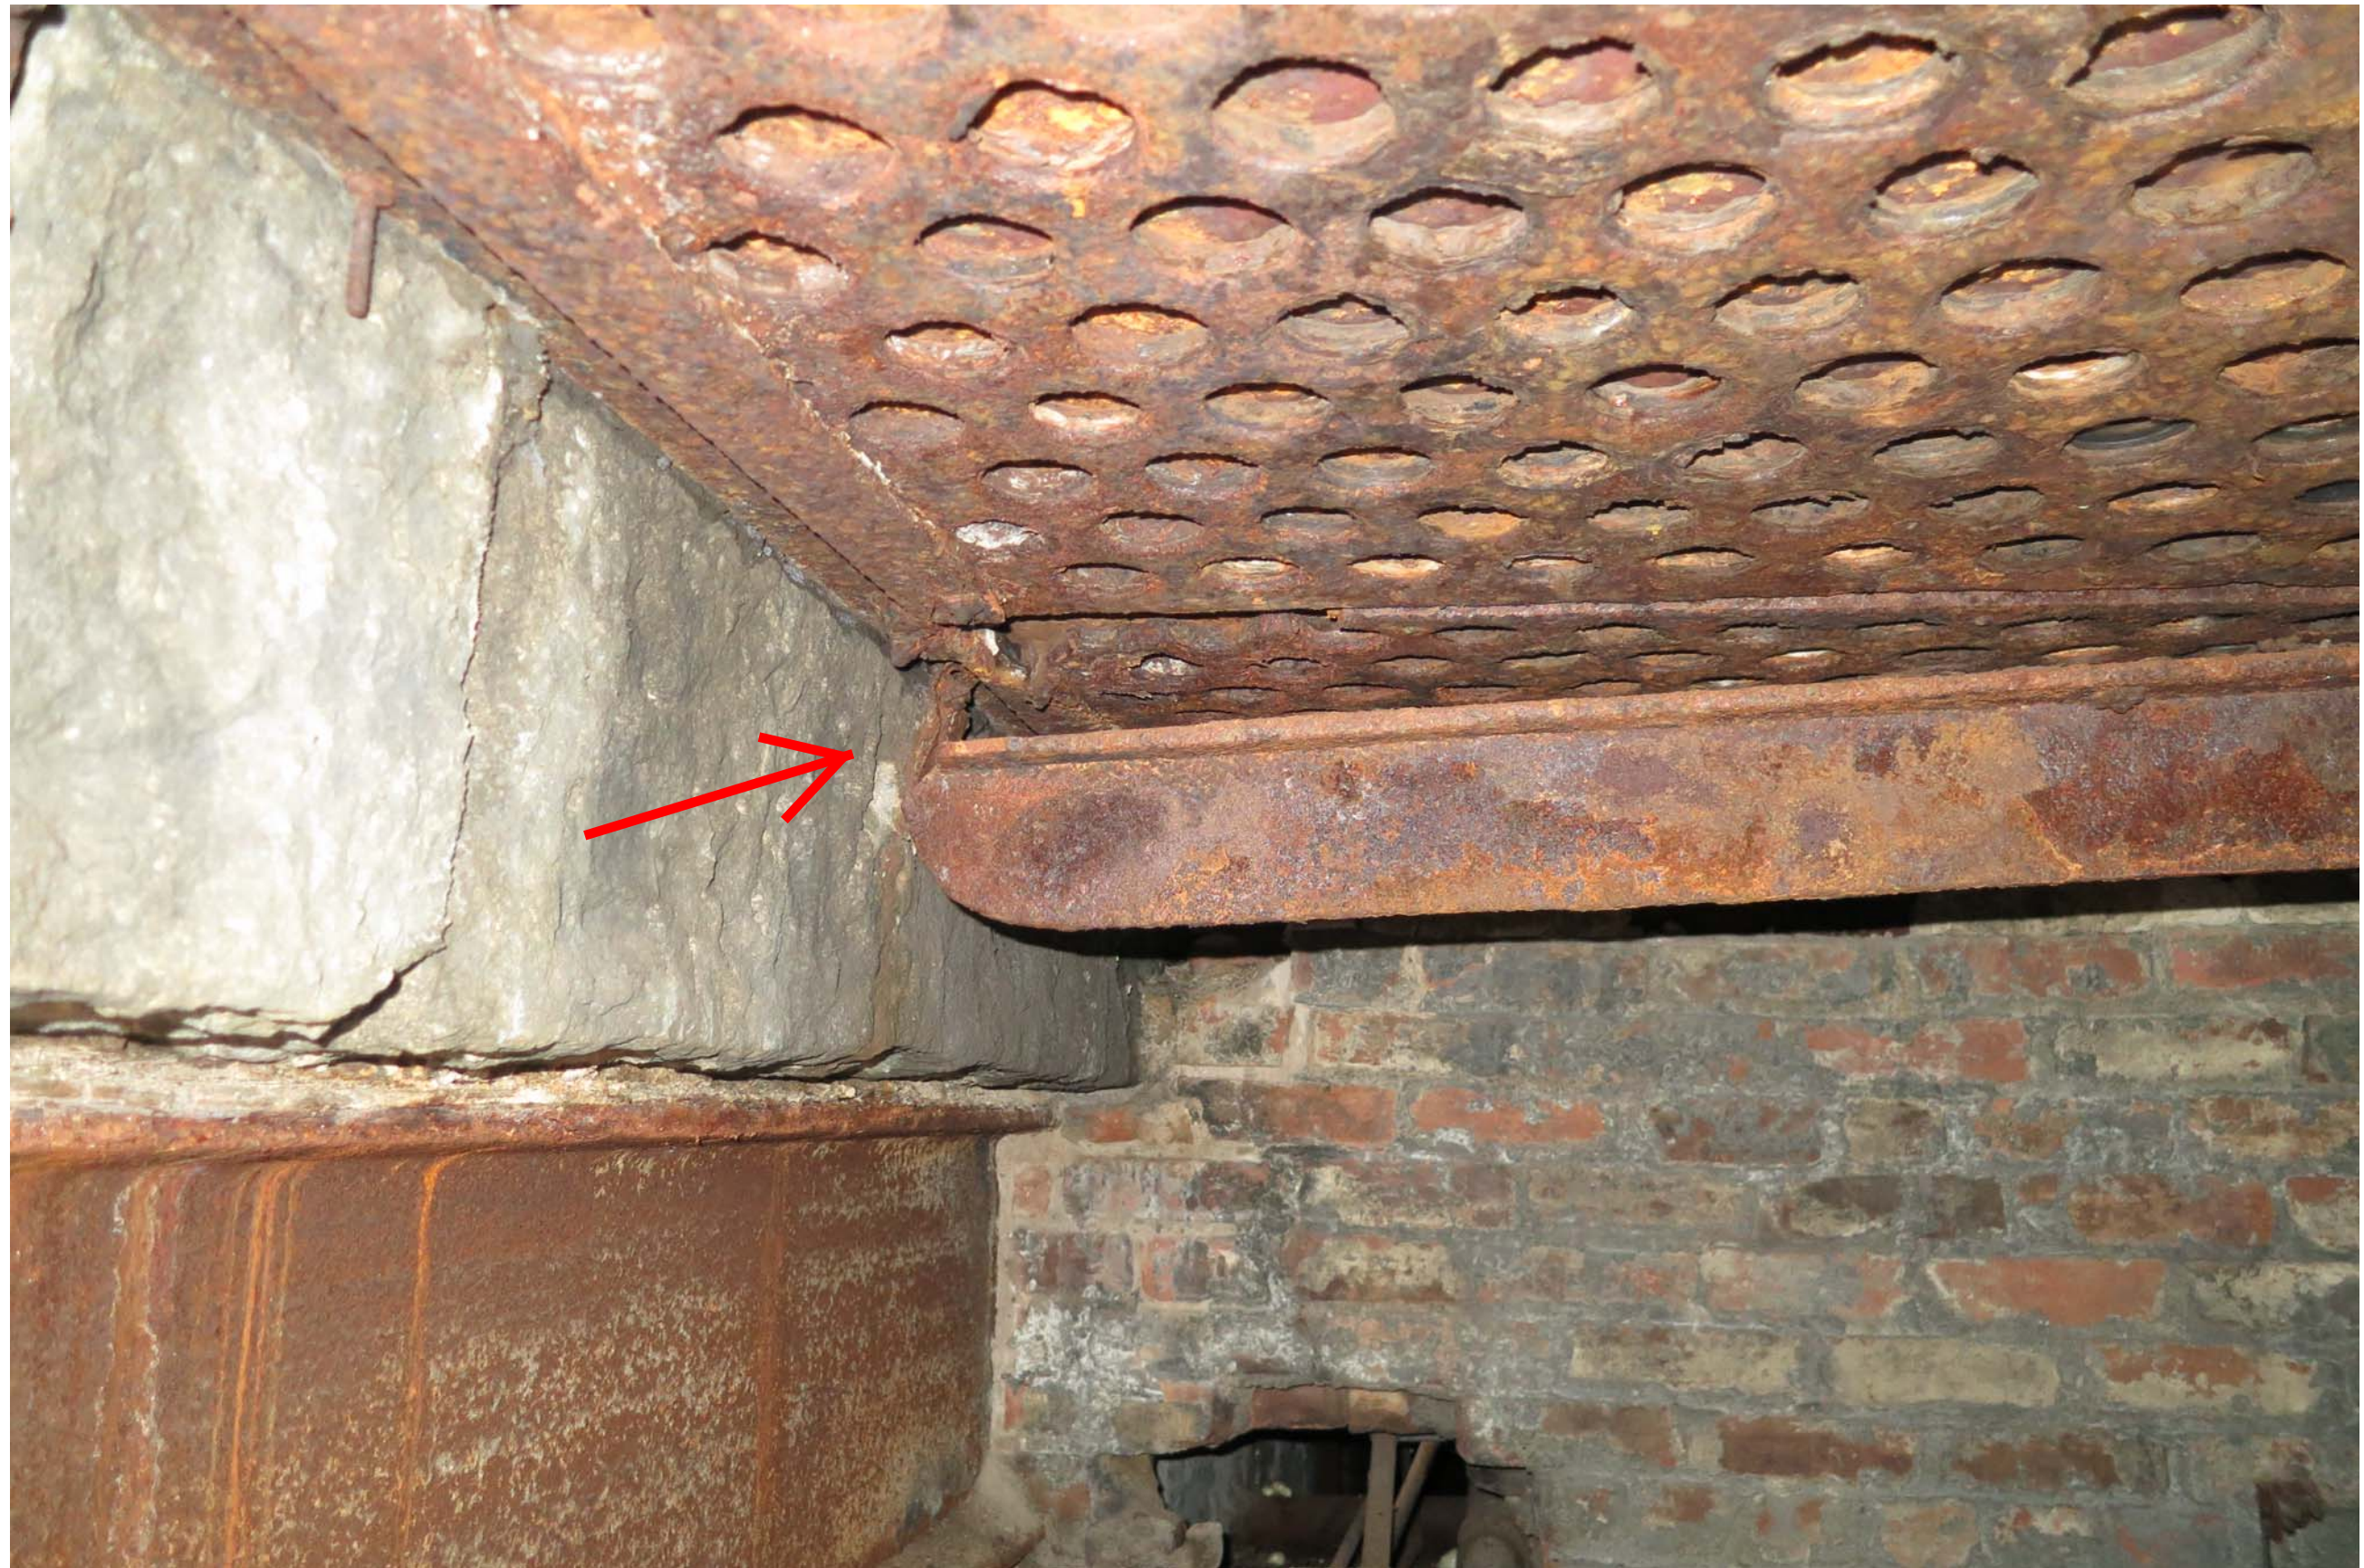
DISCONNECTED STRUCTURAL COMPONENT SUPPORTING EXISTING STEEL PLATE AND VAULT LIGHTS

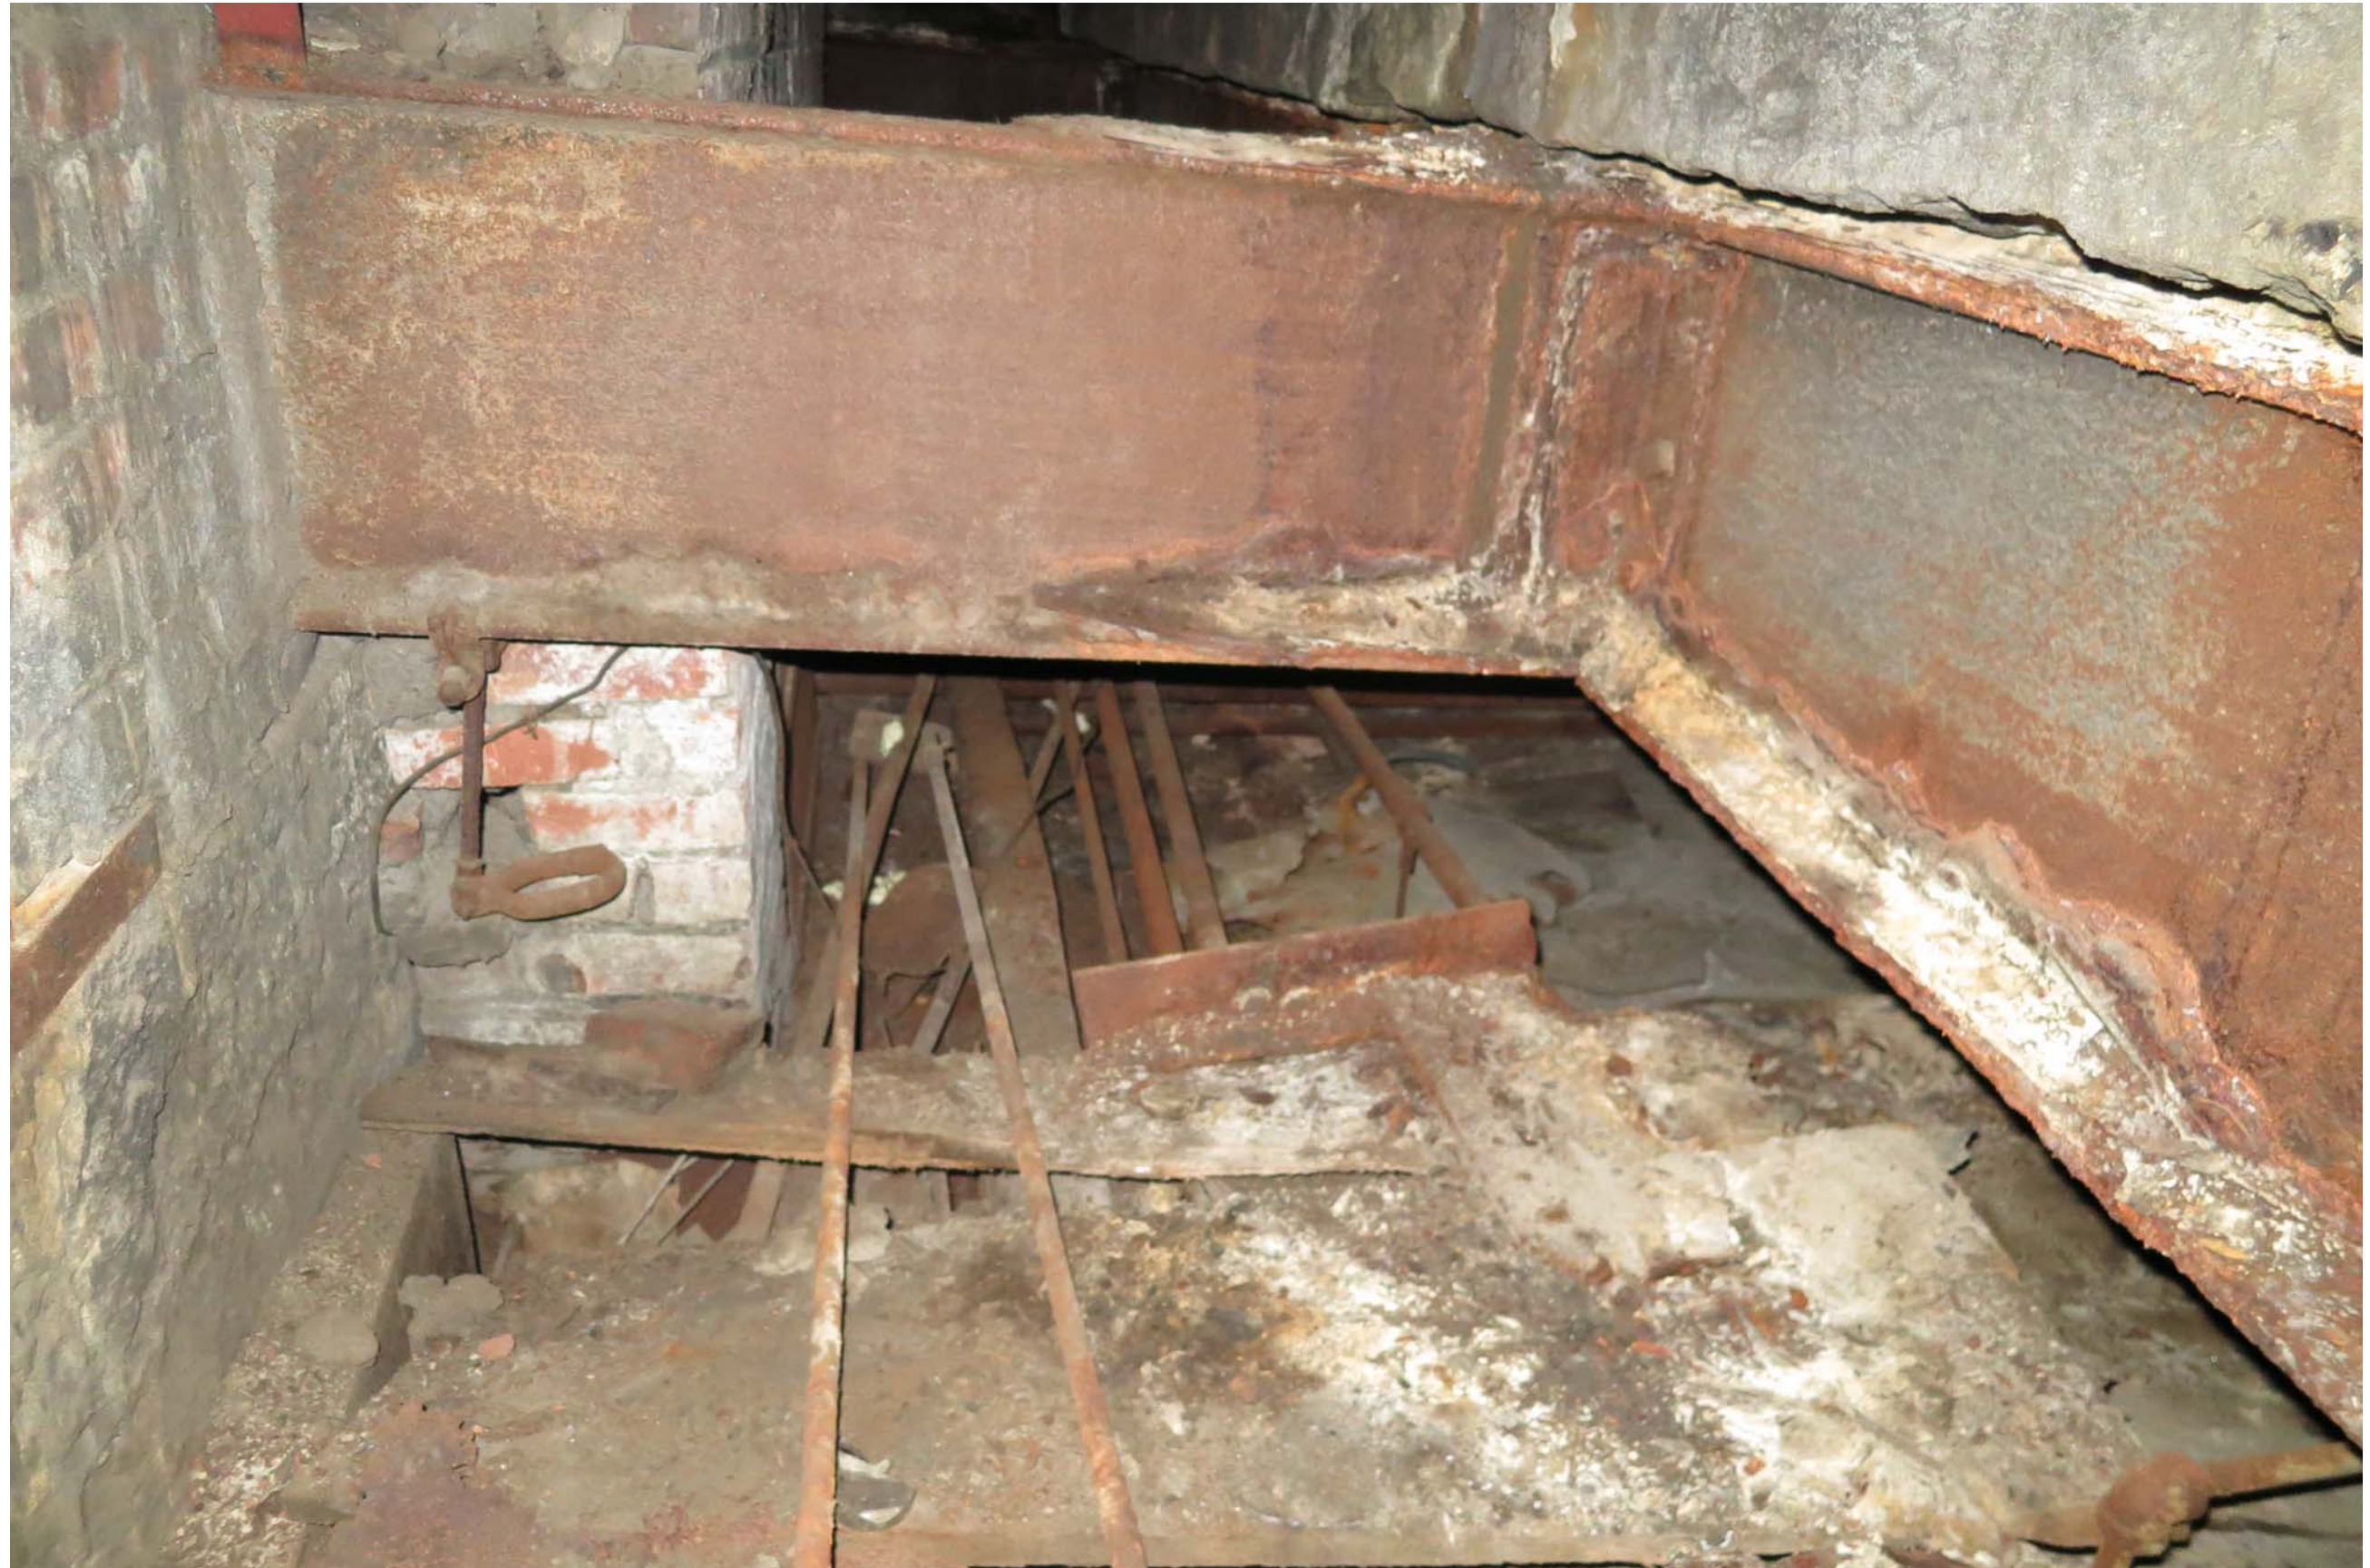
DEFECTIVE PLATING CAUSING FURTHER STRUCTURAL DAMAGE

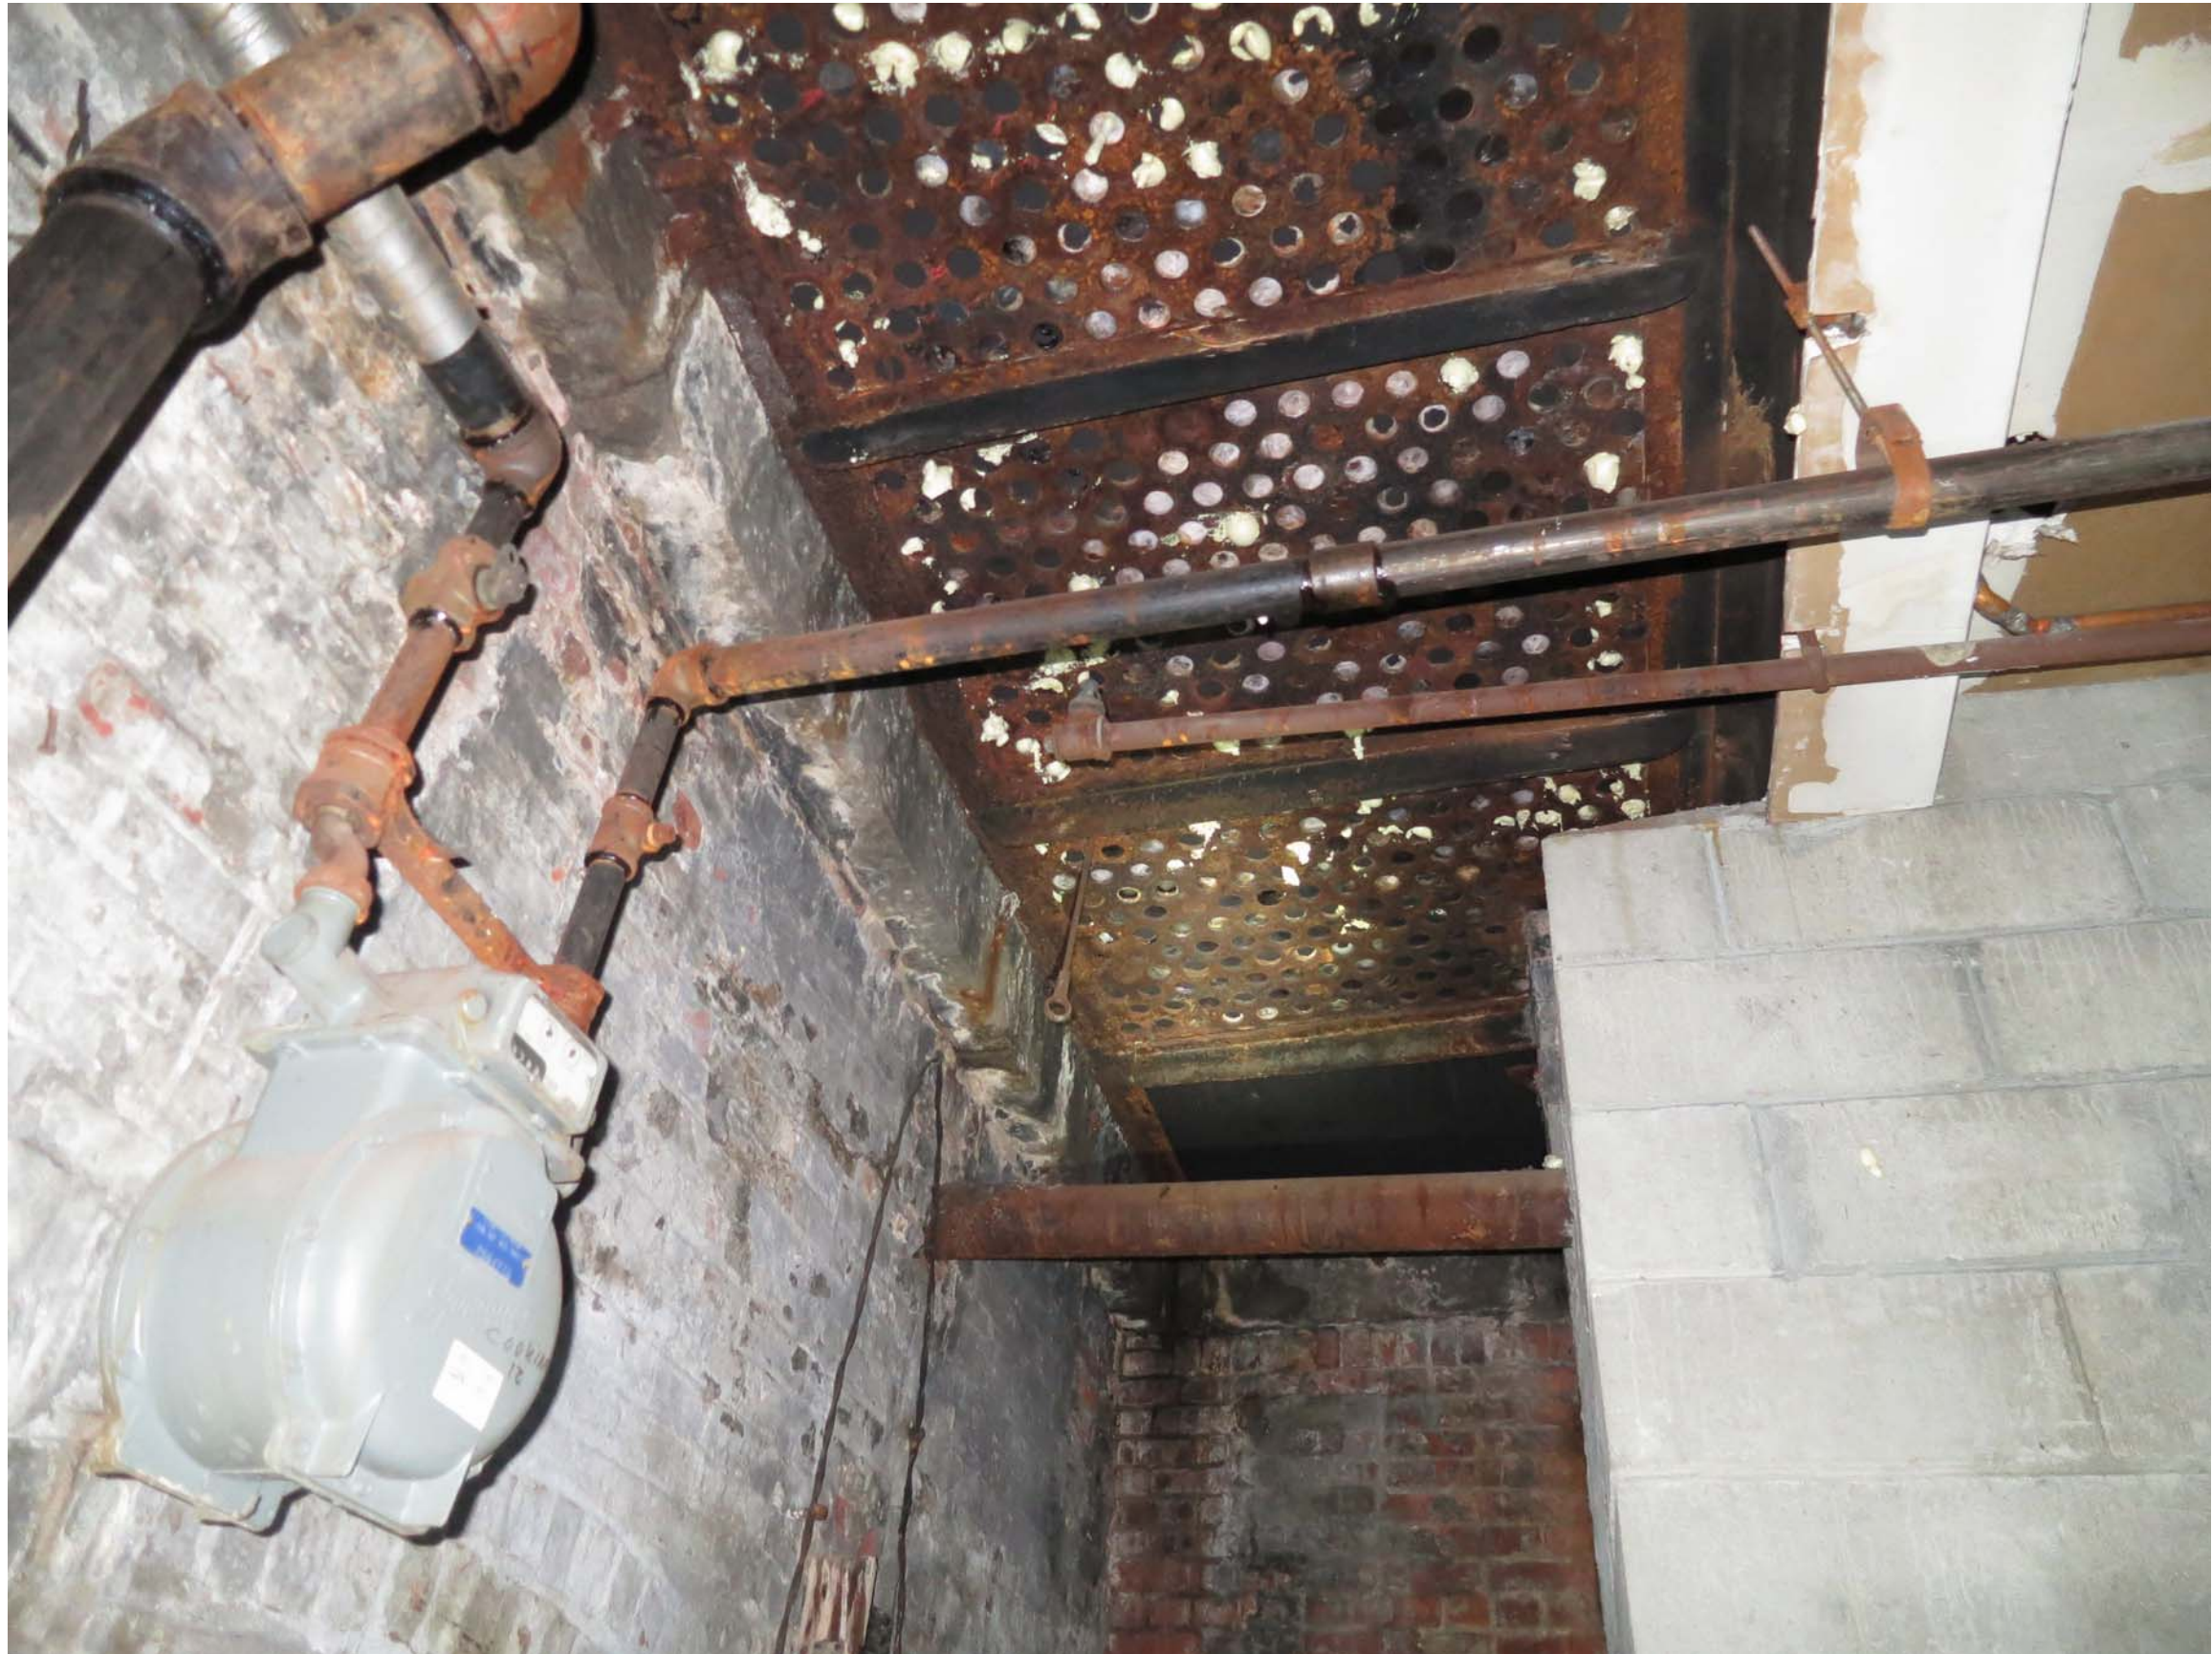
HEAVY CORROSION AFFECTING STRUCTURAL INTEGRITY

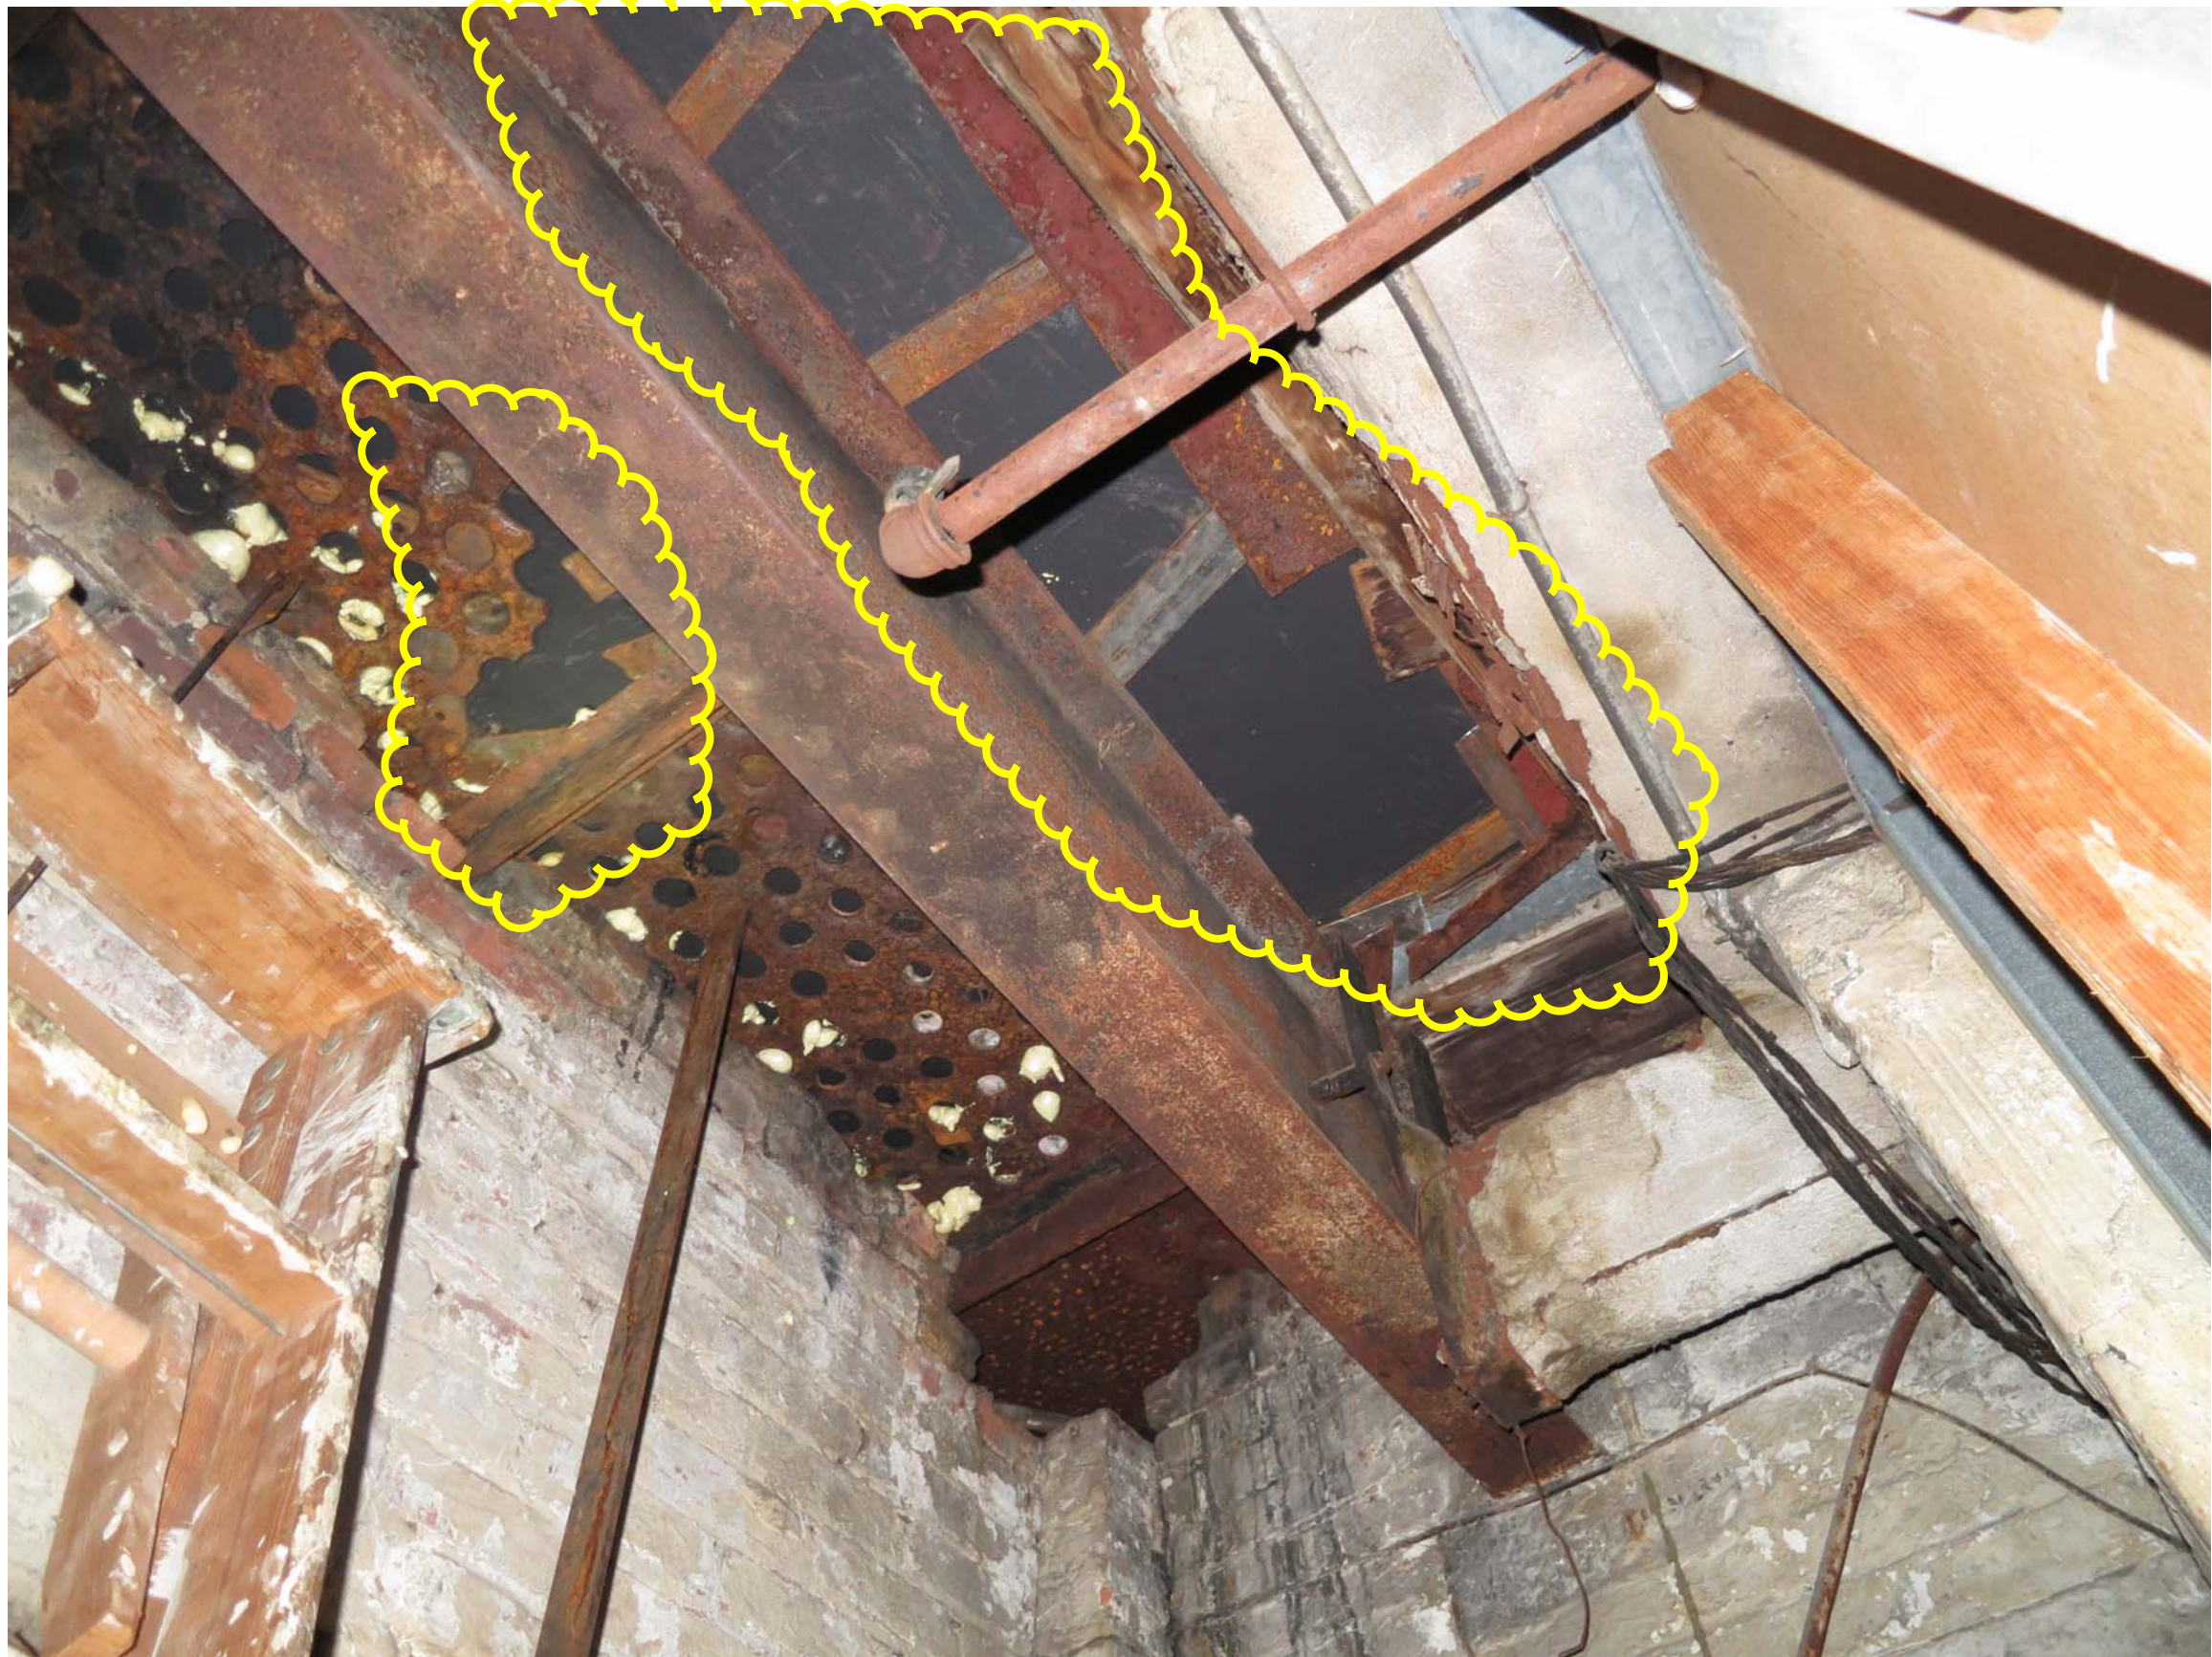
SECTIONS OF VAULT LIGHTS MISSING
