27 BLEECKER STREET - PROPOSED SIDEWALK VAULT REPAIRS - DOCKET NUMBER #17-3280

DRAFT

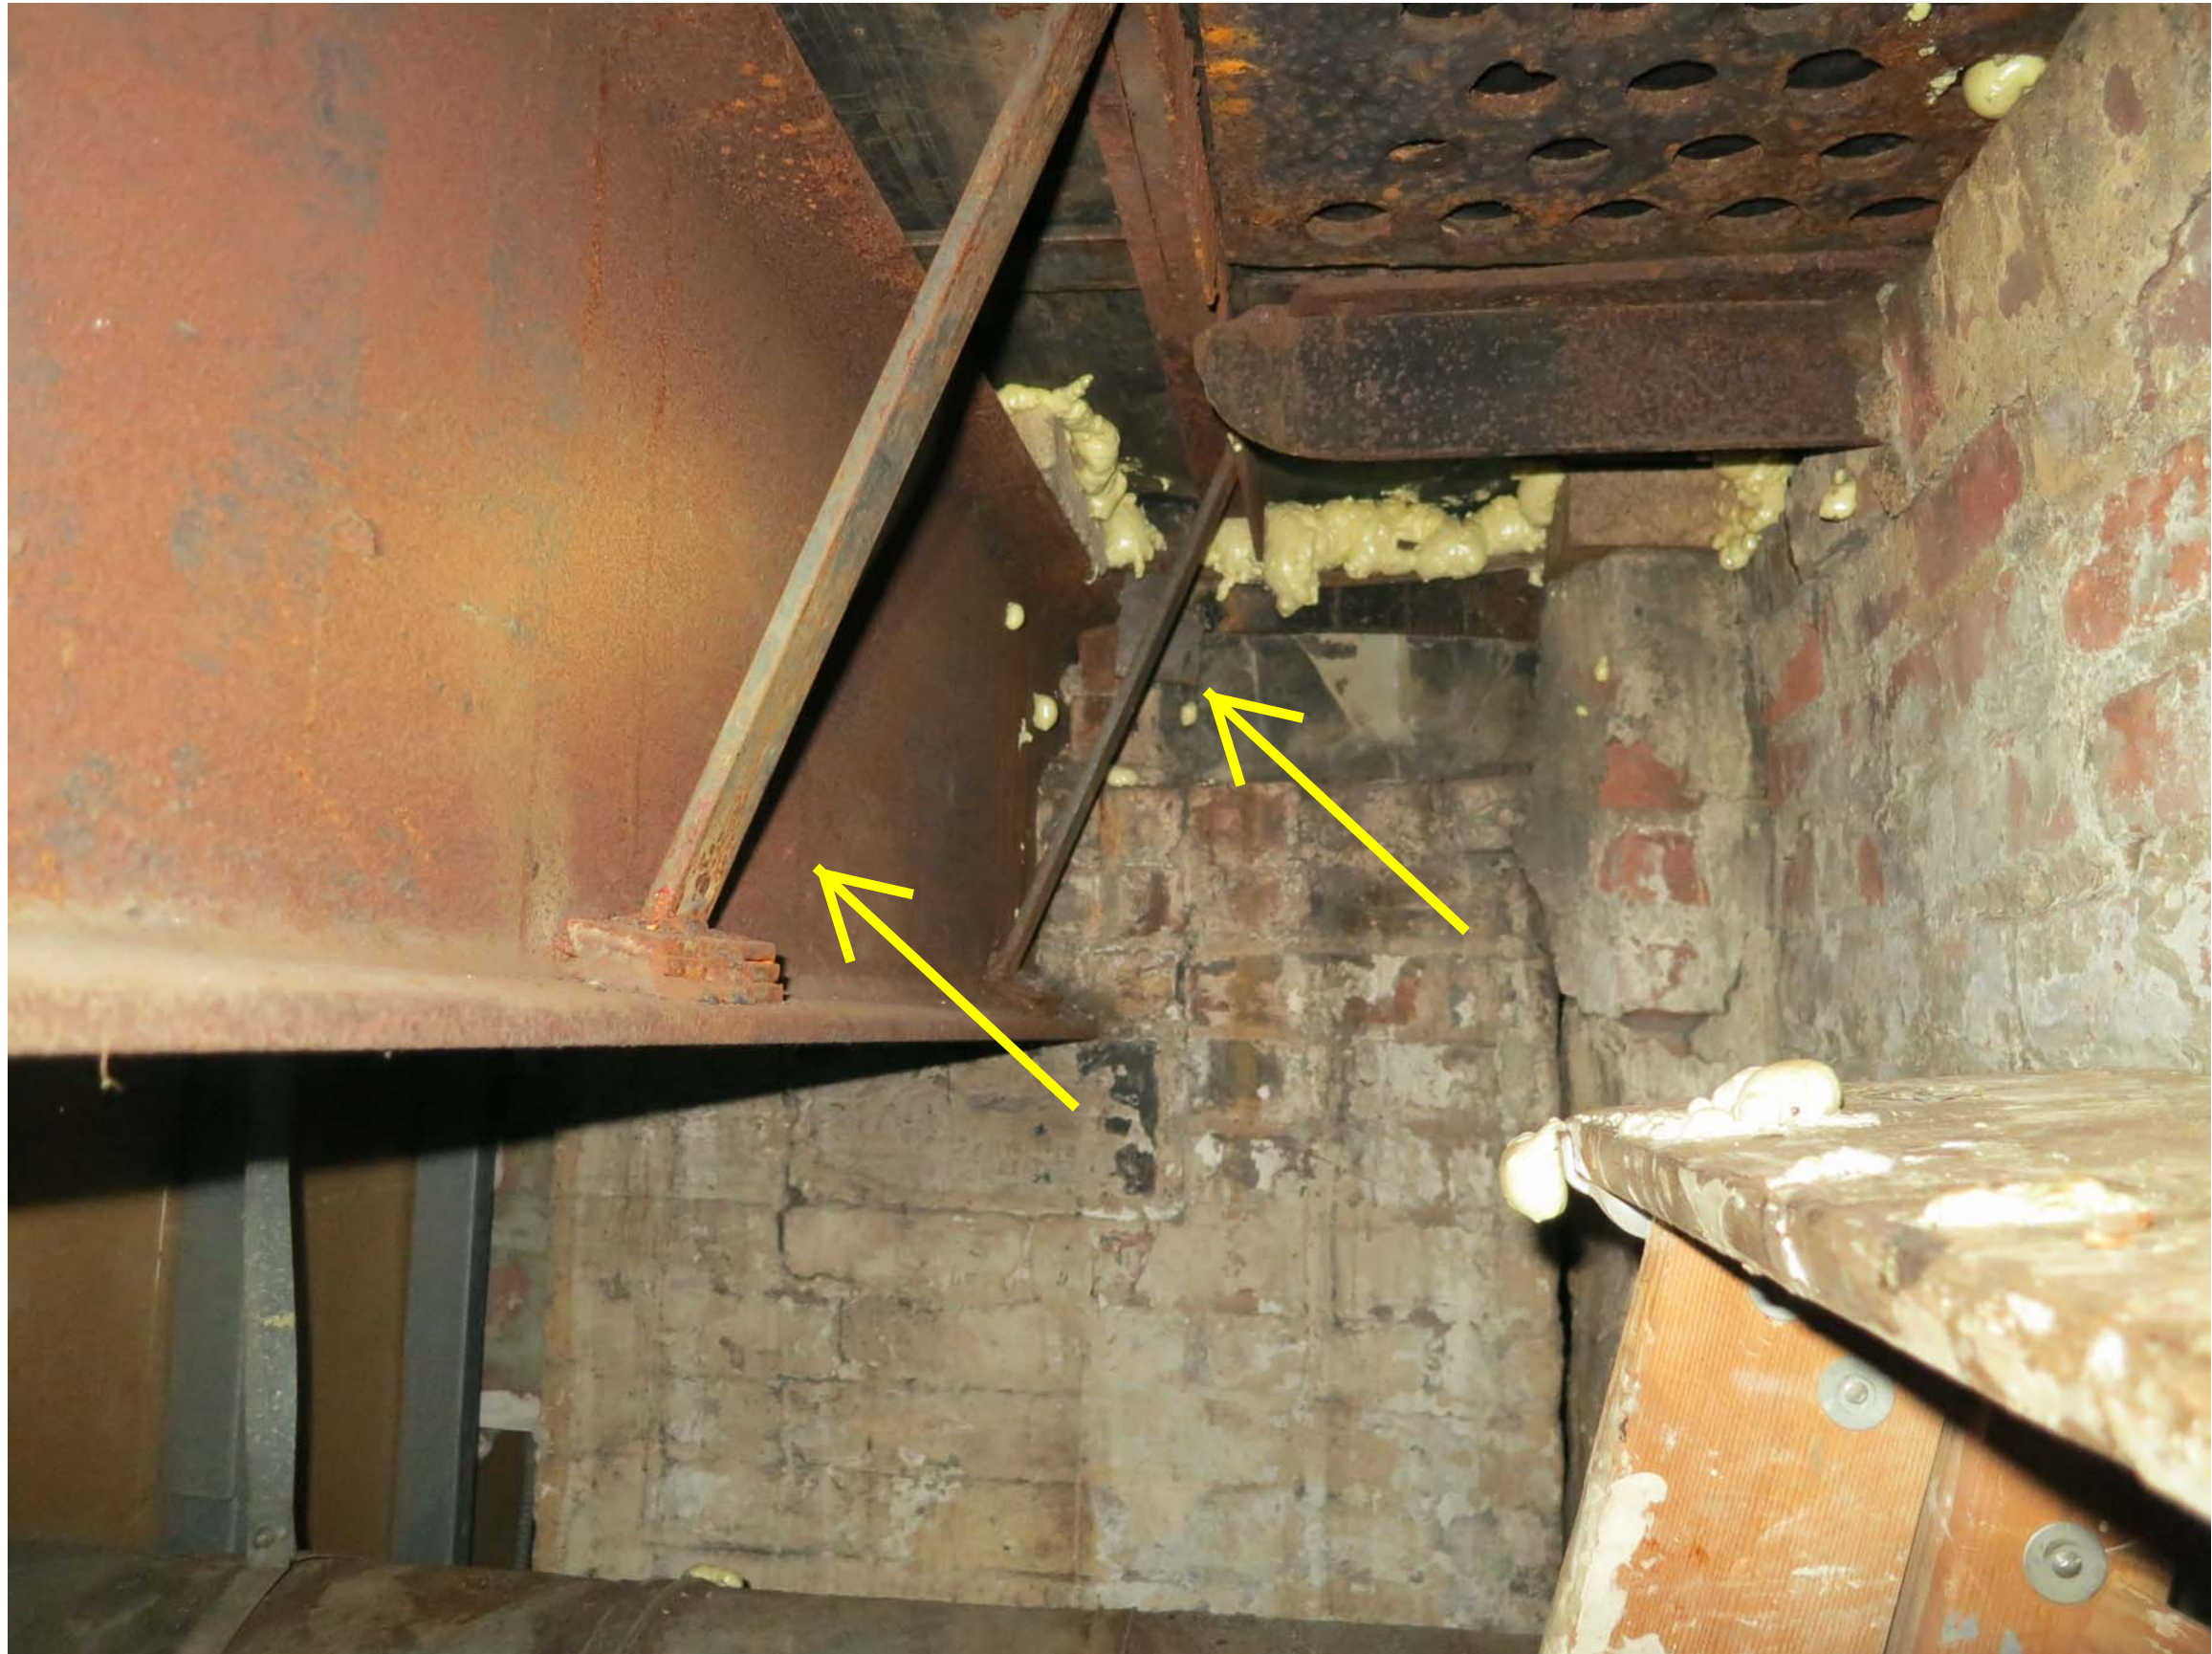
ORIGINAL STRUCTURAL FRAMING IS INADEQUATE FOR SUPPORTING THE DESIGN LOADING OVER THE STEEL PLATE

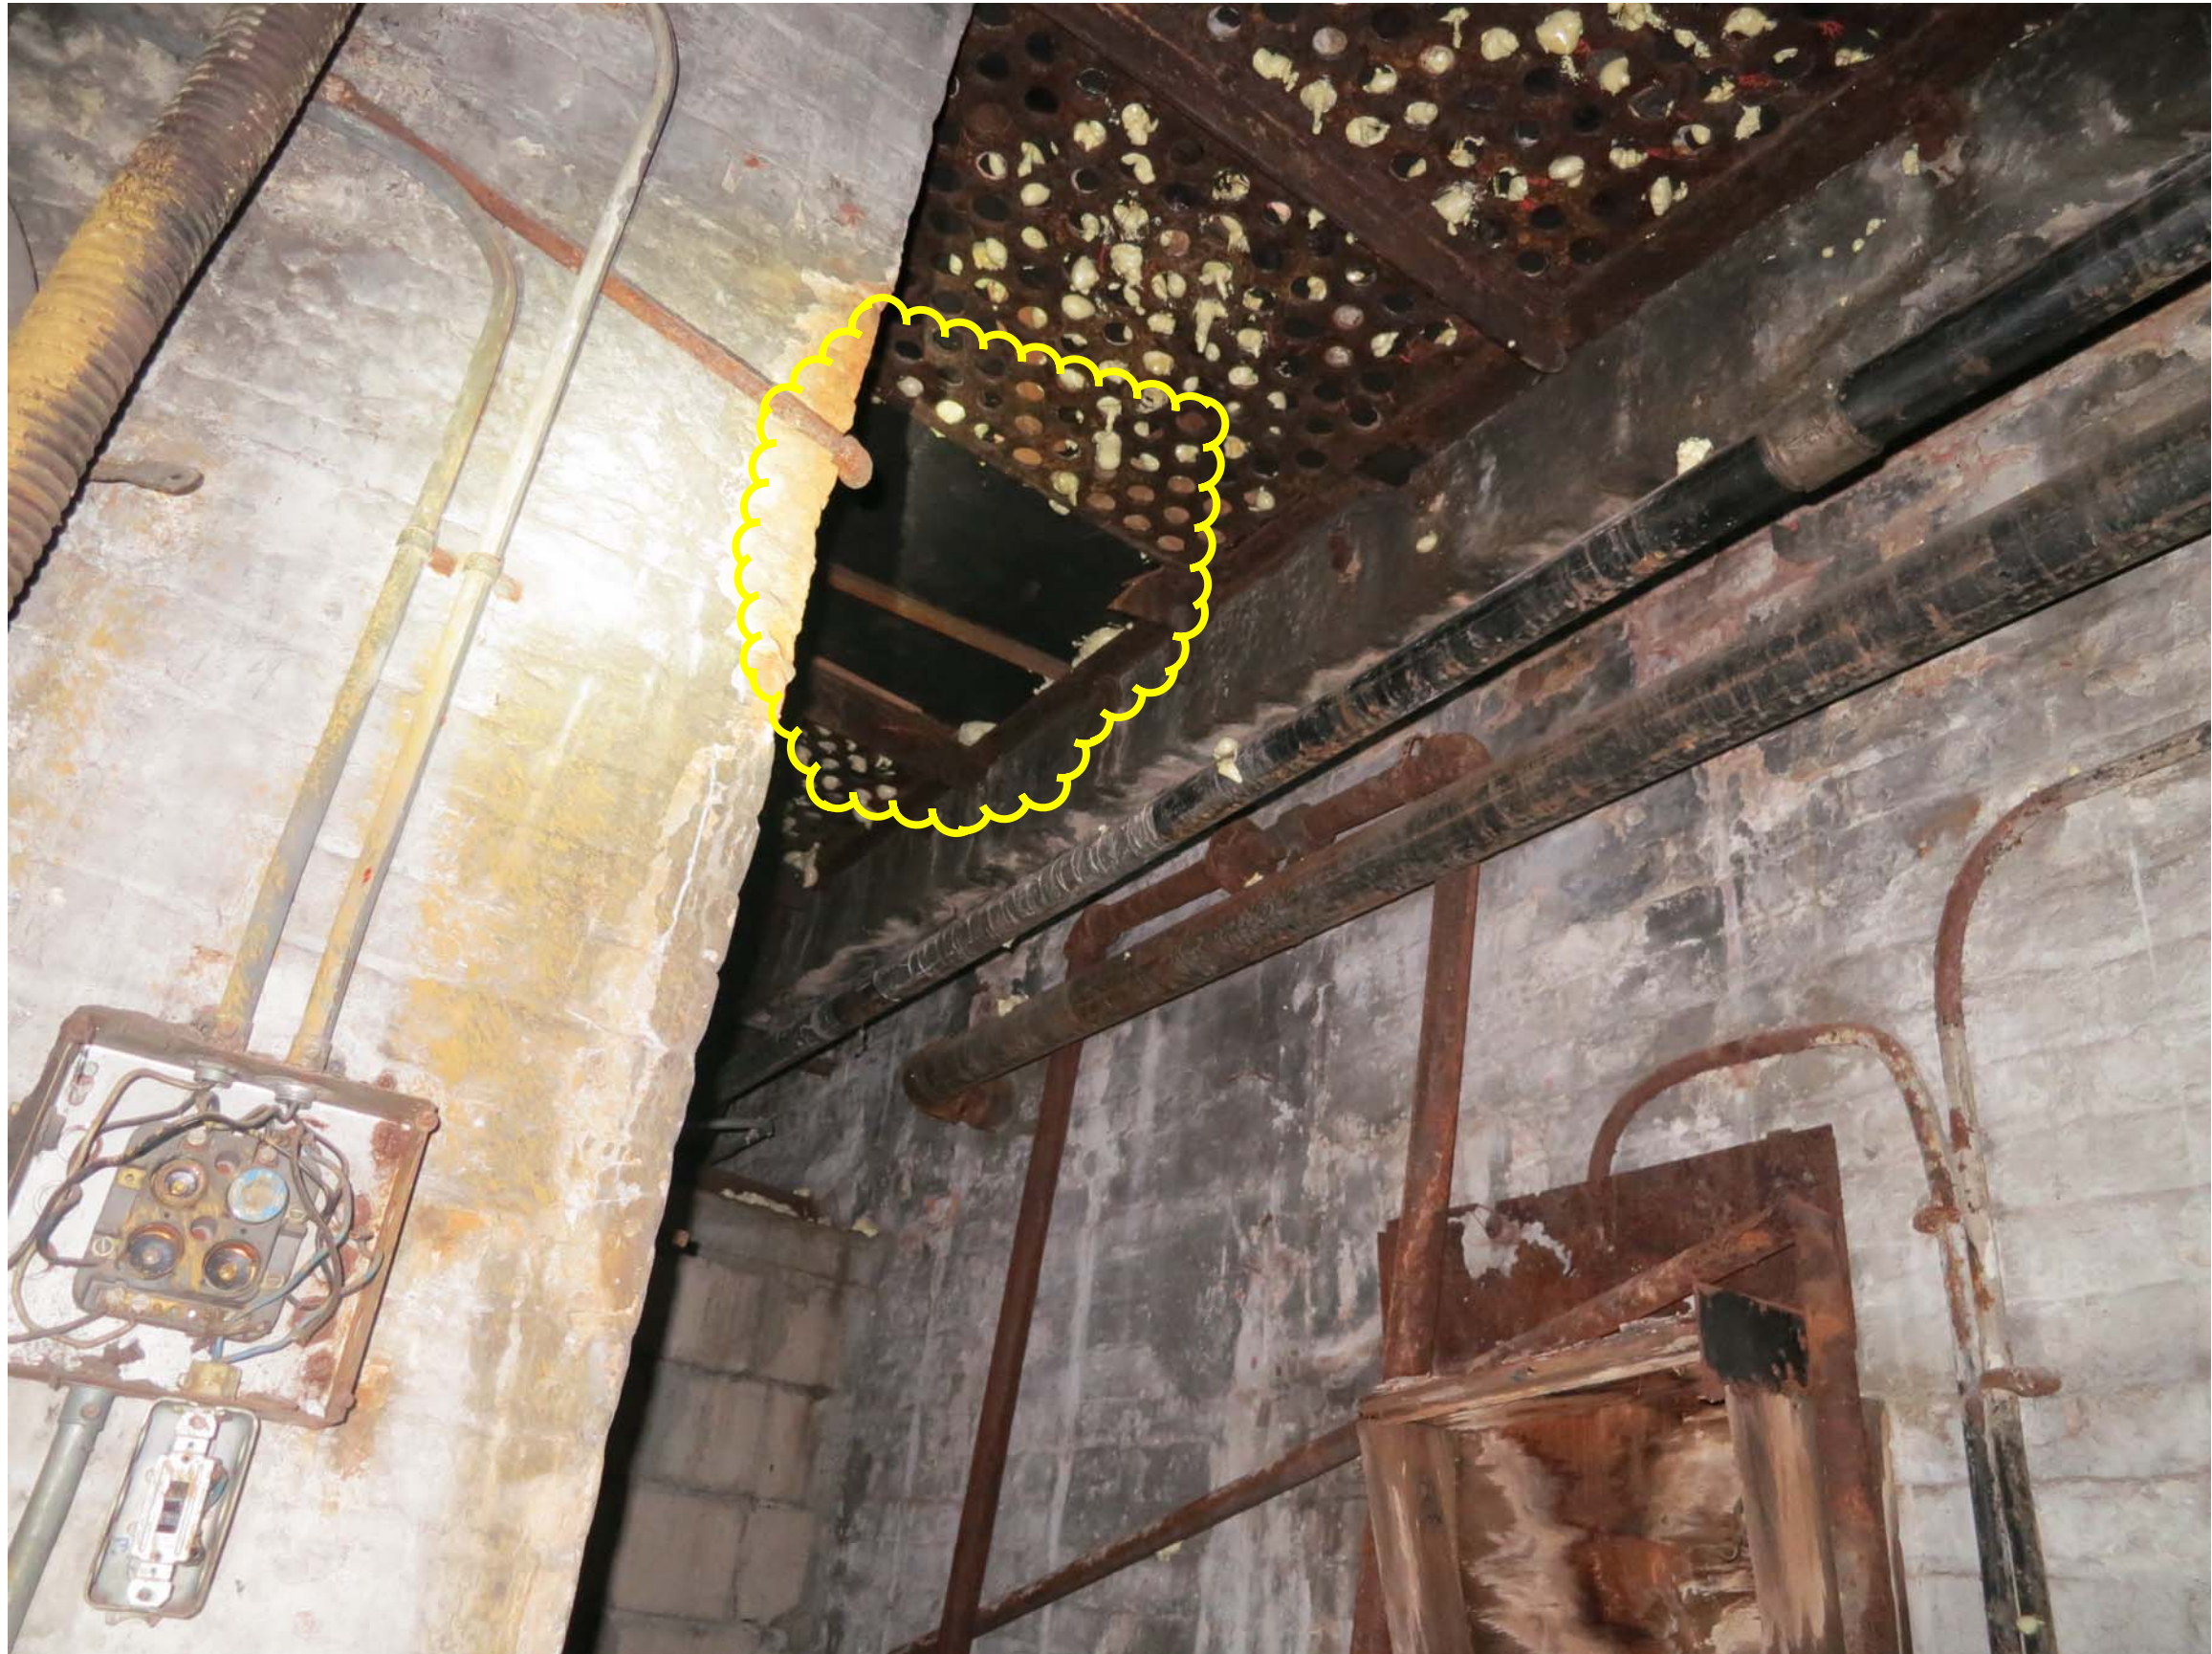
MISSING VAULT SYLIGHTS

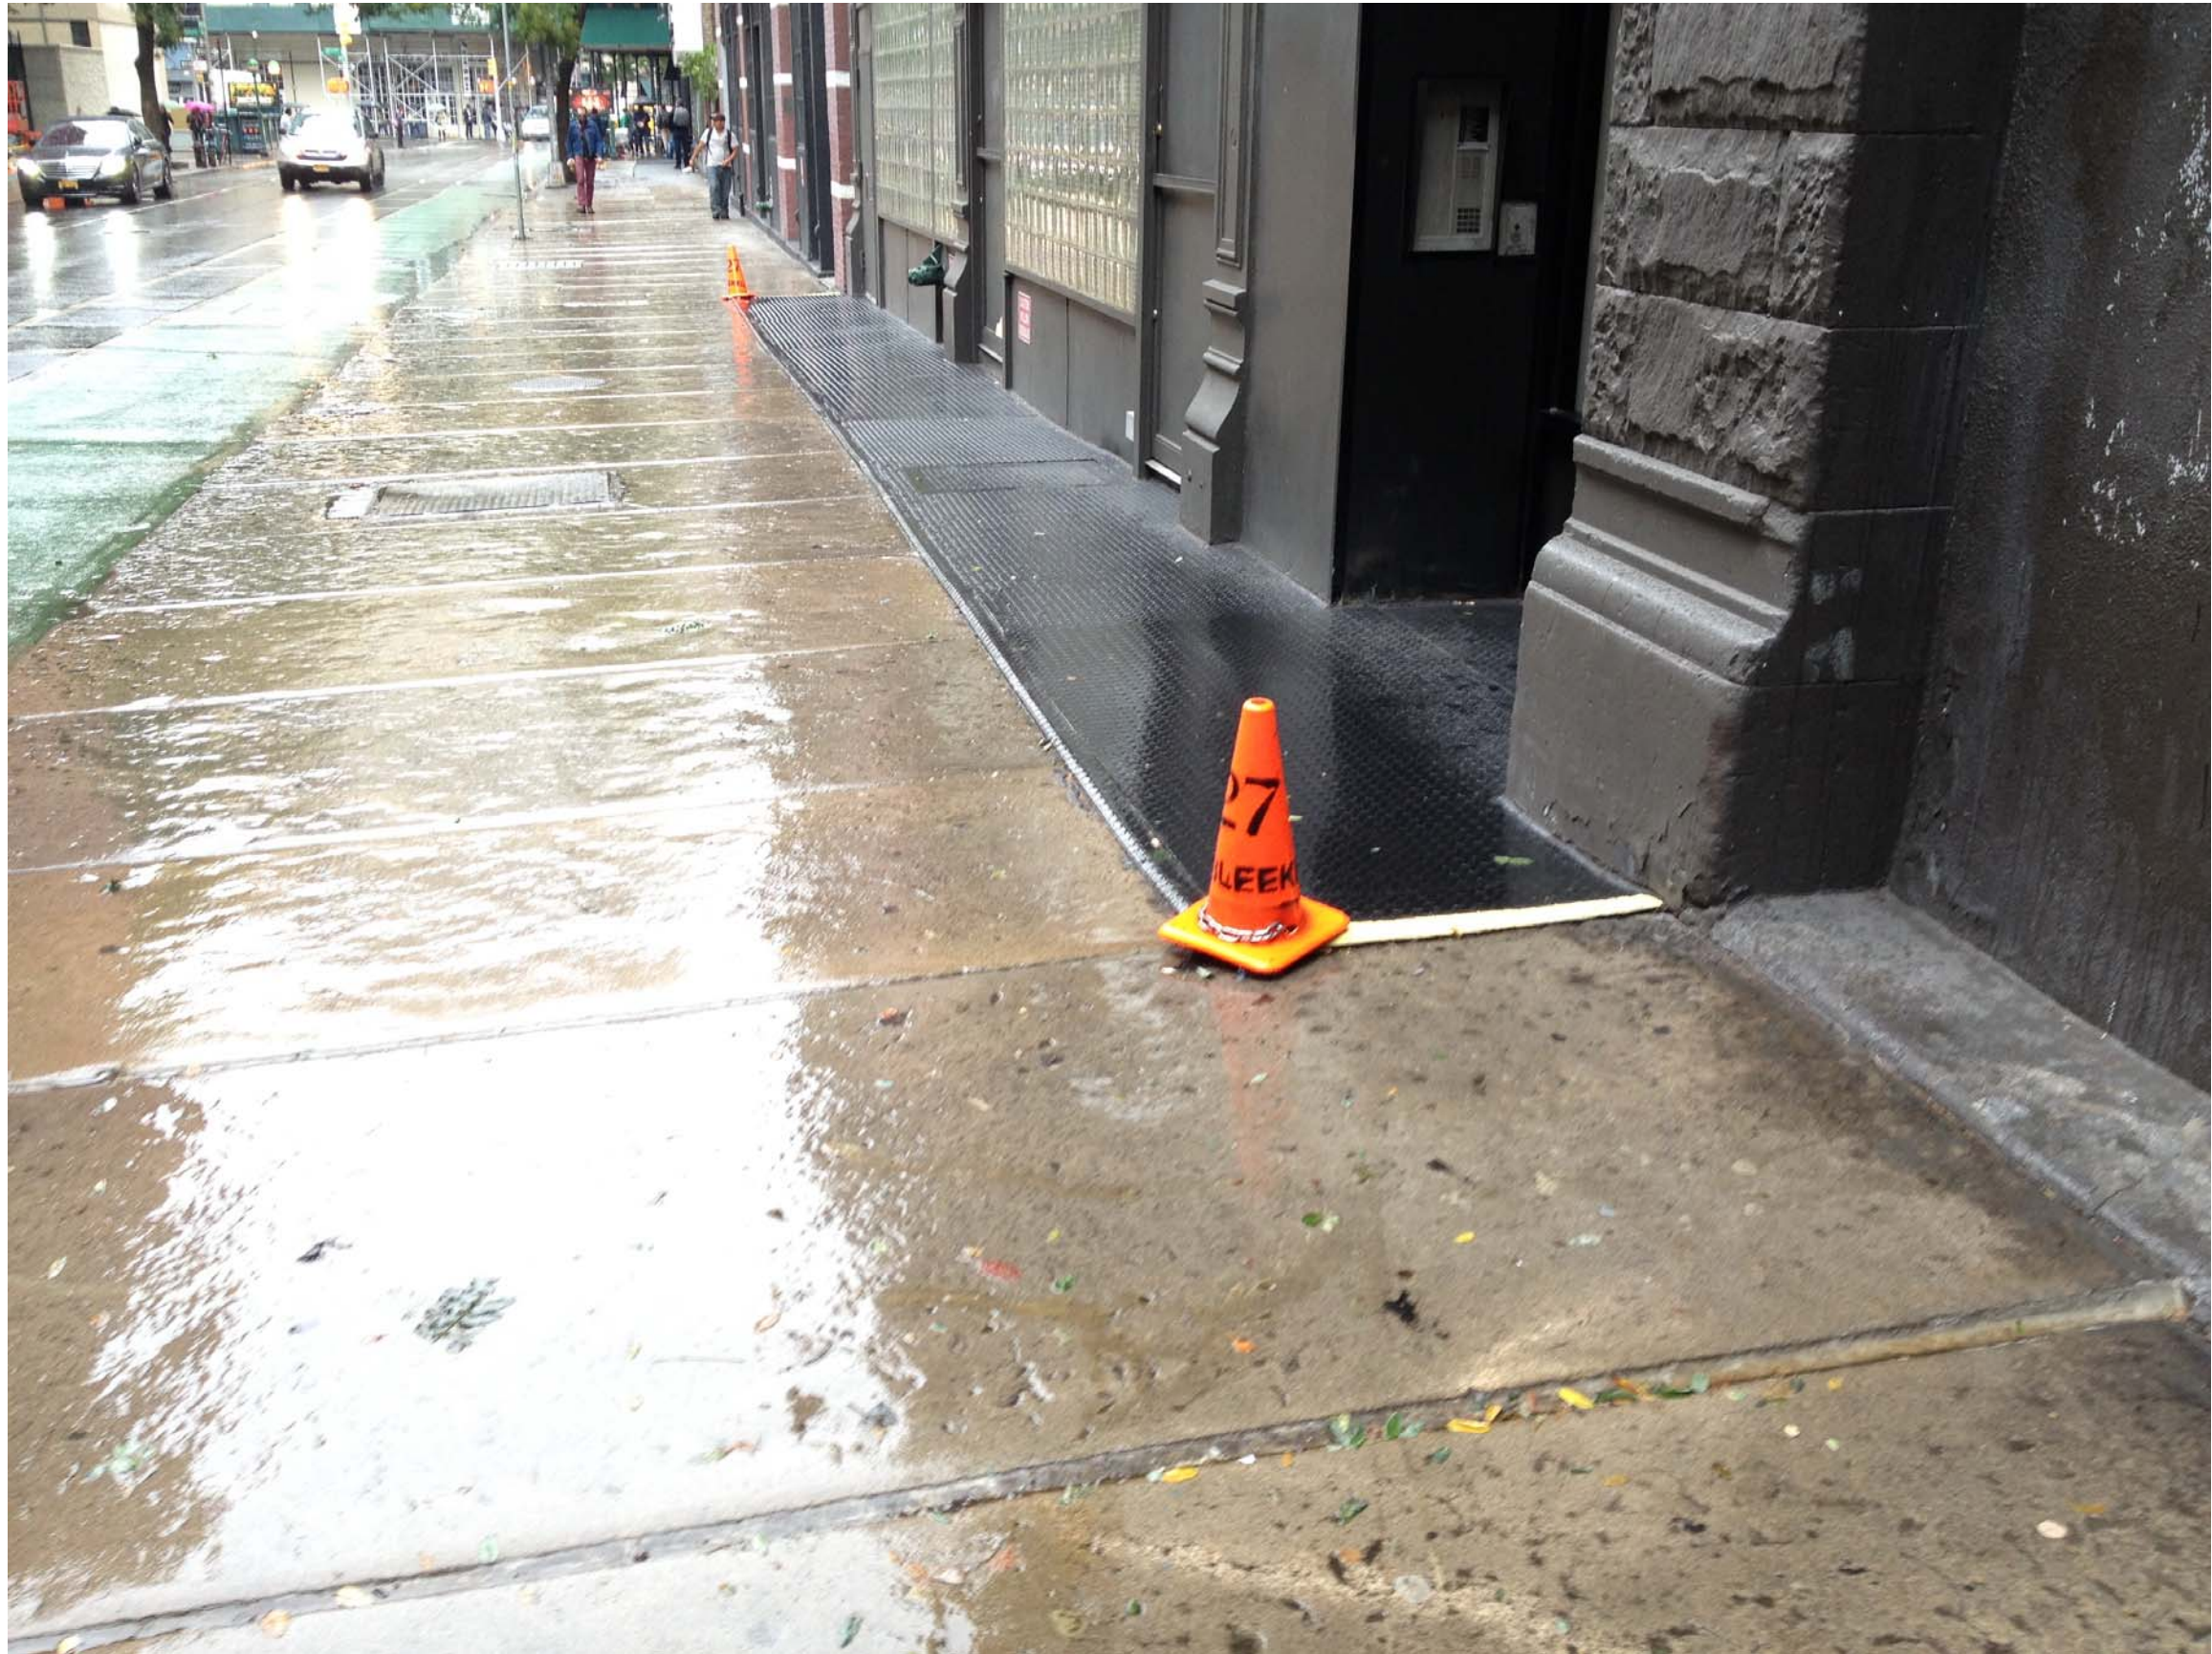
EXISTING CONDITIONS
