**44-48 WEST 12TH STREET
FACADE RESTORATION**

ADDRESS:
44 W. 12th Street
New York, NY 10011

TITLE:
PLOT PLAN,
ELEVATION, NOTES

TITLE:
STUCCO DETAILS

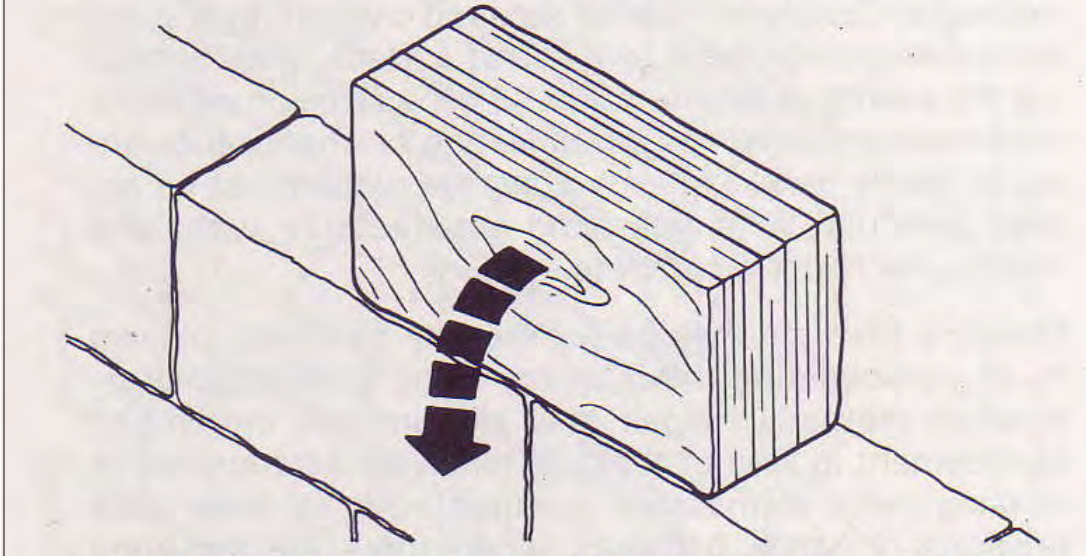
A FACE-BEDDED STONE SCALES IN LAYERS BECAUSE IT WAS PLACED ON END WITH ITS BEDDING PLANES PARALLEL TO THE FACE OF THE WALL. FACE BEDDING ACCOUNTS FOR THE POOR CONDITION OF MANY MID-19TH CENTURY BROWNSTONE BUILDINGS (ARROW INDICATES SCALING)

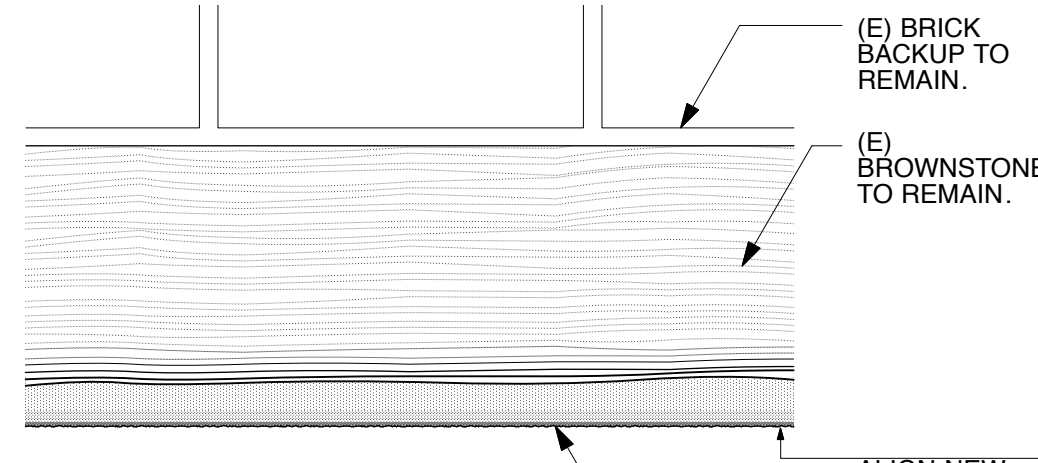
1 STUCCO SYSTEM DETAIL SECTION - EXISTING
Scale: 3" = 1'-0"

NB. ADHESION OF STUCCO DIRECTLY TO STONE IS CURRENTLY RELYING ON STABILITY OF OUTER SCALING FACE OF BROWNSTONE. SCALING BROWNSTONE HAS RESULTED IN WIDESPREAD CRACKING OF THE STUCCO & SUBSEQUENT LACK OF PROTECTION FROM WATER INFILTRATION & FREEZE-THAW CYCLES.

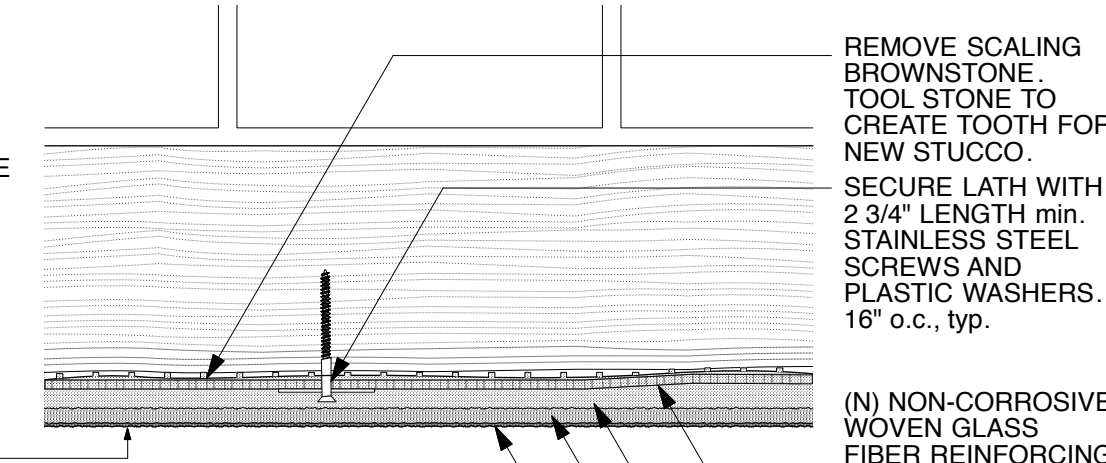
2 STUCCO SYSTEM DETAIL SECTION - PROPOSED
Scale: 3" = 1'-0"

NB. NON-CORROSIVE GLASS FIBER LATH ADDS STABILITY TO THE STUCCO BY ANCHORING INTO MORE STABLE INTERIOR LAYERS OF STONE. ADHESION OF STUCCO IS NOT RELYING SOLELY ON STABILITY OF OUTER SCALING FACE OF BROWNSTONE.

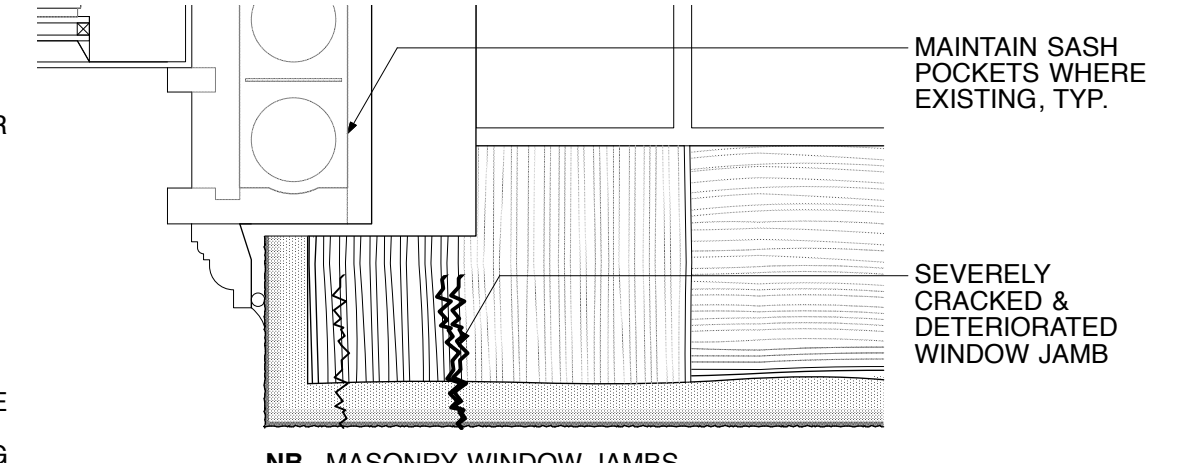
3 WINDOW JAMB DETAIL SECTION - EXISTING
Scale: 3" = 1'-0"

NB. MASONRY WINDOW JAMBS ARE SEVERELY CRACKED & DETERIORATED. REMAINING BROWNSTONE IS INSUFFICIENT TO SUPPORT THE LINTELS ABOVE.

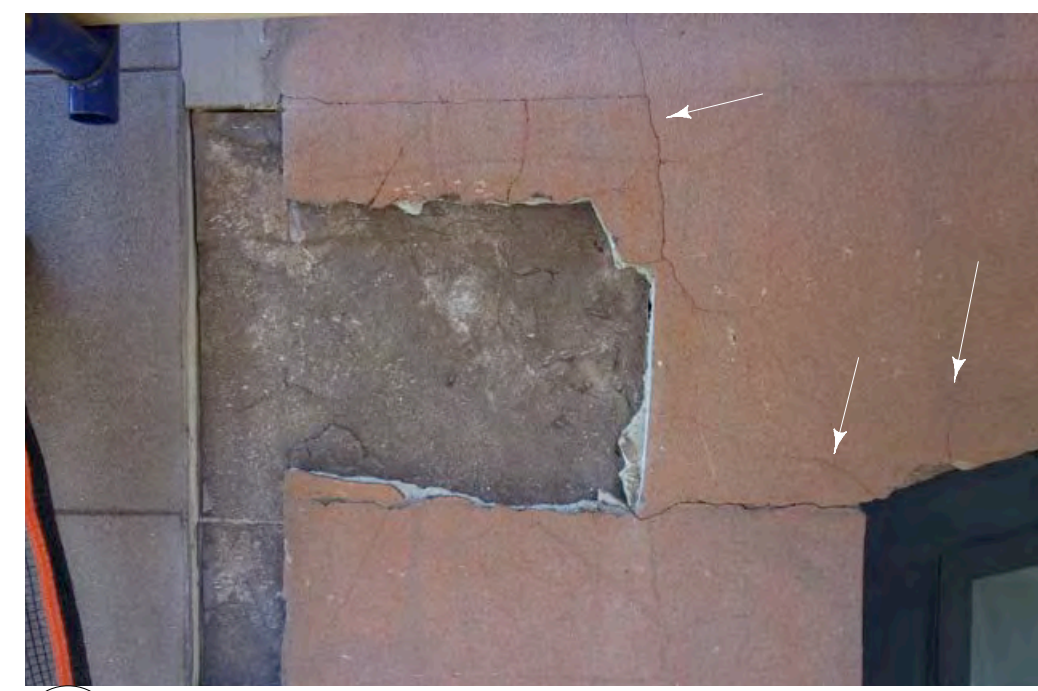
PH-1 HAIRLINE CRACKING
PROBE AT EAST SIDE OF BUILDING

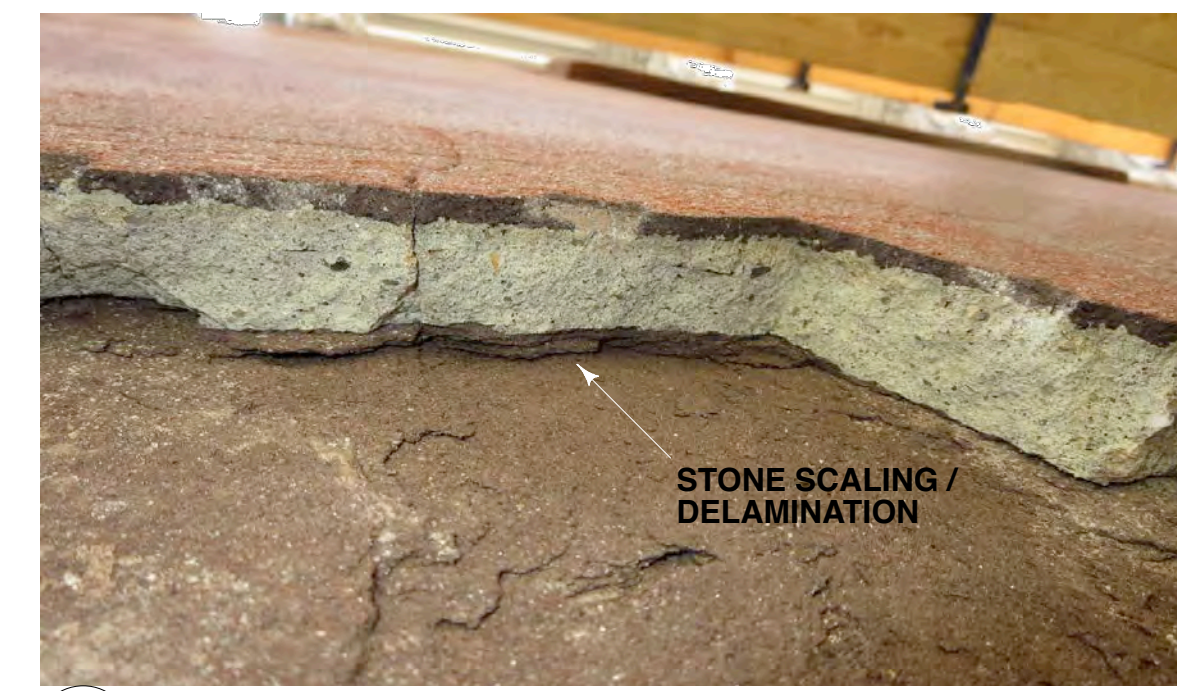
PH-2 SCALING / DELAMINATING BROWNSTONE UNDER STUCCO
CLOSE-UP AT PROBE

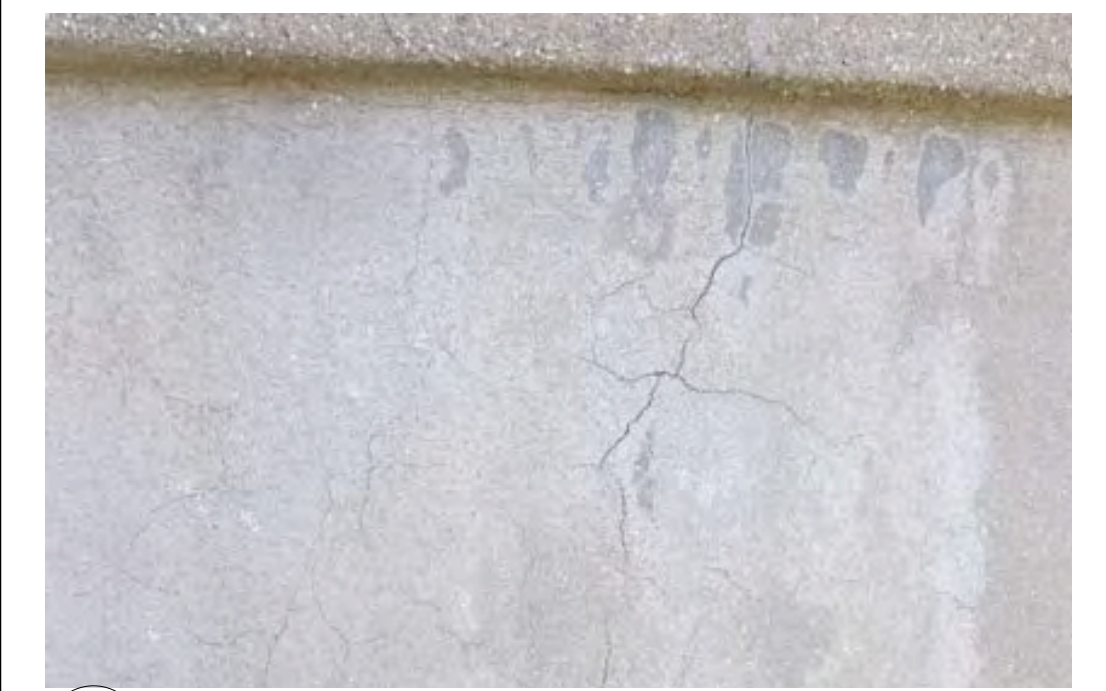
PH-9 TYPICAL HAIRLINE CRACKING
BELOW WINDOW SILL

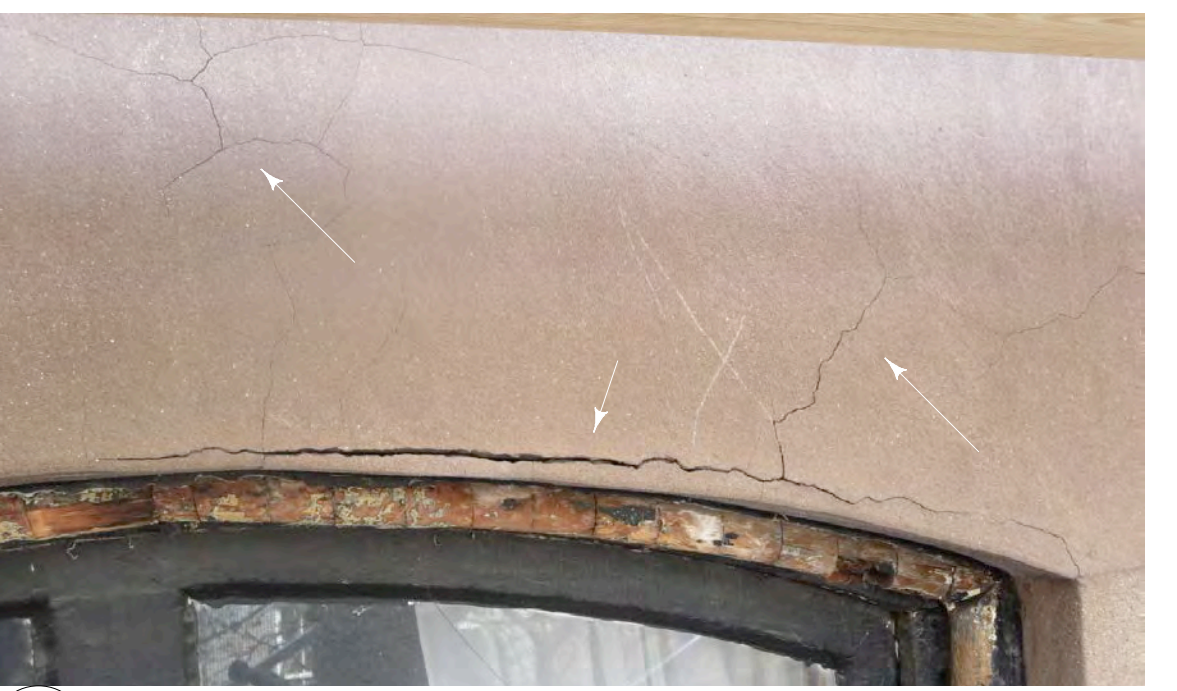
PH-10 CRACKING AT LINTEL

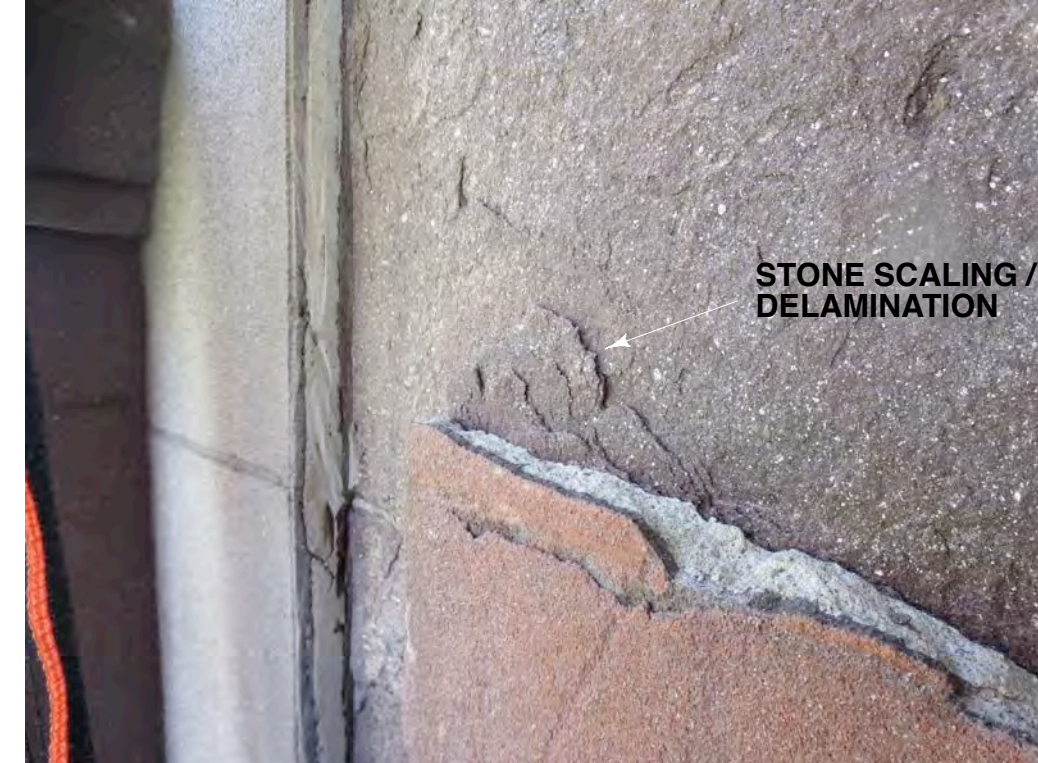
PH-3 SCALING / DELAMINATING BROWNSTONE UNDER STUCCO
CLOSE-UP AT PROBE

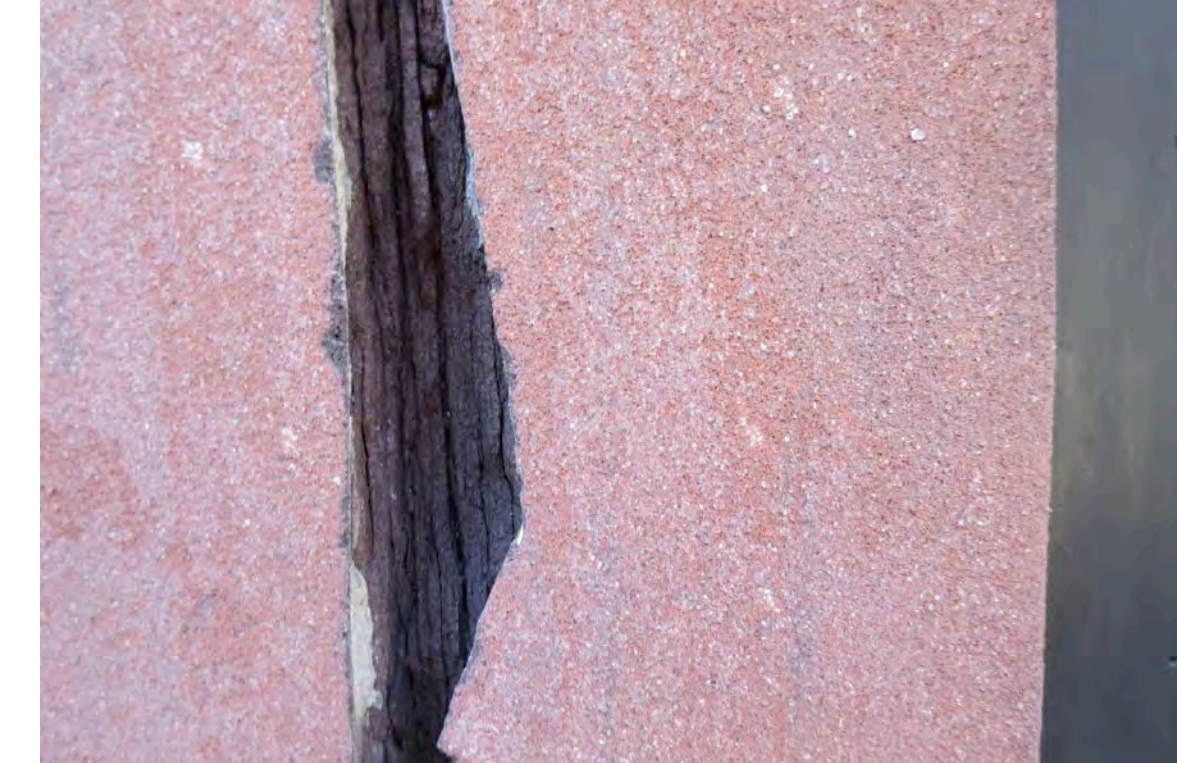
PH-4 DELAMINATING UNDERLYING MASONRY AT WINDOW JAMB
WINDOW JAMB

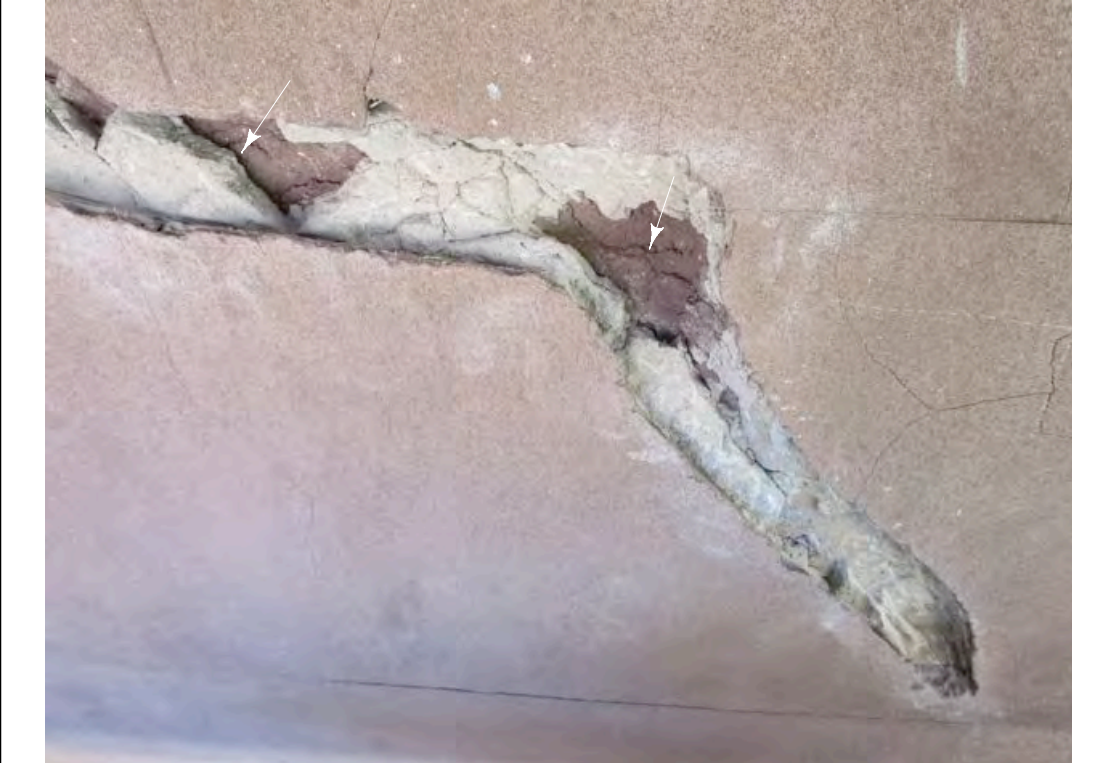
PH-11 DELAMINATING STUCCO & SCALING BROWNSTONE
BEHIND CRACKED STUCCO

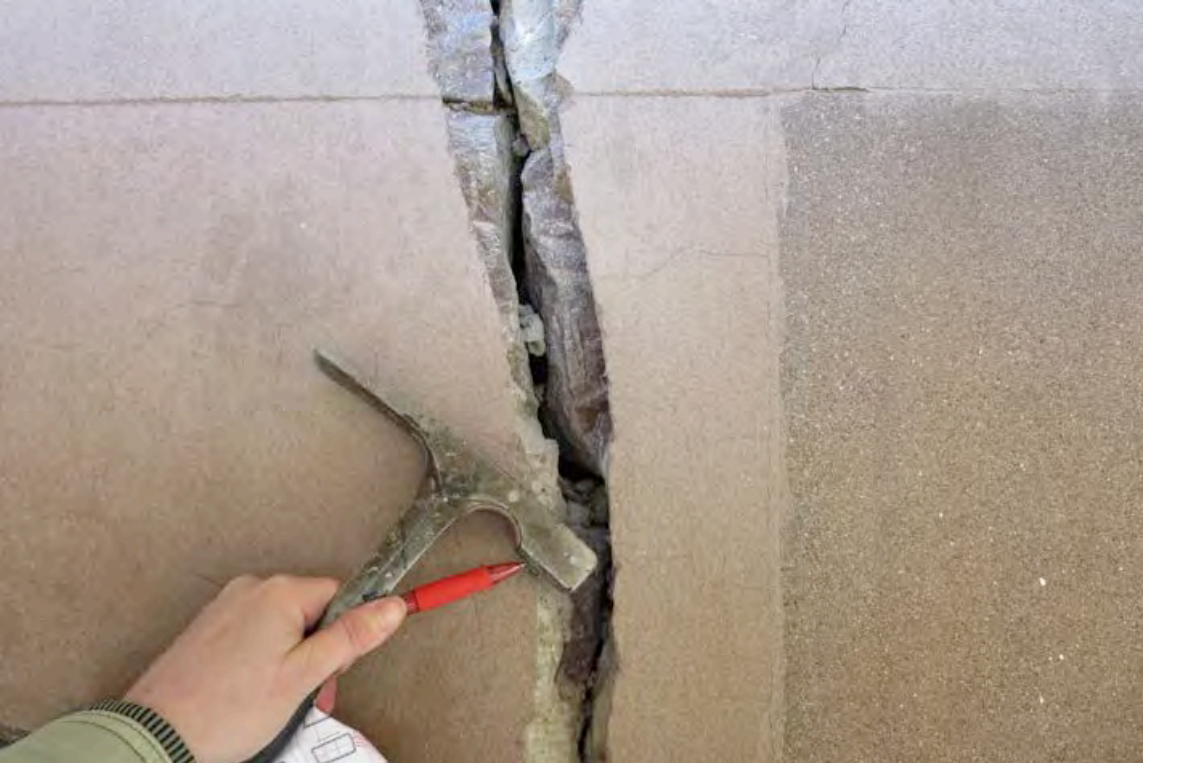
PH-12 SEVERE CRACK IN UNDERLYING BROWNSTONE
BEHIND CRACKED STUCCO

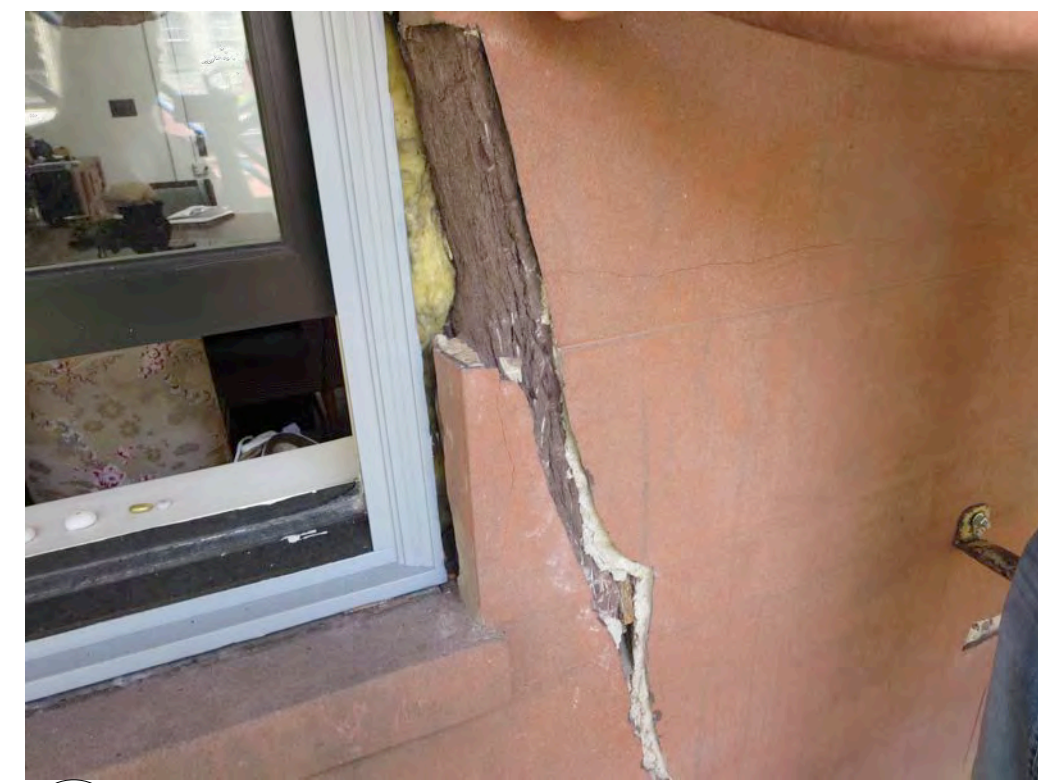
PH-5 SEVERELY DETERIORATED & MISSING MASONRY
WINDOW JAMB

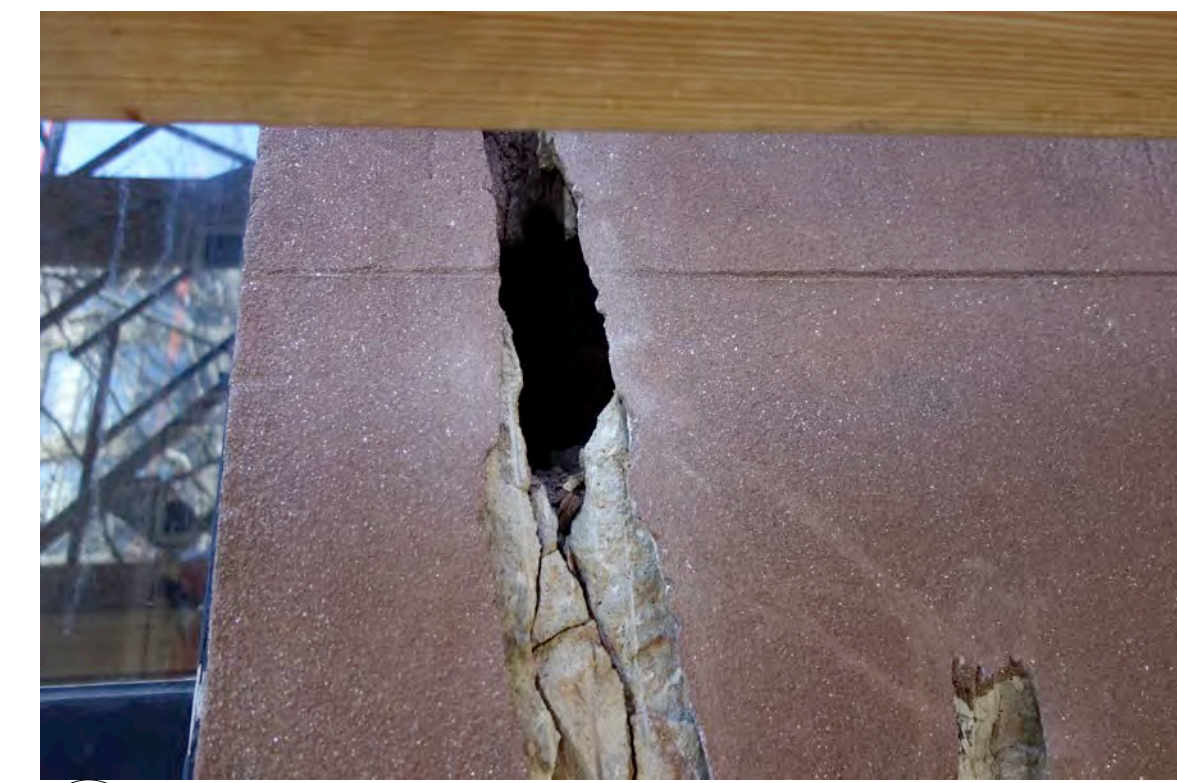
PH-6 SEVERELY DETERIORATED & MISSING MASONRY AT WINDOW JAMB
WINDOW JAMB

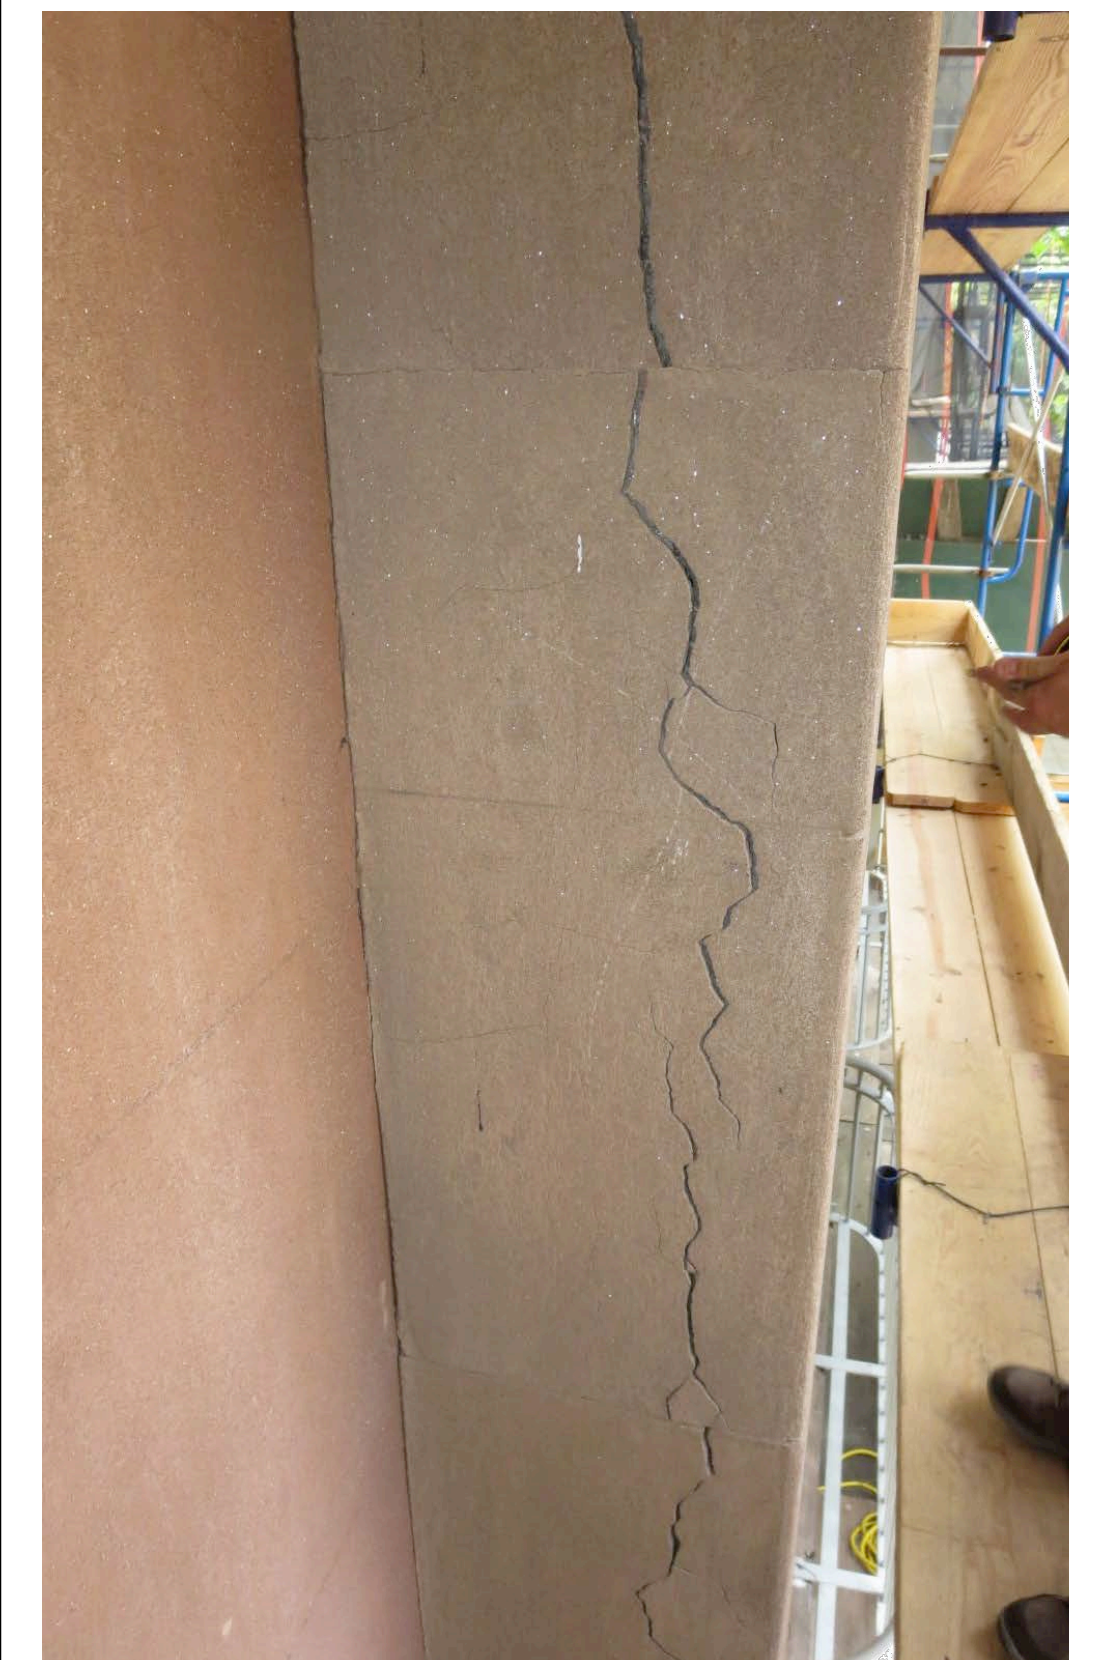
PH-13 CRACKED STUCCO
BUMP-OUT BETWEEN 44 & 48 WEST 12TH STREET

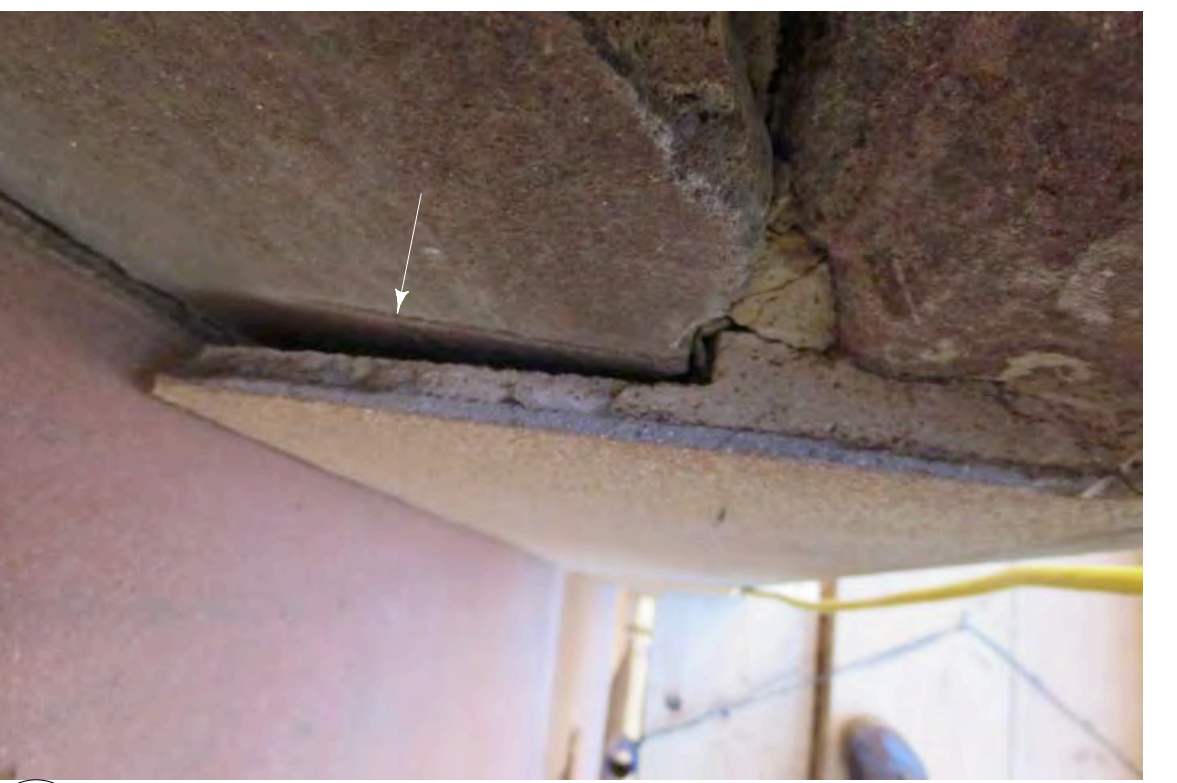
PH-14 DELAMINATED STUCCO
CLOSE-UP LOOKING DOWN AT BUMP-OUT PROBE

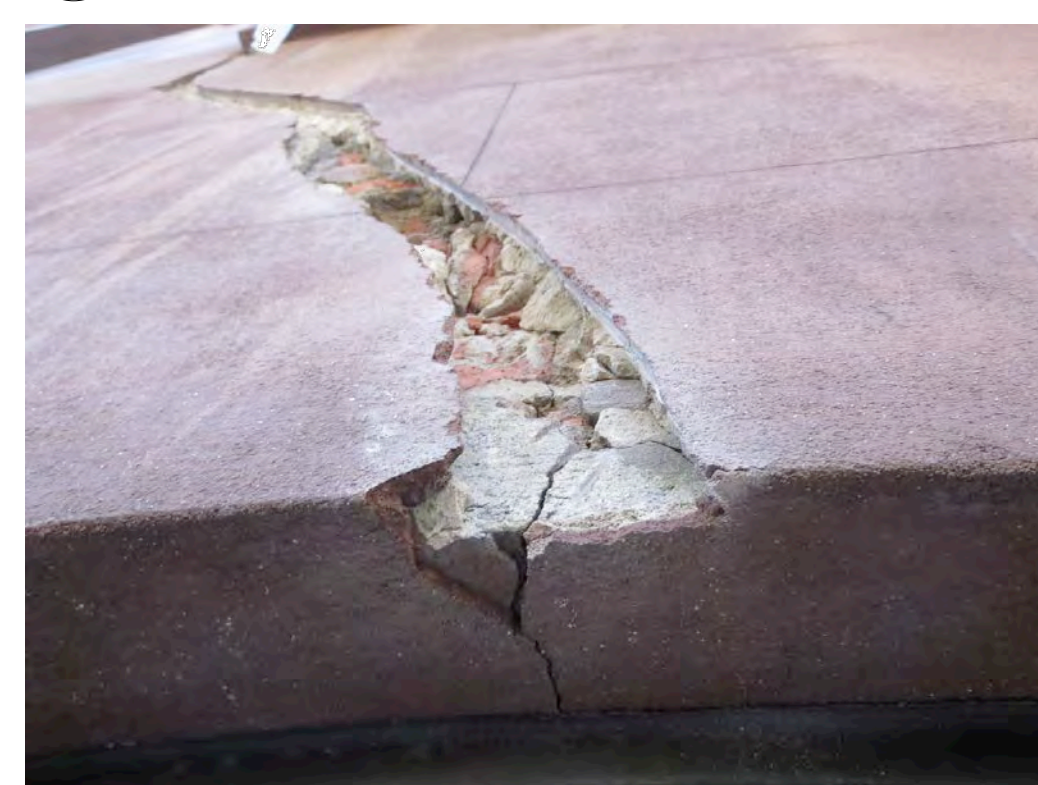
PH-7 PREVIOUS BRICK RECON. AT UNDERLYING MASONRY

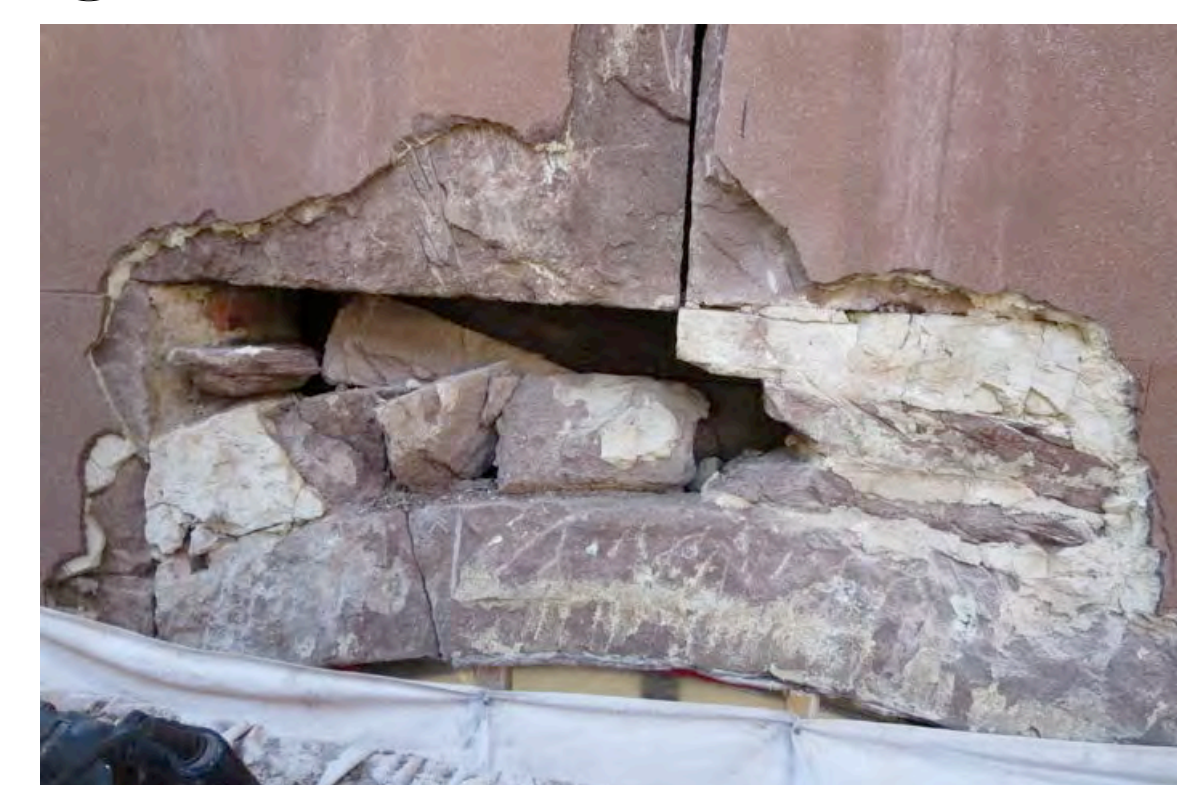
PH-8 COLLAPSED BROWNSTONE
AT PANEL BETWEEN 3RD & 4TH FLOOR WINDOWS

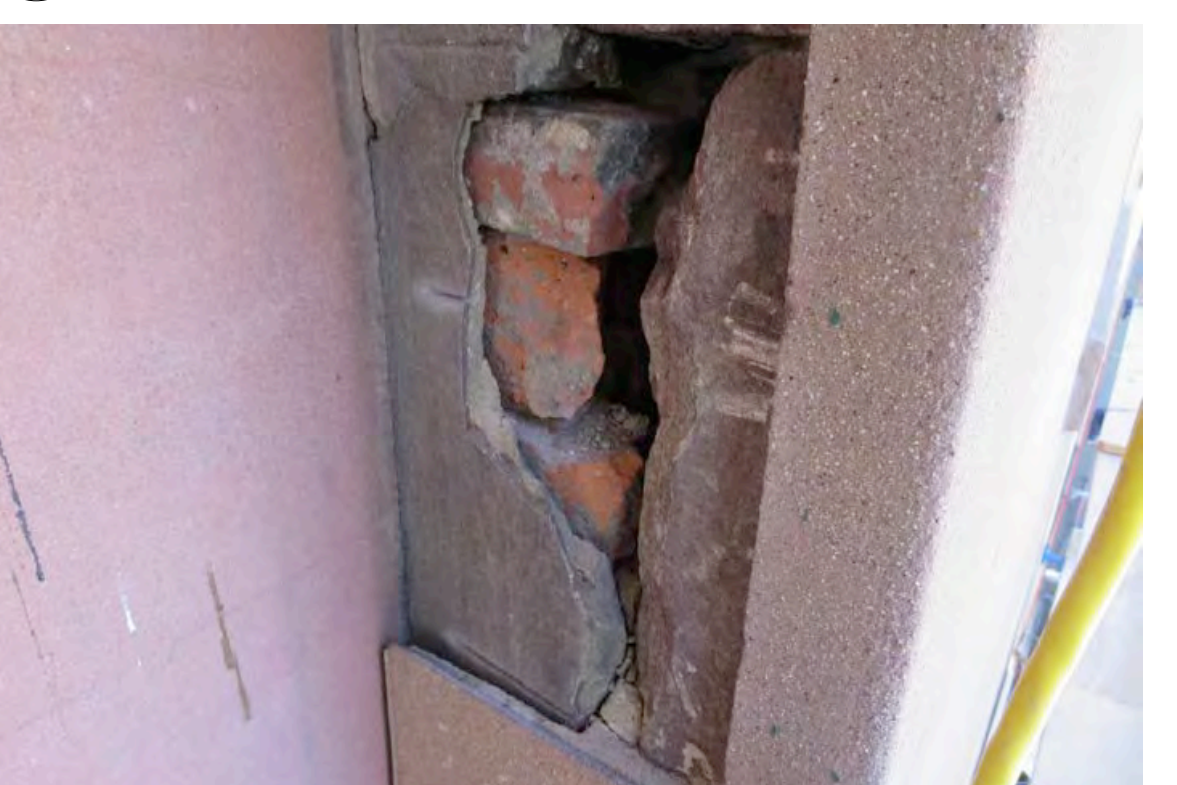
PH-15 SEVERELY DETERIORATED BRICK BACKUP MASONRY
PROBE AT BUMP-OUT BETWEEN 44 & 48 WEST 12TH STREET
