41 Greenwich Avenue Landmarks Preservation Commission August 13, 2019

Re: Inspection and Structural Assessment 41 Greenwich Ave., Manhattan, NY

ENGINEER'S REPORT 02-16-2016

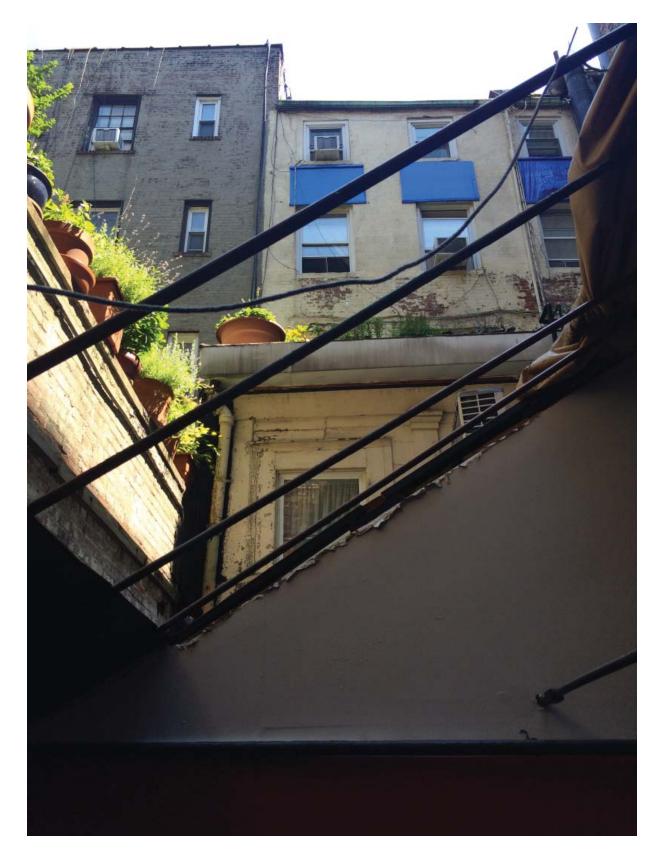
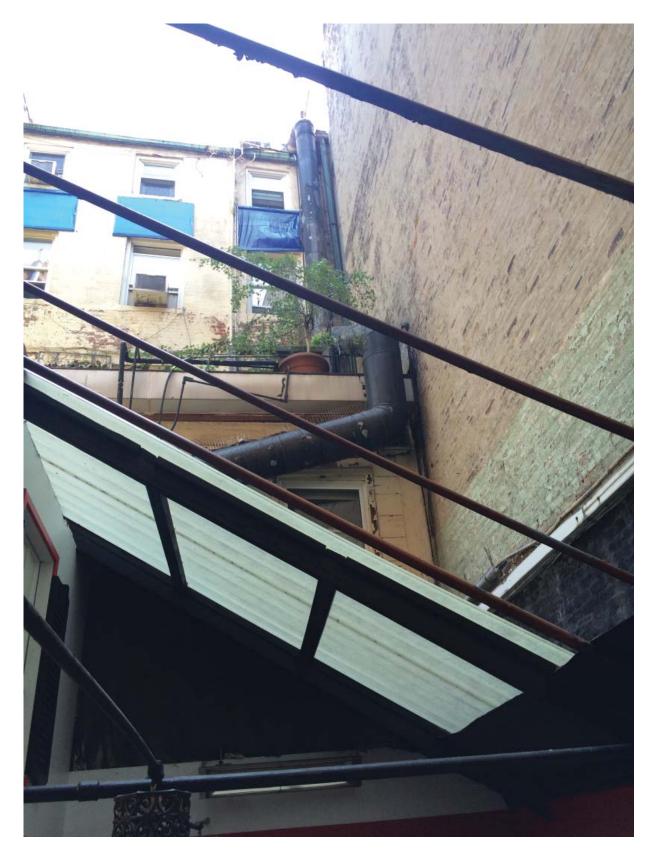
Rear Wall - Existing Condition

The rear facade has deterioration issues. A white coating applied to the brick sometime in the past has trapped moisture in the brick, which after repeated freeze-thaw cycles had deteriorated the structural capacity of the brick. We would recommend demolition and replacement of the rear façade wall.

The rear wall can be rebuilt with common brick and masonry lintels to match the original construction and architectural details. The new brick materials should be either uncoated or coated with a breathable style material to allow moisture to escape the brick substrate. This will maximize the service life of the new rear wall.
