66-68 West 10TH STREET NY, NY: TAX LOT PHOTO (1940)

MICHAEL SCHMITT ARCHITECT PC.

RESTORATION RECOMMENDATIONS

66 WEST 10TH ST NEW YORK, NY

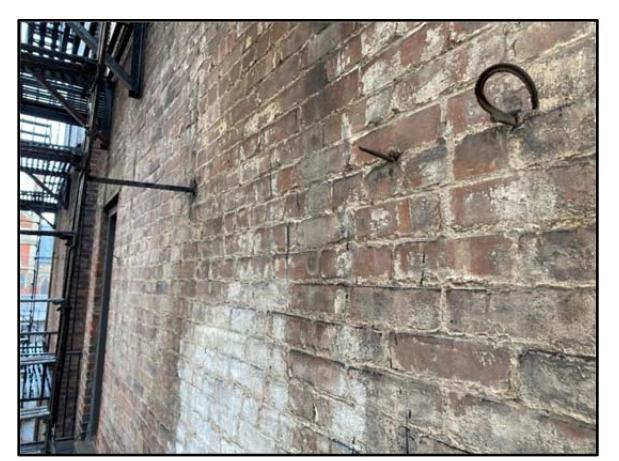
Abandoned Fixture

Abandoned fixtures can lead to deterioration when they corrode causing rust stains, and rust jacking with cracks and spalls in adjacent materials. Such fixtures typically include disused electrical equipment. Where abandoned fixtures penetrate wall materials, such as with recessed lighting or wall outlets, they can provide a point for water to enter the inner wall assembly. Fixtures may also be connected to thru-wall electrical conduit which provides a means for water to move within wall assemblies and, when it corrodes, can lead to cracks, spalls, and

At 66 W 10th St, there are abandoned fixtures throughout the front and rear façades that have been installed into the brick face. On all façades, tenant cable wiring has been run through from the roof to the interior of the building by the bottom corners of the windows. These penetrations could potentially introduce water into the wall interior.

- Cable Wiring and Abandoned Fixtures Remove all cable wiring from the roof and façades and patch any openings. Remove all abandoned fixtures and patch any openings.
- 10. Cast Iron Repair

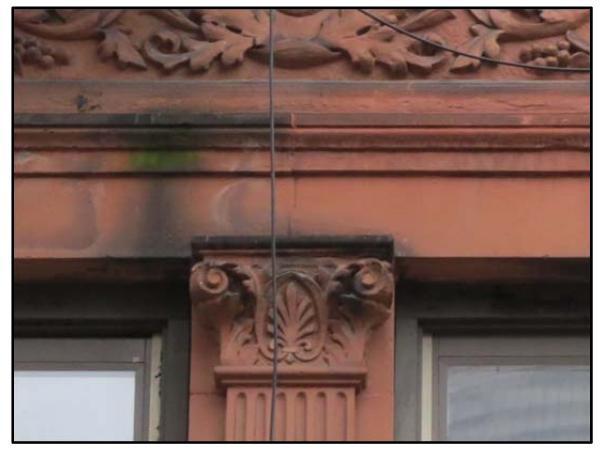
Atmospheric Soiling

Atmospheric soiling is the accumulation of air pollutants on the surface of the building over time. It is most often found as a black crust on the undersides and faces of the masonry. This crust is primarily composed of black carbon carried in the air and deposited on the building. Areas protected from rain, such as the undersides of cornices, tend to exhibit a greater build-up of crusts.

There is atmospheric soiling on the underside of protruding decorative stone elements on the front façade of 66 W 10^{th} St. This soiling is also

present within the recessed areas of stone that has been carved into high relief.

- 1. Cleaning.
 - a. General soiling and biological growth should be cleaned from the surface of masonry with cleaning chemicals as outlined in the section on Repair Materials. A cleaning test program will be undertaken to find the gentlest but most effective cleaners that will not damage the masonry. Large cleaning mock-ups will be performed to ensure the cleaners are effective on a large scale and that the cleaning products have not been modified by the manufacture. Ensure that cleaning products are effective at cleaning the brownstone, sandstone, and brick.

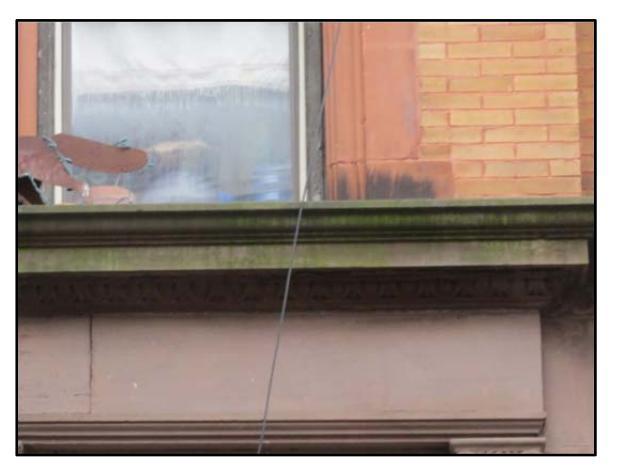
Biological Growth

Biological growth on masonry is a symptom of excess moisture in the masonry. Biological growth can be present in the form of micro-flora such as algae, moss and lichen, or macro-flora such as vines and saplings. Bacteria and lichen produce oxalic acids that damage masonry. Vines and saplings will usually damage masonry, but need to be carefully monitored because if they have become too integrated into the building removal could cause the wall to break down farther. Biological growth clogs pores, thus making it hard for water to escape and this will

also farther deterioration of masonry. Root growth can also deteriorate the mortar and cause masonry displacement.

At 66 W 10^{th} St, biological growth is present on many protruding stone elements on the front façade. There is heavy soiling on the brownstone band course along the third story, as well as on the railings of the front stoop.

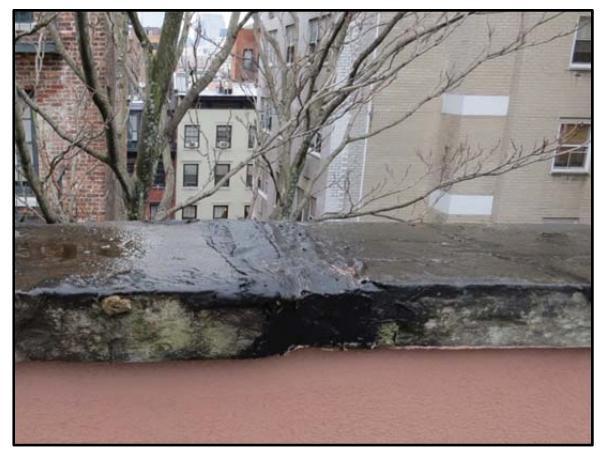
Bituminous Coating

A bituminous coating is a type of coating that creates a water-proof and vapor-proof barrier. It is a mixed substance that has a viscous consistency, and can contain fiber reinforcements such as asbestos. A bituminous coating is usually applied as an inexpensive method of waterproofing in roof construction. This type of coating can cause serious deterioration of masonry as it can trap water that is absorbed by the stone. This water can then expand as a result of freeze-thaw cycles⁴, which can lead to spalling at the surface.

At 66 W 10th St, a bituminous coating has been applied to the joints of the bluestone coping on the parapet. Many of the stone window sills on the rear facades have also been coated with a bituminous coating at the corners where the sill meets the window.

Remove bituminous coating from bluestone coping.

Remove all bituminous coatings surrounding the sills throughout the rear facades. Tool any deteriorated stone back to sound stone and patch where necessary to ensure water is properly shed from the wall. Any open joints should be repointed as per recommendations below.

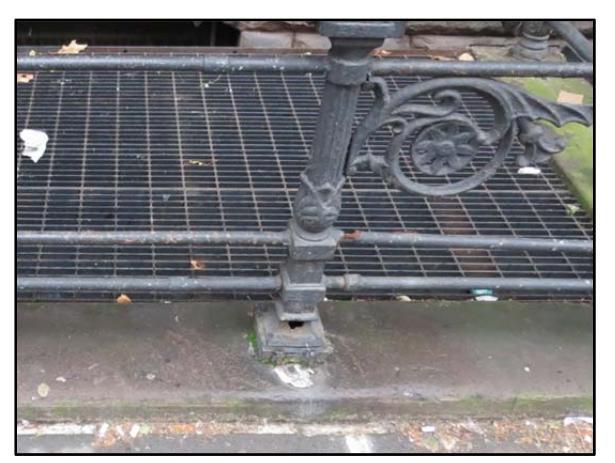
Corrosion

accelerate corrosion.5

Iron and steel, when unprotected, oxidize rapidly when exposed to moisture. The oxidation of iron is a highly destructive process. The product of the oxidation is rust, which initially consists of a mixture of ferrous and ferric hydroxides, and later becomes hydrated ferric oxide (with some traces of carbonate). The minimum relative humidity necessary for rusting is 65 percent, but it can be lower in the presence of pollutants. Salts act as electrolytes that will accelerate the corrosion of iron and steel. Once a rust film occurs, its porosity can hold additional water which will also

The cast-iron railings along the front façade of 66 W 10th St have some areas of corrosion where previous coatings have failed. In one area, a post base has an opening that is the result of corrosion. In some places, the railings are corroded at the point where they meet the post, which could cause the railing to fail if untreated.

Remove existing coatings on the cast iron railings on the front façade. Fill any openings or losses with appropriate filler material (see section on Repair Materials).

Prime and paint to match the original historic finishes.

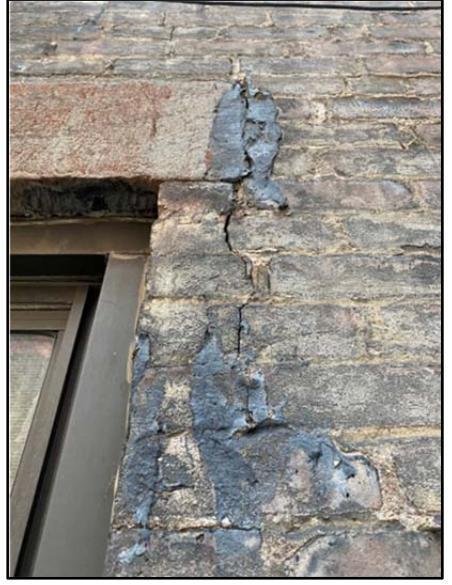
Crack

A crack is an individual fissure, visible to the naked eye, resulting from the separation of one part from another. When tension is relieved in a material, it cracks. In general cracking can be caused by weathering, flaws in the material, rusting ferrous embedments, excessively hard repair materials, vibrations, thermal and moisture expansion and/or contraction, efflorescence, and ice formation within the material. Masonry cracks are usually caused by several different deterioration mechanisms. Stresses such as excessive sheer, compressive or tensile loads, or impact can crack masonry. Cracks in masonry are often indicators of greater structural issues. Additionally, cracks in the masonry allow water and salts to infiltrate, thereby leading to further deterioration of the material.

At 66 W 10th St, there are some hairline cracks in the stone

and brick, as well as larger cracks in areas where architectural elements meet, such as along the brick beneath a window lintel. There are also cracks along the sandstone band courses as well as in areas where previous patches have failed. These cracks must be patched in order to avoid the continued deterioration and possible spalling of large masonry units.

For cracks narrower than 3/8-inch, route the crack and patch with composite patching material which matches the color, texture, profile, and vapor permeability of the surrounding clean stone.

Cracks equal to or wider than 3/8-inch shall be patched with approved composite patch material to match the color, texture, profile and vapor permeability of the surrounding clean stone.

Hairline cracks can be left as is.

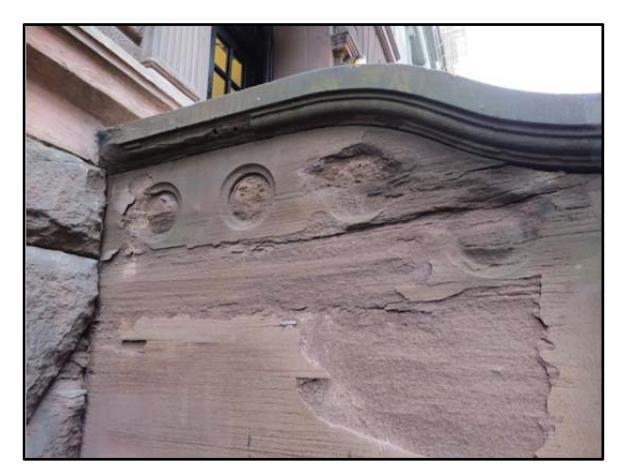
Delamination is a detachment process affecting laminated stones (mostly sedimentary rocks and some metamorphic rocks). It corresponds to a physical separation into one or several layers following the stone laminate (layers). The thickness and the shape of the layers are variable. The layers may be oriented in any direction with regards to the stone surface. Delamination may be caused by the swelling and shrinking of clays in the sedimentary layers during wetting and drying, or it may be caused by the crystallization of soluble salts between sedimentary layers.

At 66 W 10th St, there are large areas of delamination throughout the brownstone base and stoop. This type of delamination is common in brownstone and must be patched in order to avoid further deterioration. Previous patches have delaminated or otherwise failed and are in need of replacement.

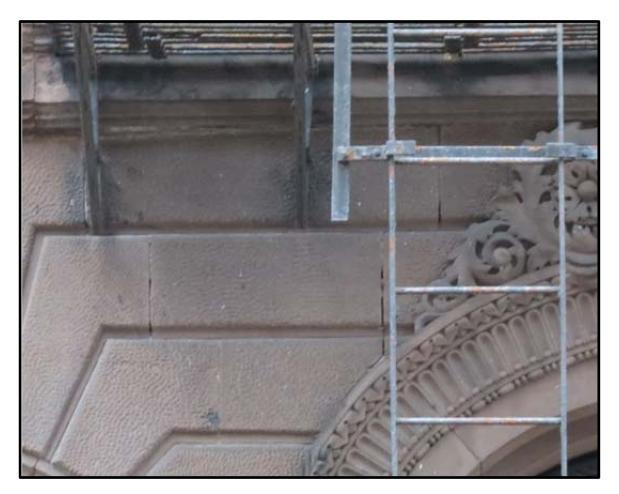
Open Joints/Failed Mortar Joints

The severe deterioration of mortar joints between masonry units can result in mortar loss. Mortar can fail for a number of reasons: movement of the masonry wall, inappropriate mortar mix and installation, erosion, water infiltration, freezethaw damage, acid attack and physical movement. Once the mortar joints have failed, water can enter the masonry wall and cause additional deterioration.

Incompatible pointing material can lead to accelerated deterioration of the masonry, for example, if the open joints have been filled with

caulking material. Joints should be soft and permeable enough to allow water that enters the masonry to evaporate through the joints. If the mortar or joint material is impermeable, water can get trapped in the wall or it is forced to evaporate through the masonry units themselves. Water in the masonry units can cause freeze-thaw damage⁶. Water passing through the masonry units can result in efflorescence. Both can then lead to a physical break down of the masonry.

At 66 W 10th St, there are several open joints between segments of brownstone and sandstone on the front façade. Much of the pointing on the inner brick faces at the cellar level has failed and is in need of replacement. There are several larger areas on the rear brick façades that require

repointing. These areas are mainly along the bases of the fire escapes and just below the windows.

Caulking used as mortar should be removed and any open joints repointed as per recommendations below. All skyward facing joints should be filled with lead Ts.

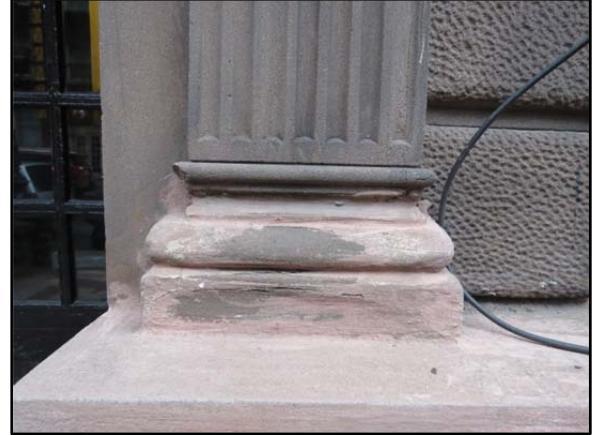
Patching is a repair technique that fills losses, usually with a cementitious or bituminous coating. It can be found where there are large areas of missing or damaged material, or over areas of mechanical damage or alterations. Patching is inappropriate when it does not match the original material in terms of composition, shape, color, or surface texture. Inappropriate patching can also trap moisture beneath the surface, allowing additional deterioration to occur behind the patch.

At 66 W 10th St, there has been extensive patching done to the brownstone stoop. Many areas of patching have delaminated and need to be replaced, manly on the stair risers. Some areas of the sandstone band courses have also been patched. These patches are cracked in some areas and may lead to spalling if untreated. The previous patch repairs were not properly matched to the original stone color, and so they will need to be stained.

Remove all failing masonry patches and replace with new patches.

Stain sound patches to match the color of the surrounding masonry.

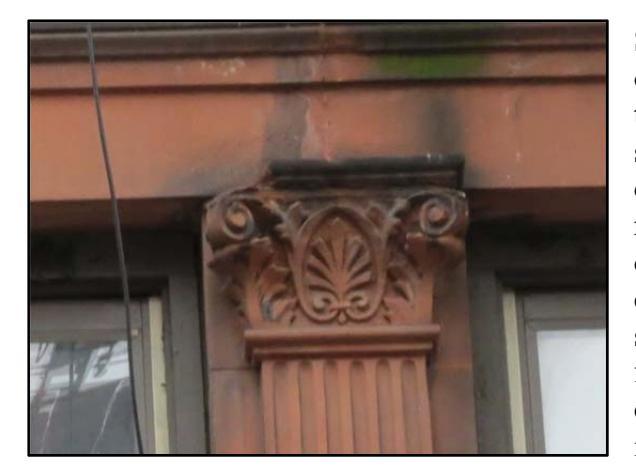
Spall, or the loss of surface material, generally occurs as the result of a buildup of stresses below the surface. When the stresses become significant enough to fracture the material, pieces disengage from the body. These internal stresses may include corrosion of metallic anchors, deterioration of patches or glazing, freeze/thaw cycles, or crystallization of salts beneath the surface. Spalls can also be caused by external forces such as the application of a non-breathable coating trapping moisture inside the masonry, impact or vandalism.

Some spalling has occurred to the brownstone and sandstone on the front façade of 66 W 10th St, mainly at the corners and edges of carved decorative elements. These spalled areas will need to be patched and recarved to match the surrounding profile and detail of the original.

Patch small spalls (those deeper than 1/2-inch but less than 4-inches) in the stone using breathable composite patching materials that match the surrounding stone in color, texture, tooling and vapor permeability (see section on Repair Materials). The profile of patches applied to carved elements is to match the level of detail, texture, reflectance, and pattern of the element to which it is applied. Patch repairs are required at the brownstone and sandstone on the front façade.

Repair larger spalls (those which exceed 4-inches in depth) using dutchmen. Profile and detailing should match the original element.

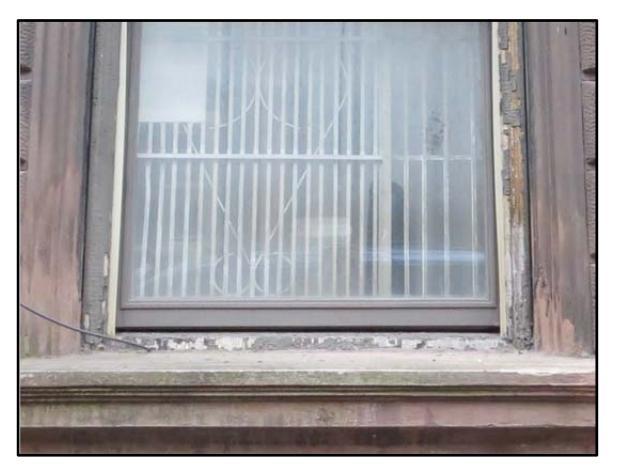
Wood deterioration

Moisture and ultraviolet radiation cause wooden window frames and sashes or other wooden elements to deteriorate. Paint minimizes the damage to wood but without proper maintenance, wood will continue to deteriorate.

At 66 W 10th St, the wooden window frames on the front façade are highly deteriorated. This is likely the result of failing paint, which has left the raw wood exposed. These elements will need to be replaced with new painted wood.

The windows on the front façade were replaced by the building owner within the last 20 years. The windows should be inspected and all broken or heavily deteriorated wood framing should be replaced in kind or with compatible tight grained wood. Replace all failing window sealant.

- A. Deteriorated wood should be replaced in kind. New wood is to be tight grained and compatible. Wood is to be primed on all faces.
- B. New painted finishes for wood shall be breathable, high-quality exterior-grade acrylic coatings, such as Benjamin Moore, or approved equal. Obtain primer and finish products from the same manufacturer and verify with manufacturer that products are compatible for use in overlapping coats.
