170 Bleecker Street

170 Bleeker Street: Existing Conditions

170 BLEECKER STREET, 10/24/2017

THE SRA GROUP, LLC (SHEET A-107.00)

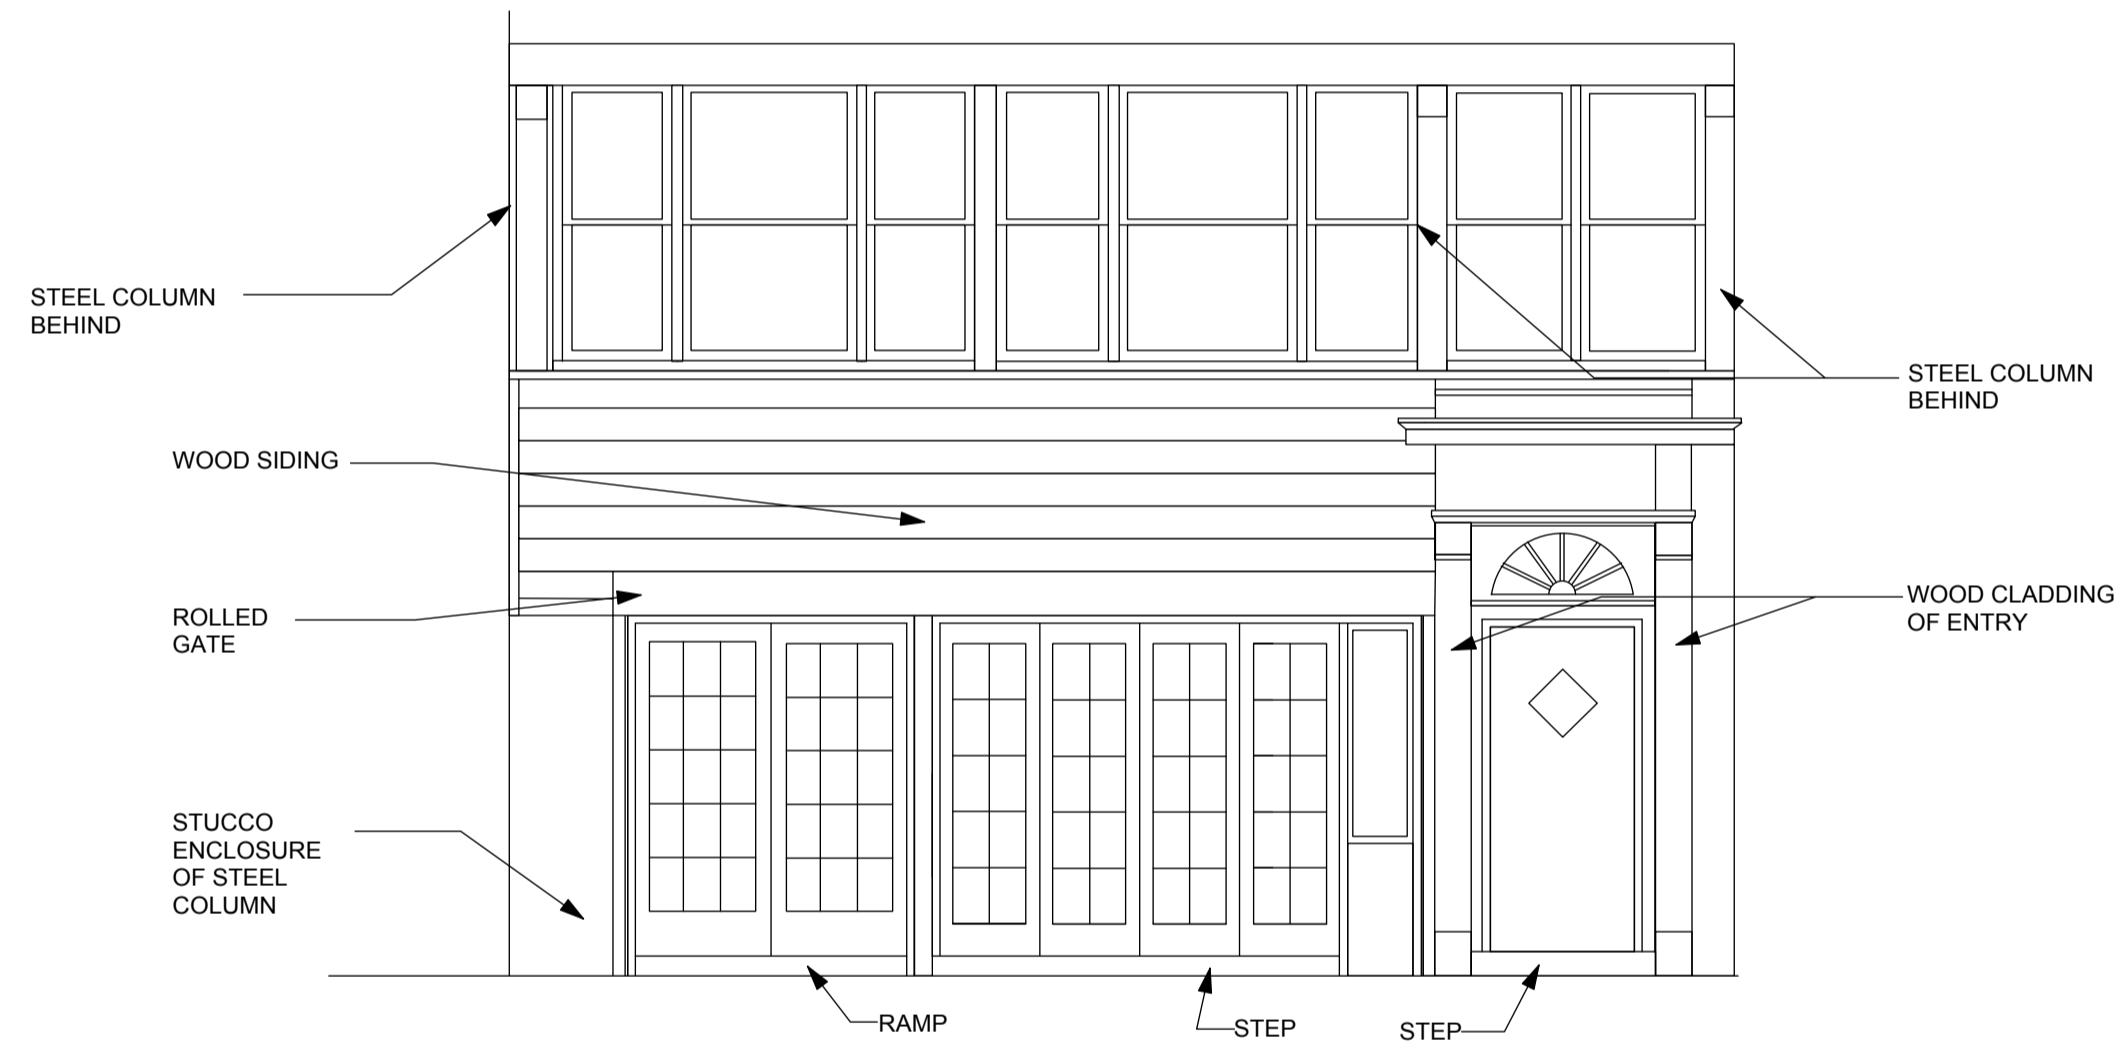
1 EXISTING BLEECKER STREET ELEVATION
Scale: 1/4" = 1'-0"

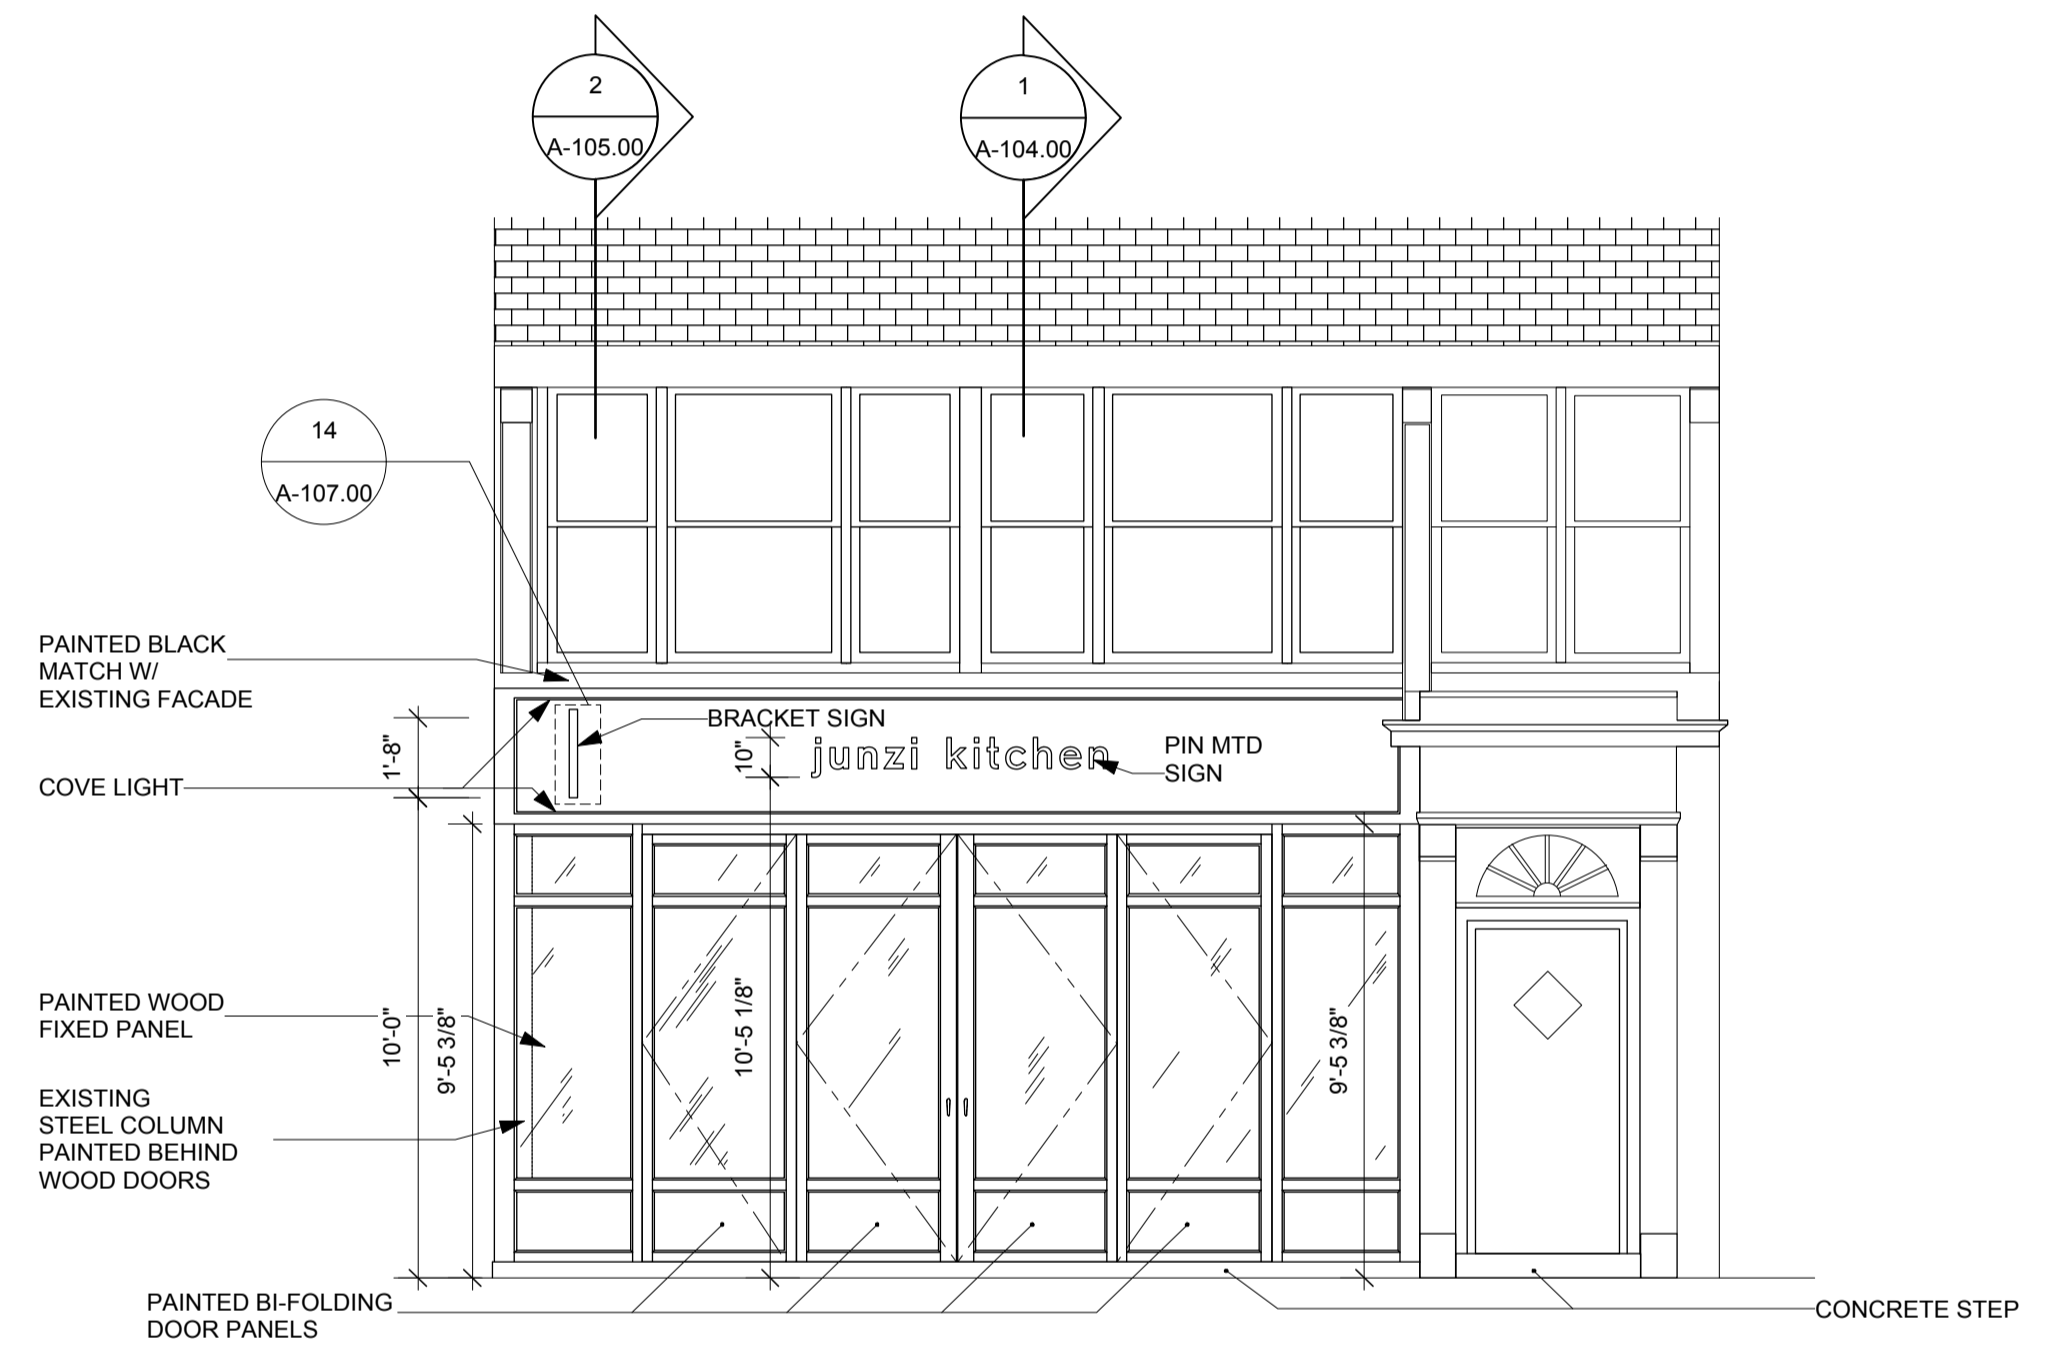
2 NEW BLEECKER ELEVATION
Scale: 1/4" = 1'-0"

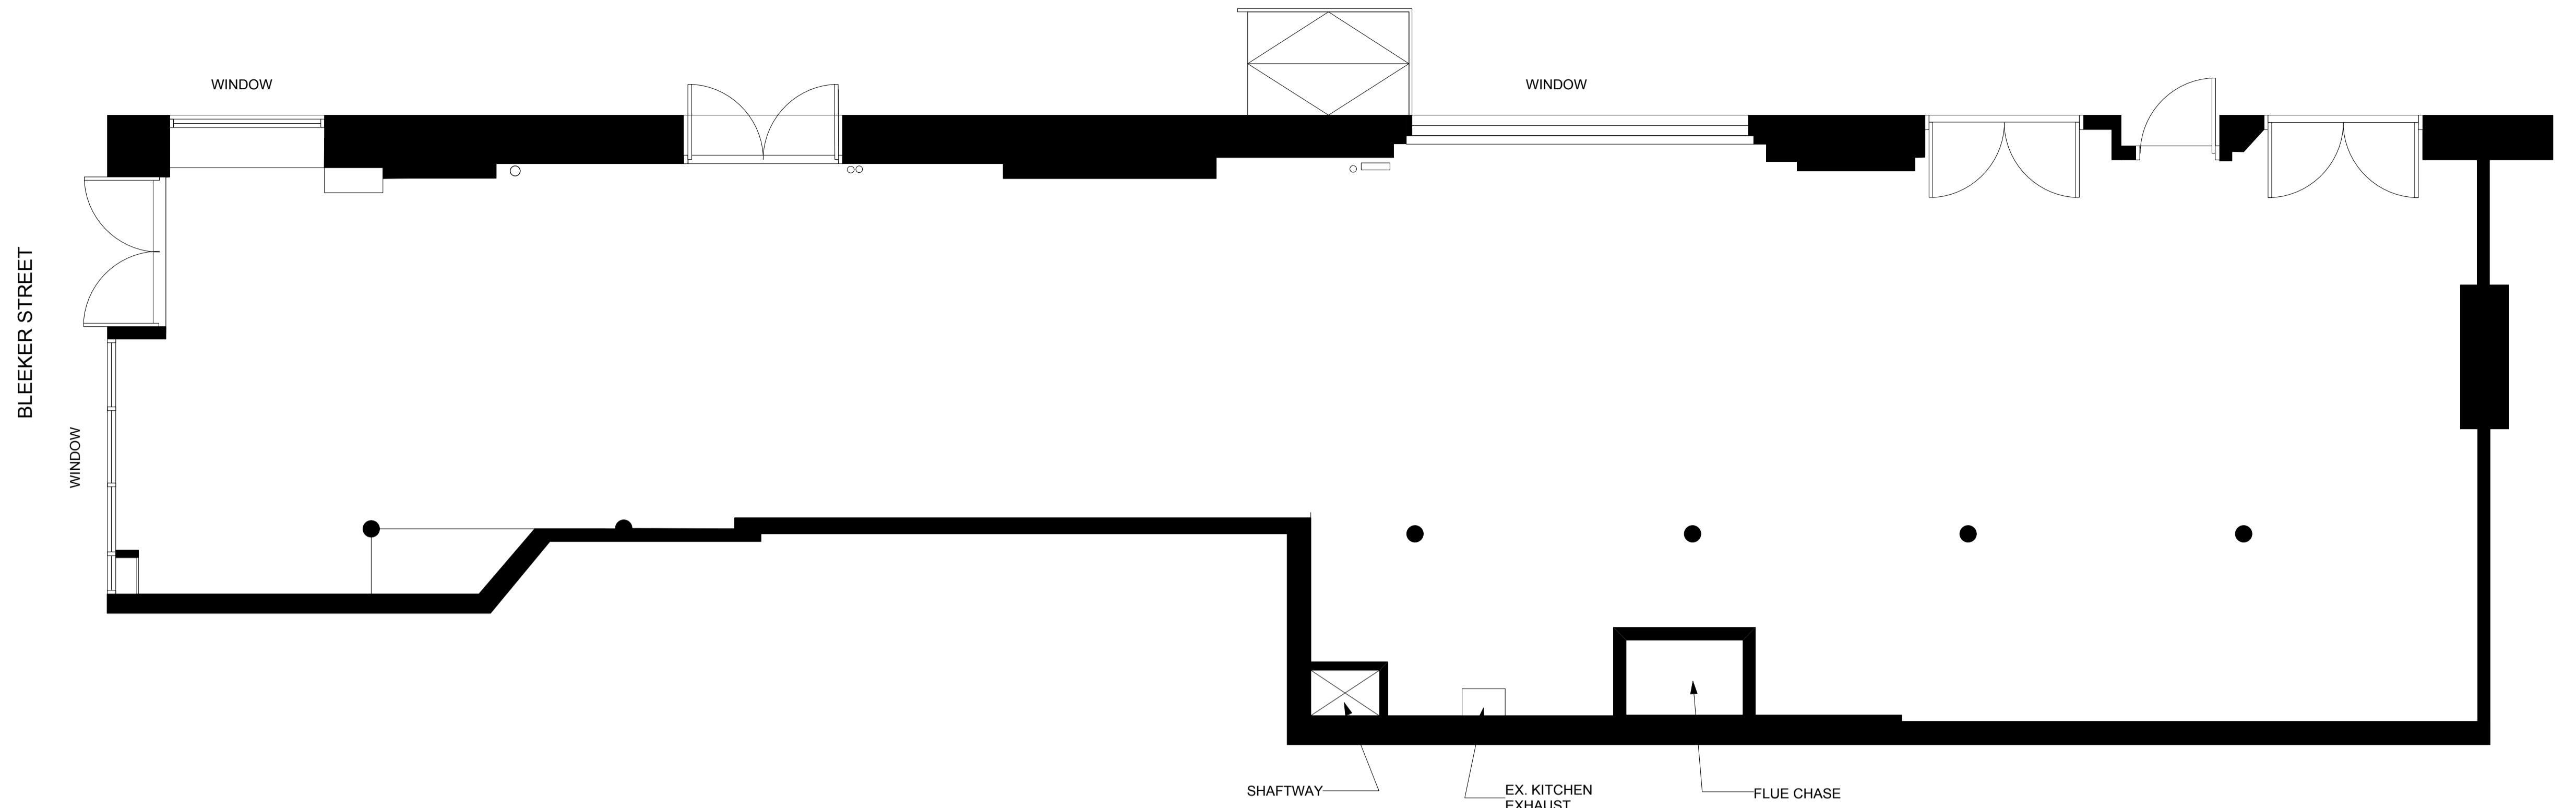
1 EXISTING 1ST FLOOR PLAN
Scale: 1/4" = 1'-0"

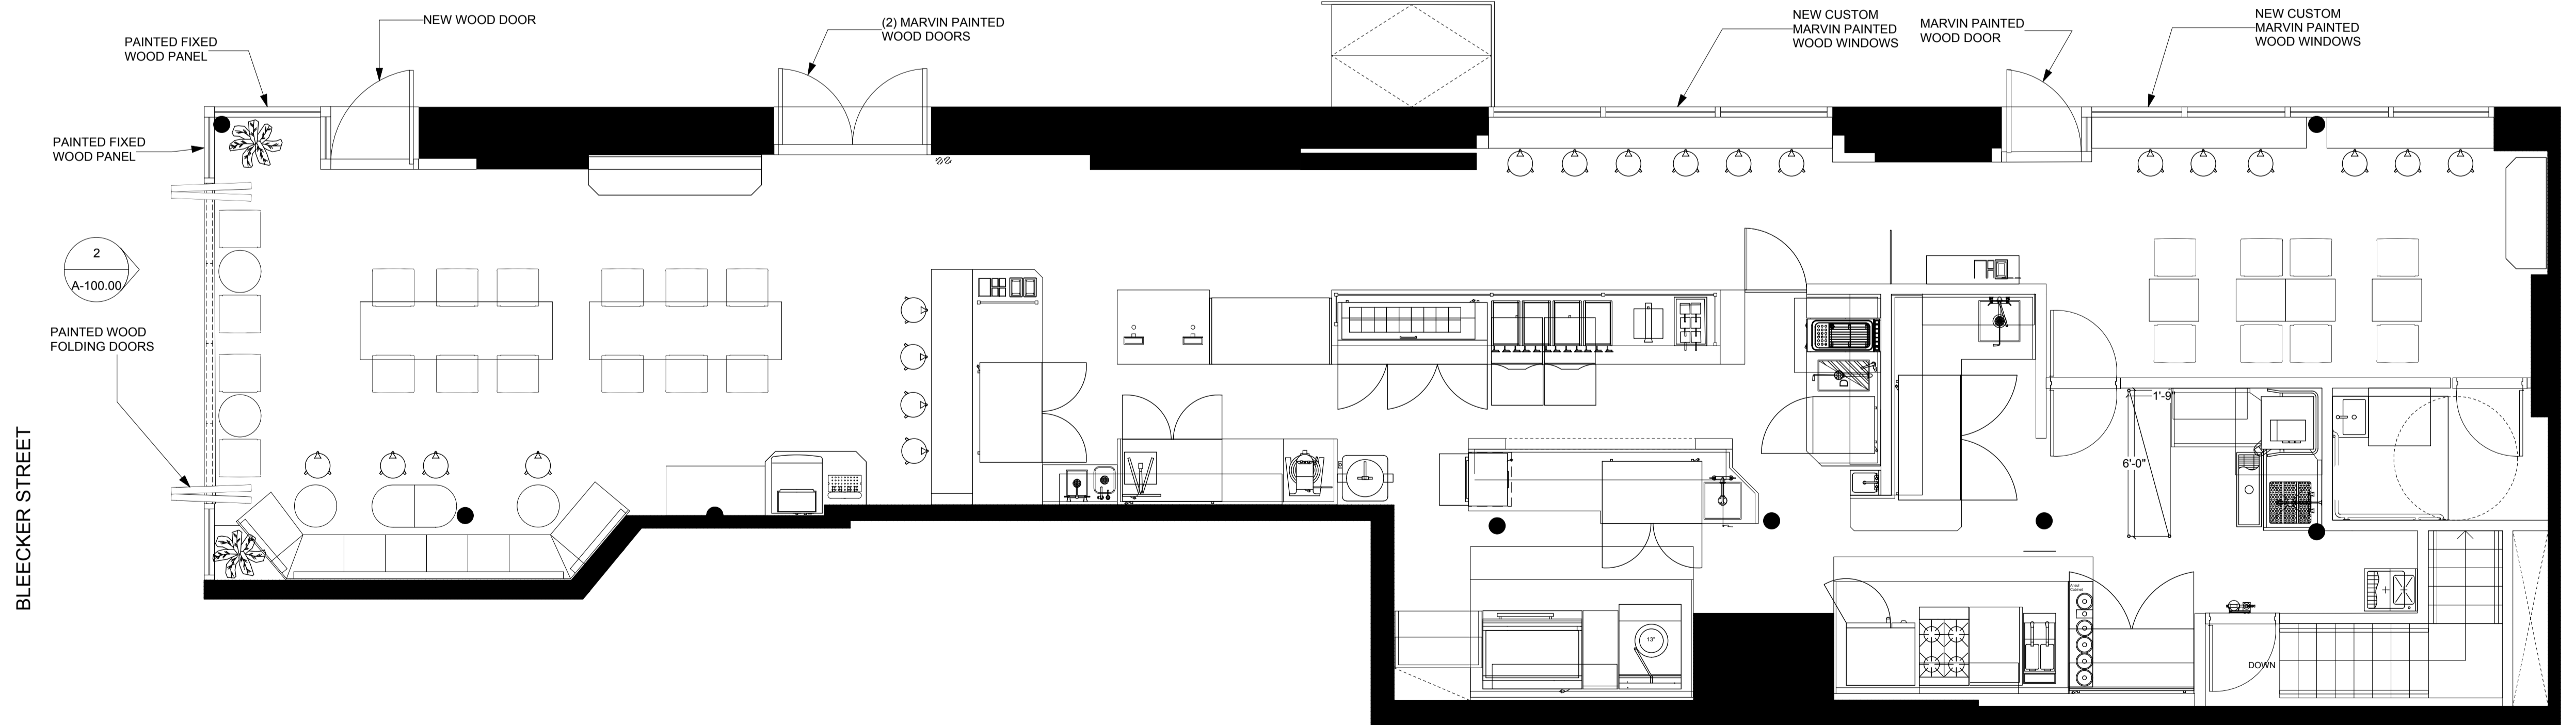
3 PROPOSED 1ST FLOOR PLAN
Scale: 1/4" = 1'-0"

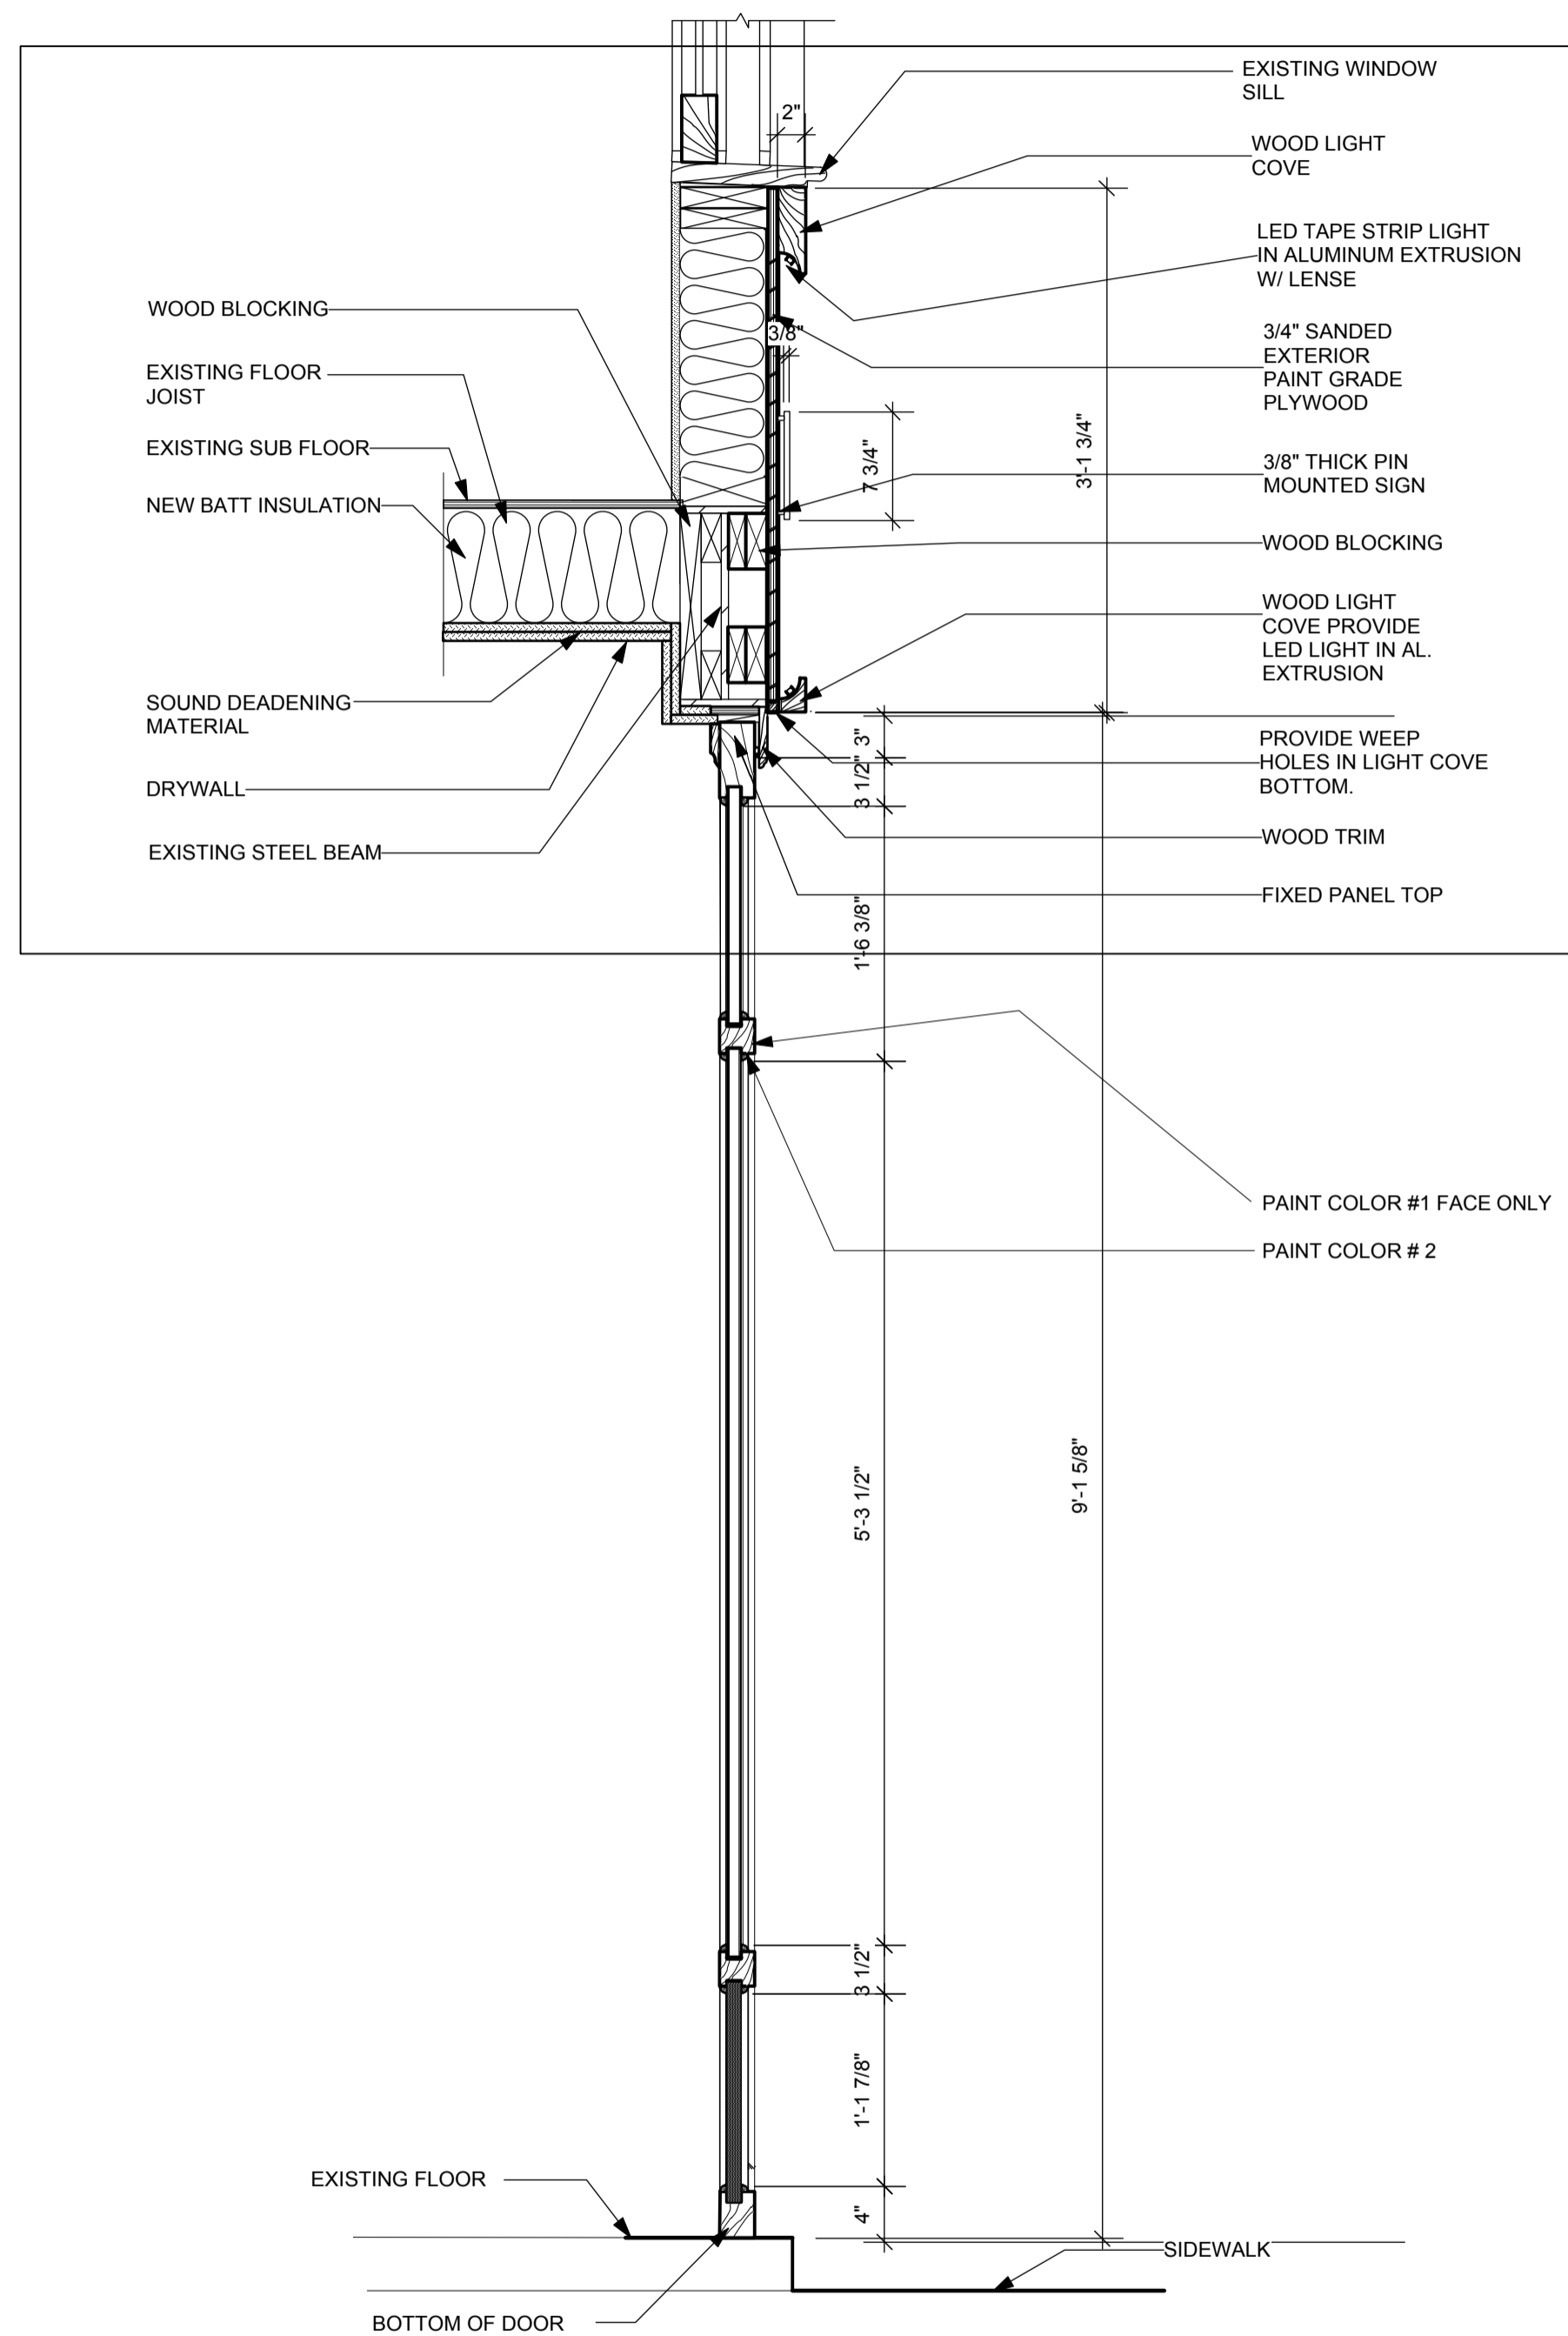
3 SECTION THROUGH FIXED GLAZING
Scale: 1" = 1'-0"

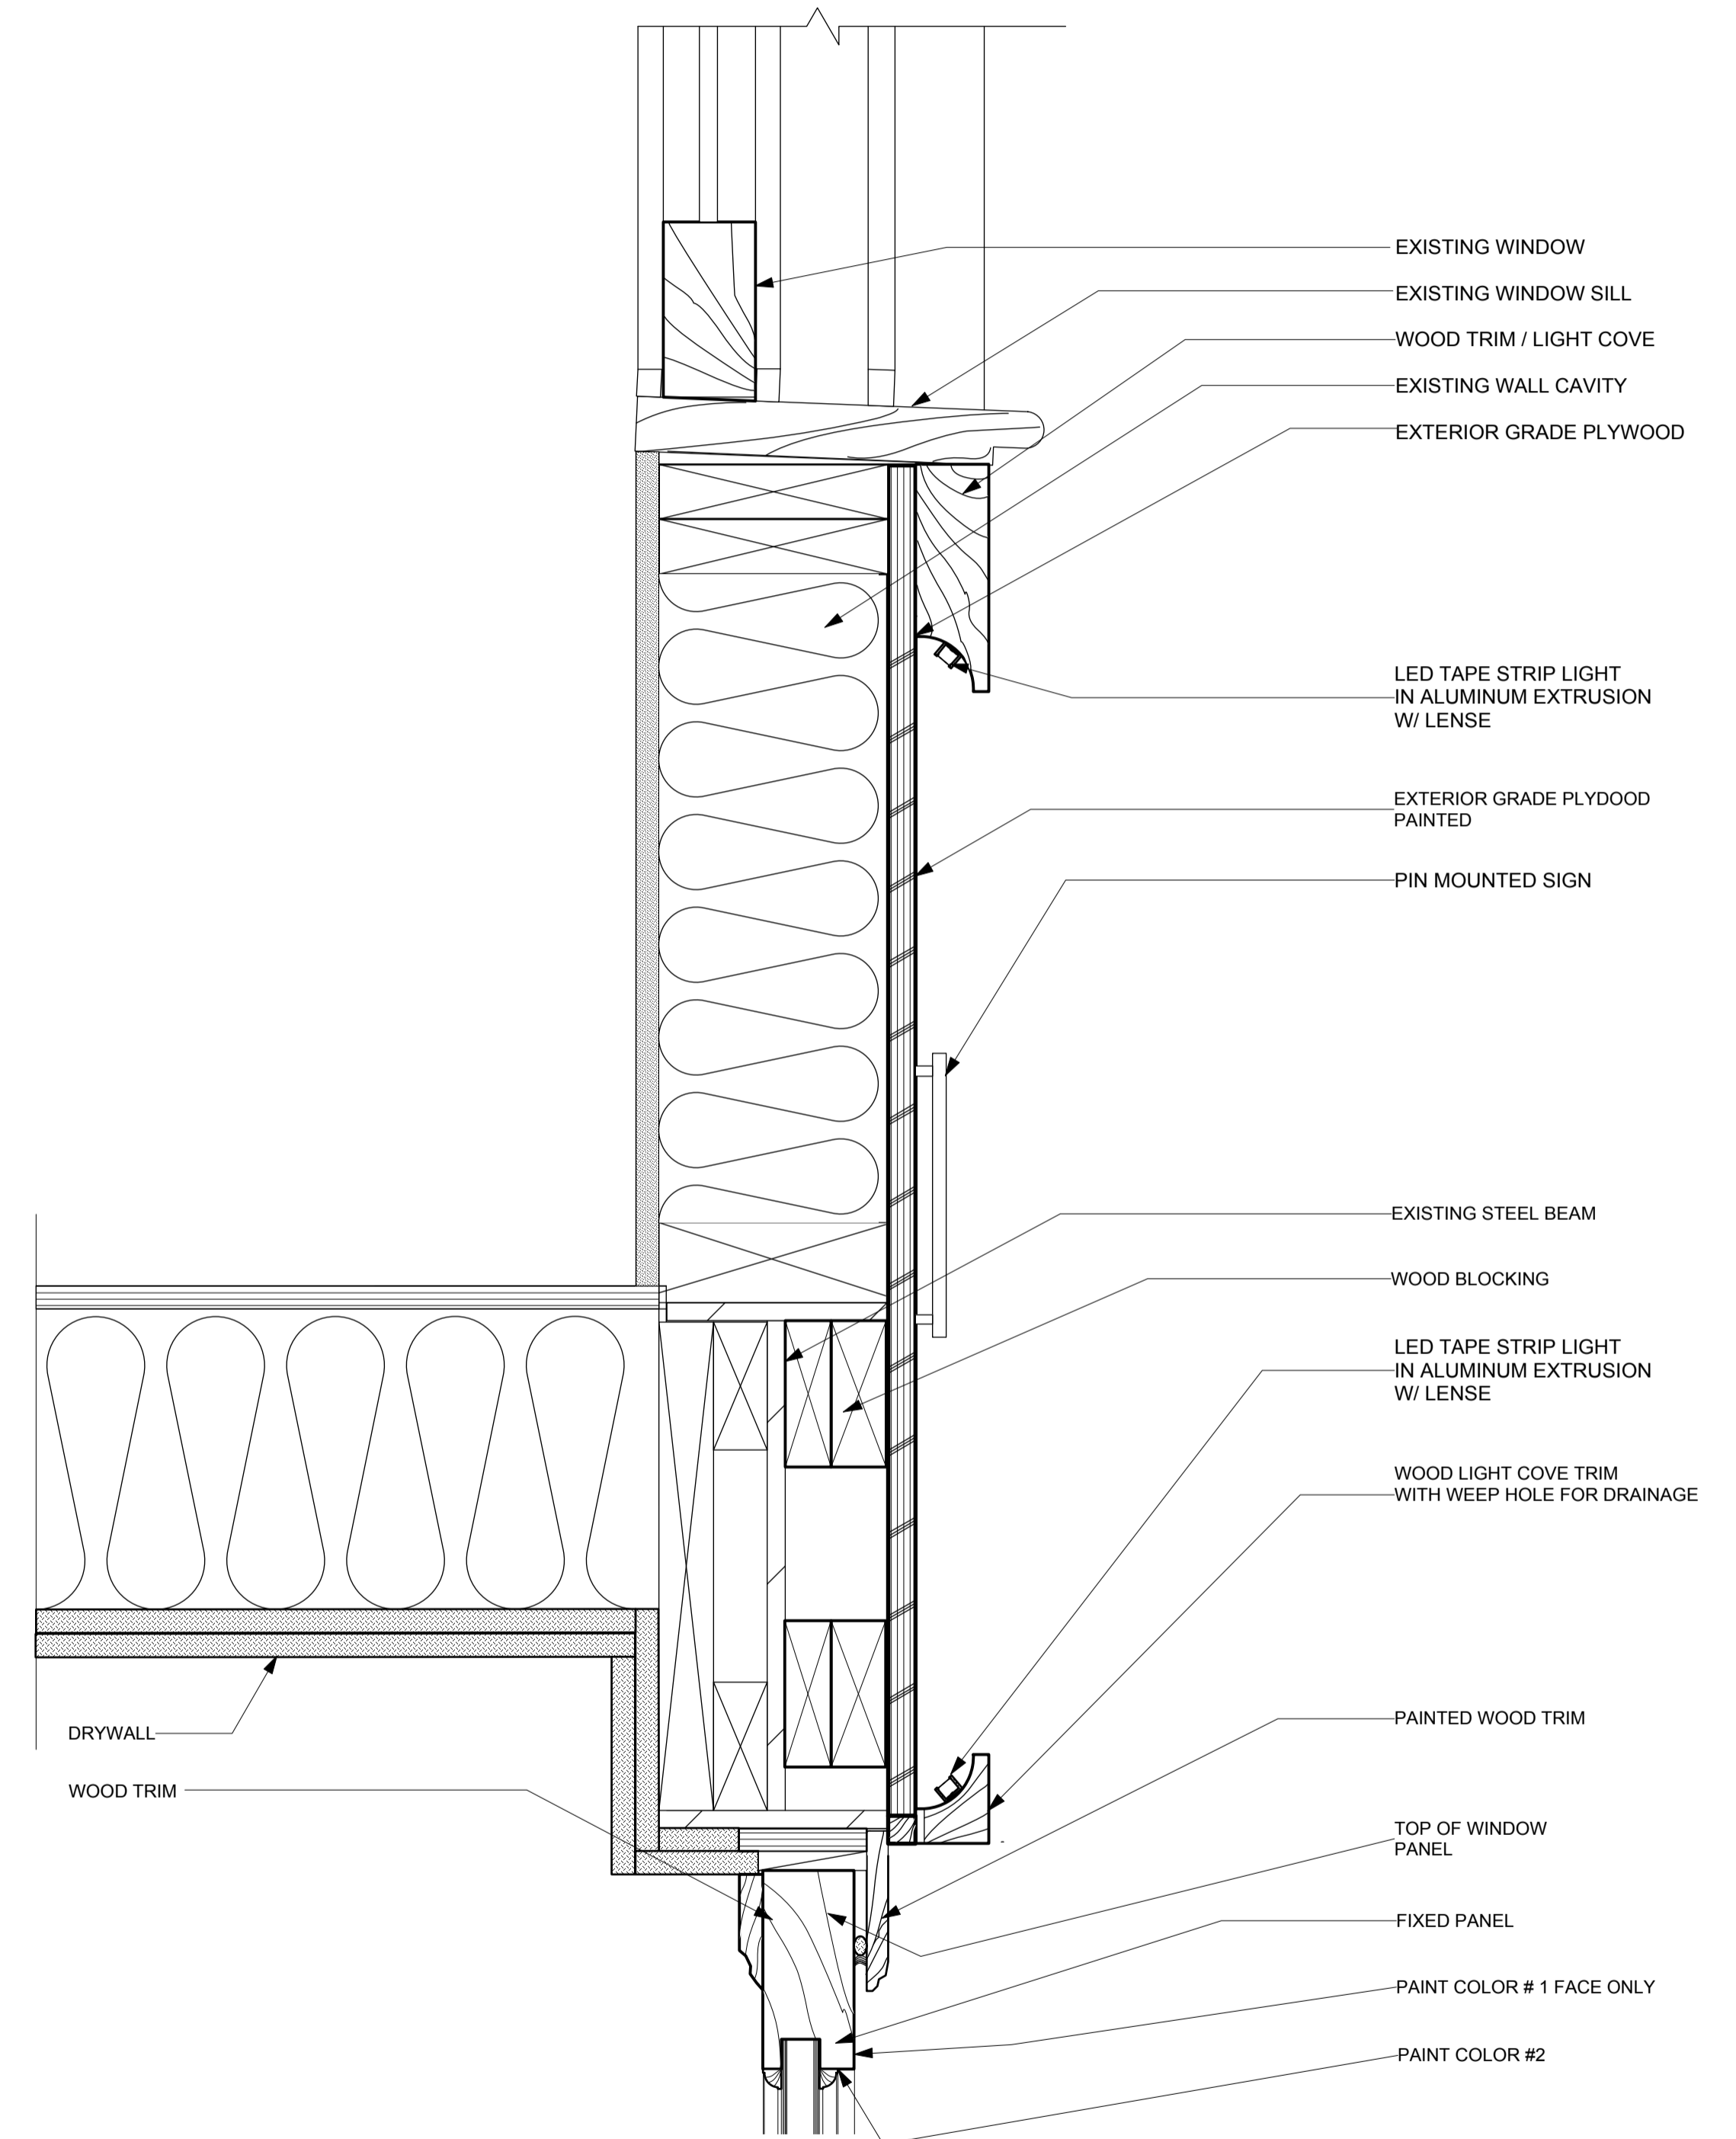
4 EXPANDED VIEW
Scale: 3" = 1'-0"

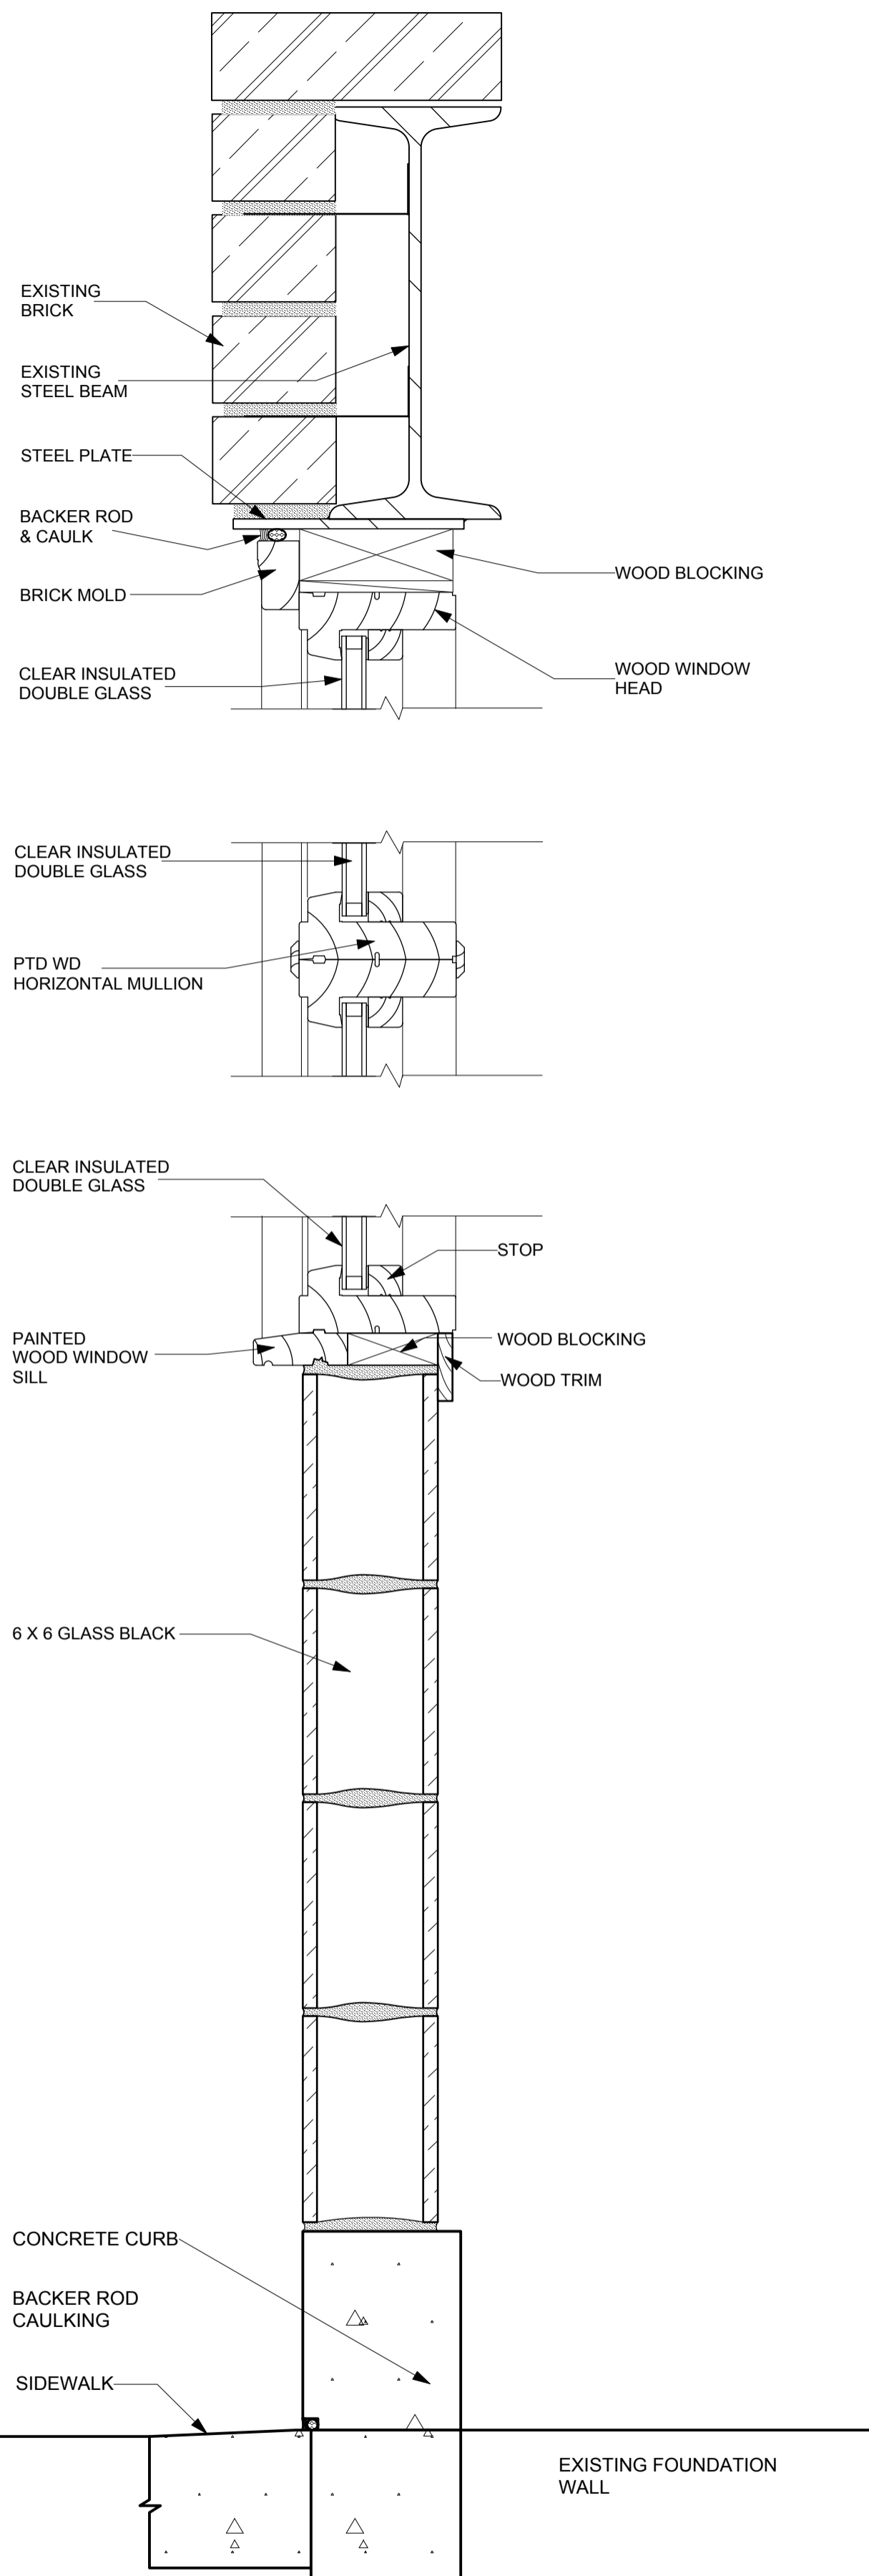
9

Sullivan Street Typical Window Wall Section
Scale: 3" = 1'-0"

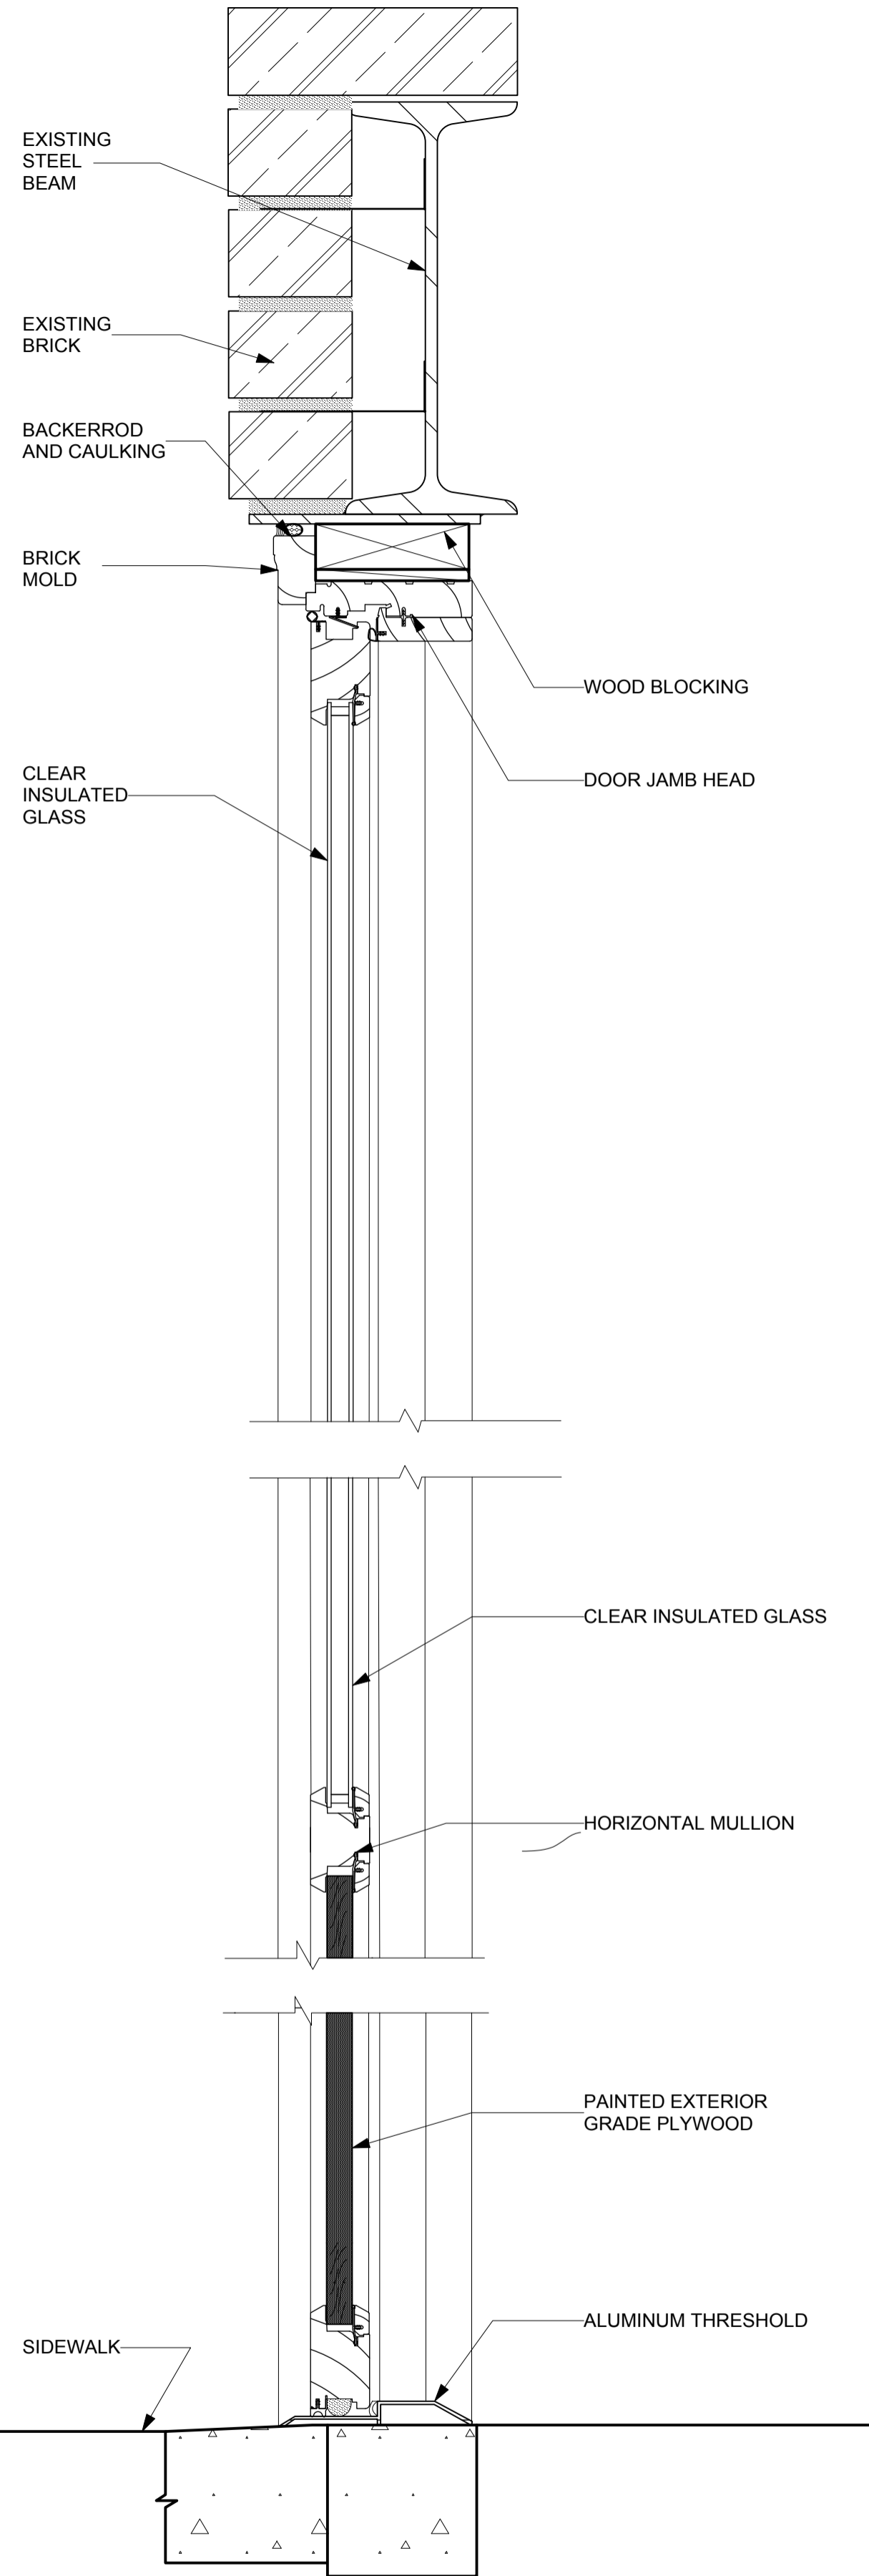
10

Sullivan Street Door Wall Section
Scale: 3" = 1'-0"

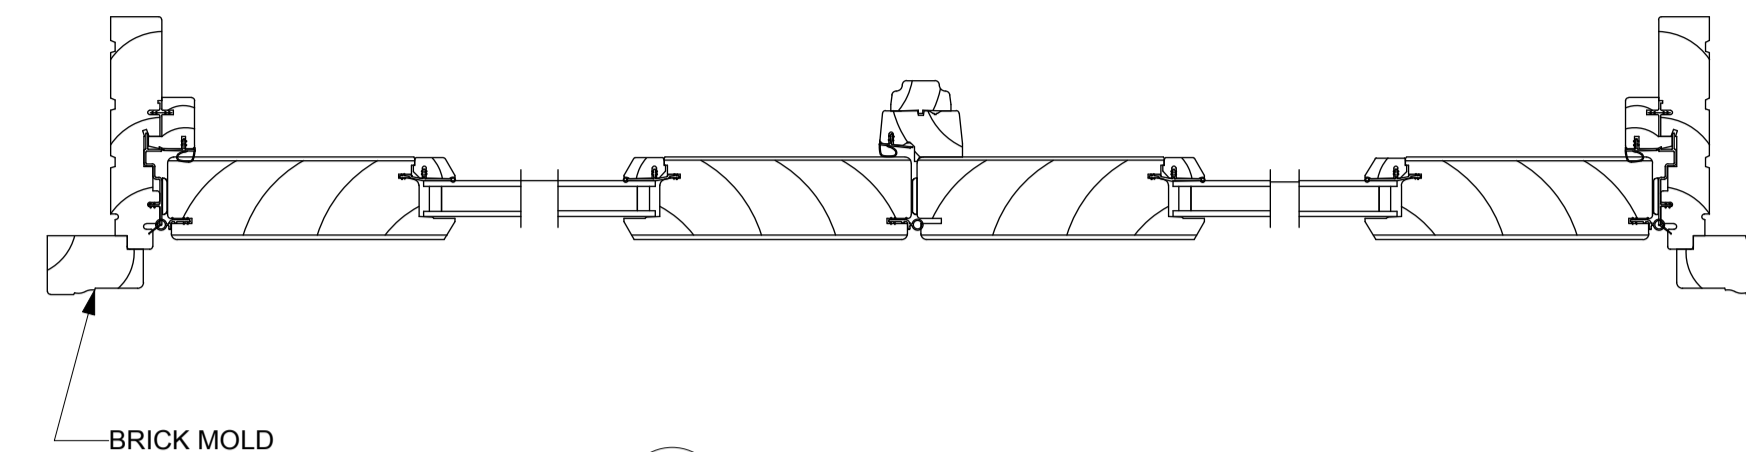
11

Door Wall Horizontal Section
Scale: 3" = 1'-0"

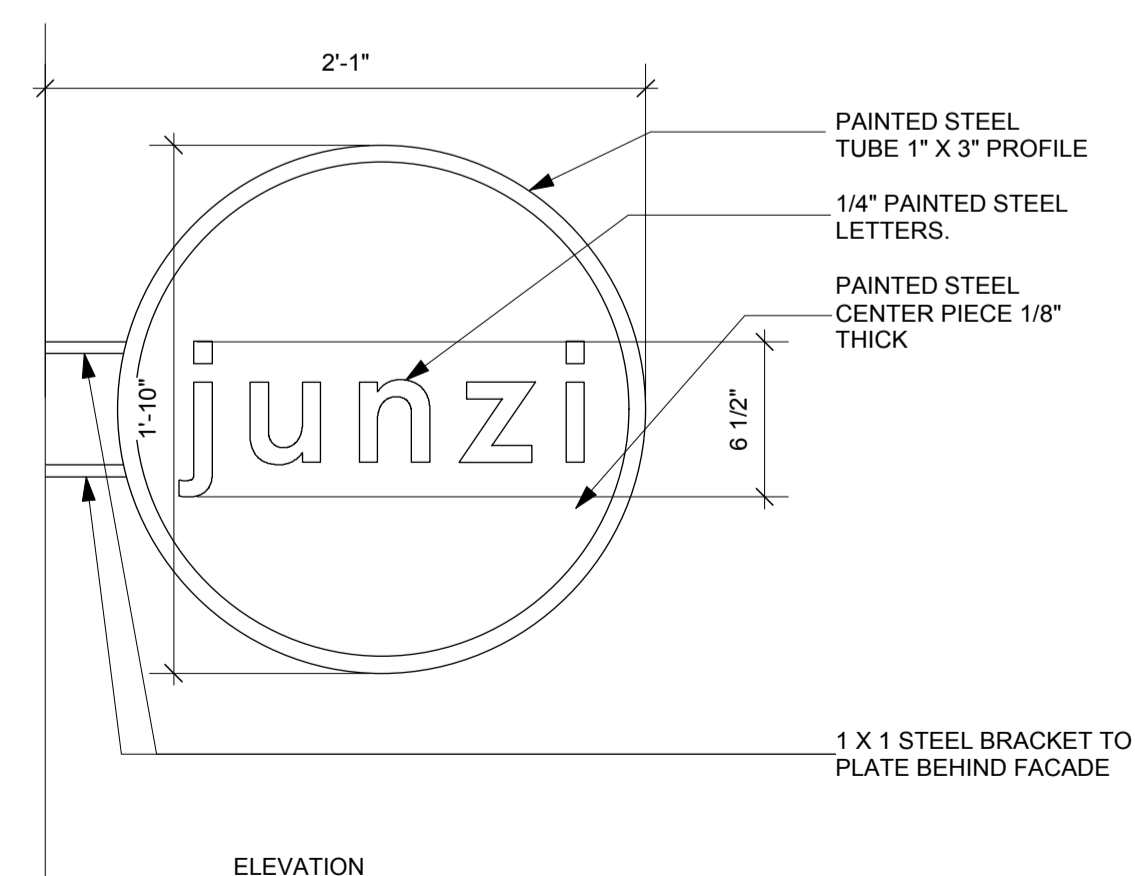
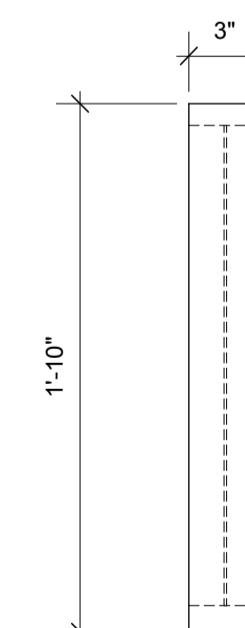
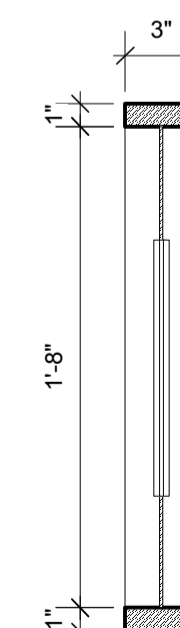
14

BLADE SIGN DETAIL
Scale: 1 1/2" = 1'-0"
