#### **FRONT ELEVATION** Existing and Proposed

**SECTION** Proposed Ammendment

NORTH (REAR) SECTION LPC COFA #: 14-4486, 2012 Feb. 12

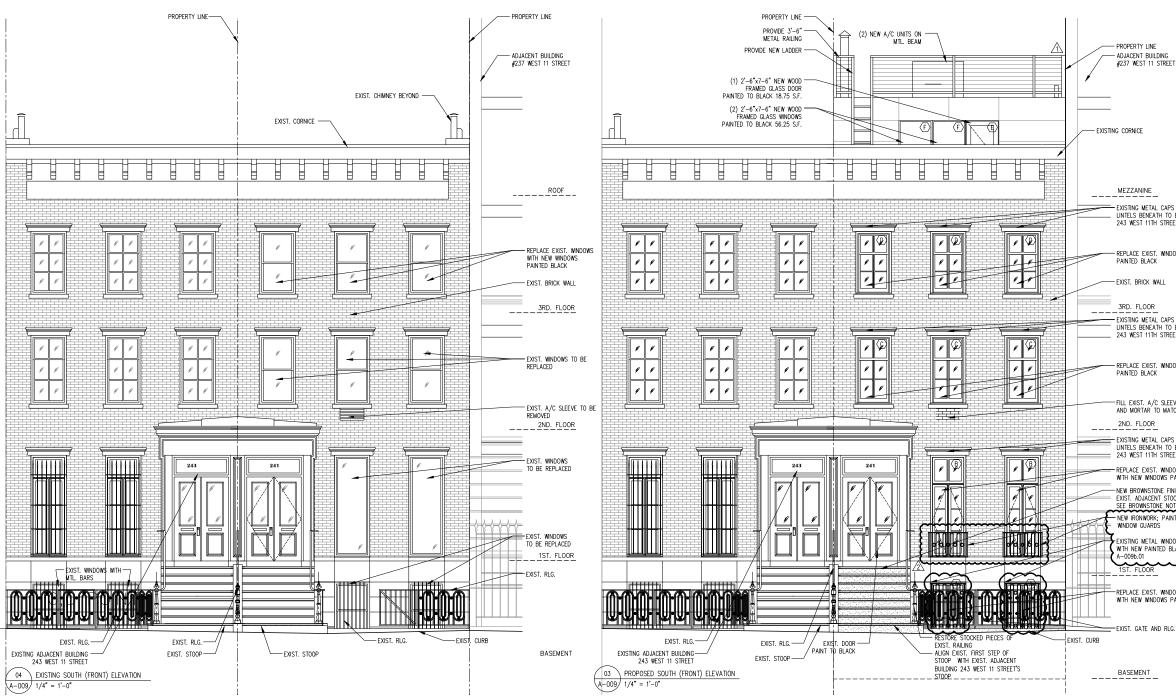
EXISTING METAL CAPS TO BE REMOVED; BROWNSTONE LINTELS BENEATH TO BE REPAIRED AND FINISHED TO MATCH 243 WEST 11TH STREET ⚠ REPLACE EXIST. WINDOWS WITH NEW WINDOWS PAINTED BLACK - EXIST. BRICK WALL 3RD. FLOOR EXISTING METAL CAPS TO BE REMOVED; BROWNSTONE UNITELS BENEATH TO BE REPAIRED AND FINISHED TO MATCH 243 WEST 11TH STREET  $\triangle$ - REPLACE EXIST. WINDOWS WITH NEW WINDOWS PAINTED BLACK -FILL EXIST. A/C SLEEVE OPENING WITH BRICK. NEW BRICK AND MORTAR TO MATCH EXIST. EXISTING METAL CAPS TO BE REMOVED; BROWNSTONE LINTELS BENEATH TO BE REPAIRED AND FINISHED TO MATCH 243 WEST 11TH STREET  $\triangle$ - REPLACE EXIST. WINDOWS WITH NEW WINDOWS PAINTED BLACK NEW BROWNSTONE FINISH ON RISER AND TREAD TO MATCH
EXIST. ADJACENT STOOP
SEE BROWNSTONE NOTES ON SHEET A-009 - NEW IRONWORK; PAINTED BLACK TO MATCH EXISTING EXISTING METAL WINDOW GUARDS TO BE REPLACED WITH NEW PAINTED BLACK IRONWORK SEE SHEET 1ST. FLOOR

- REPLACE EXIST. WINDOWS WITH NEW WINDOWS PAINTED BLACK

EXIST. GATE AND RLG.

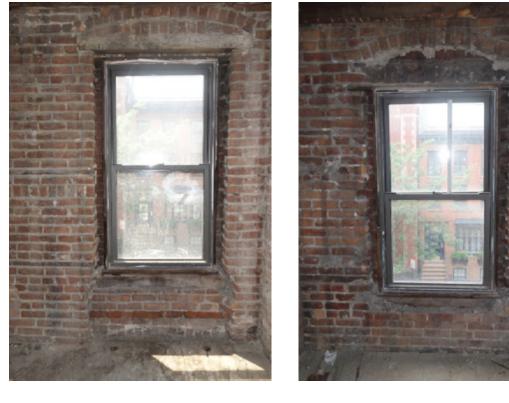
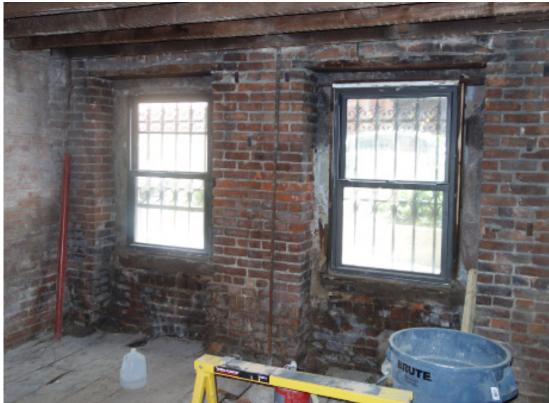
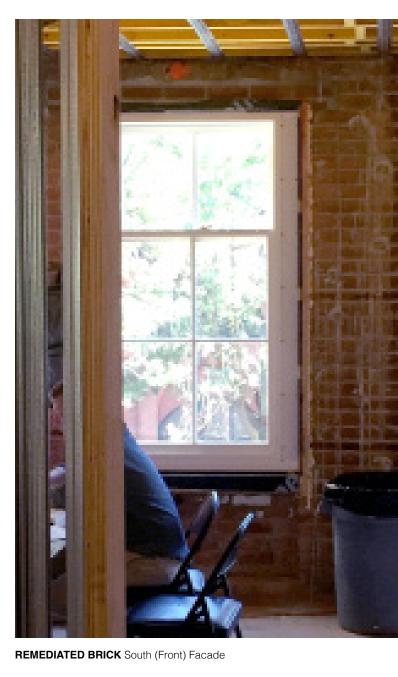
EXISTING DETERIORATED BRICK South (Front) Facade

BRICK REMEDIATION South (Front) Facade

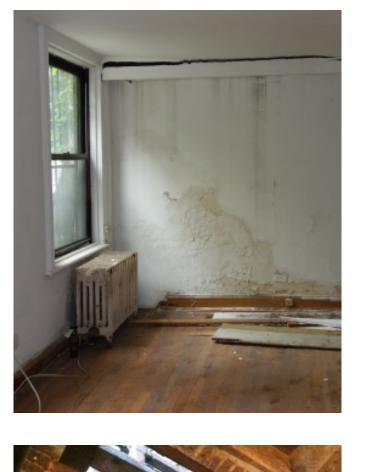
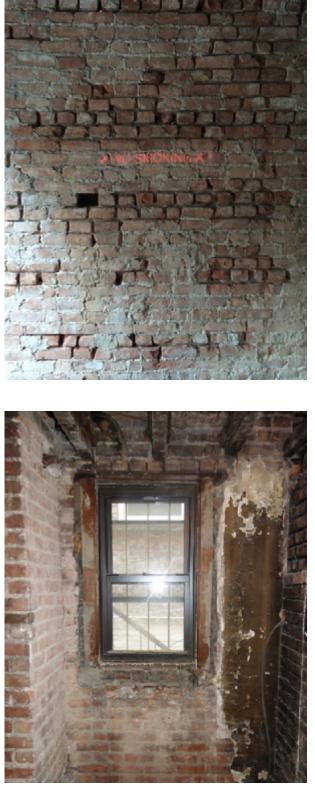
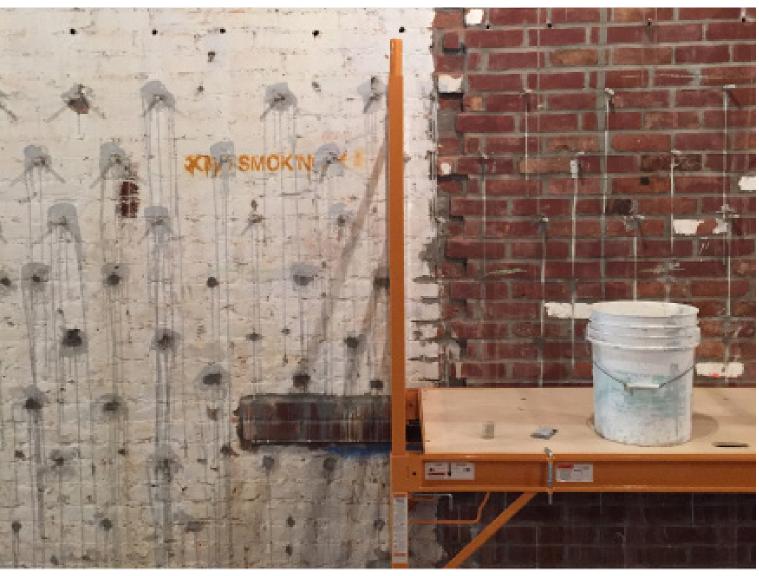
REMEDIATED BRICK East Wall

EXISTING DETERIORATED BRICK East Wall

### BRICK REMEDIATION East Wall

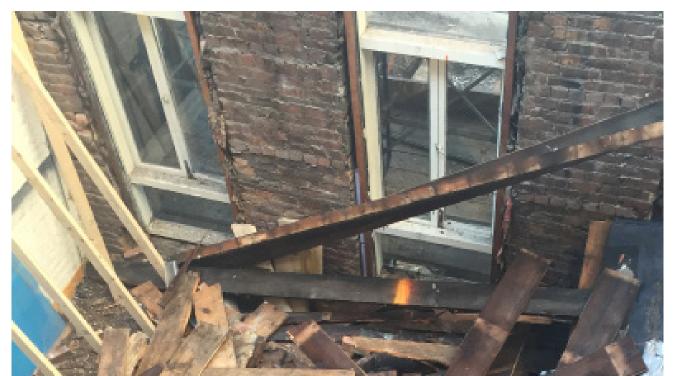
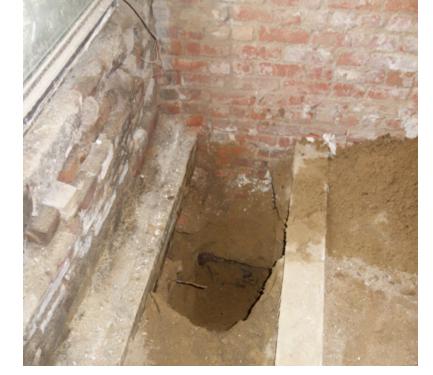
EXISTING DETERIORATED BRICK North (Rear) Facade

BRICK REMEDIATION North (Rear) Facade

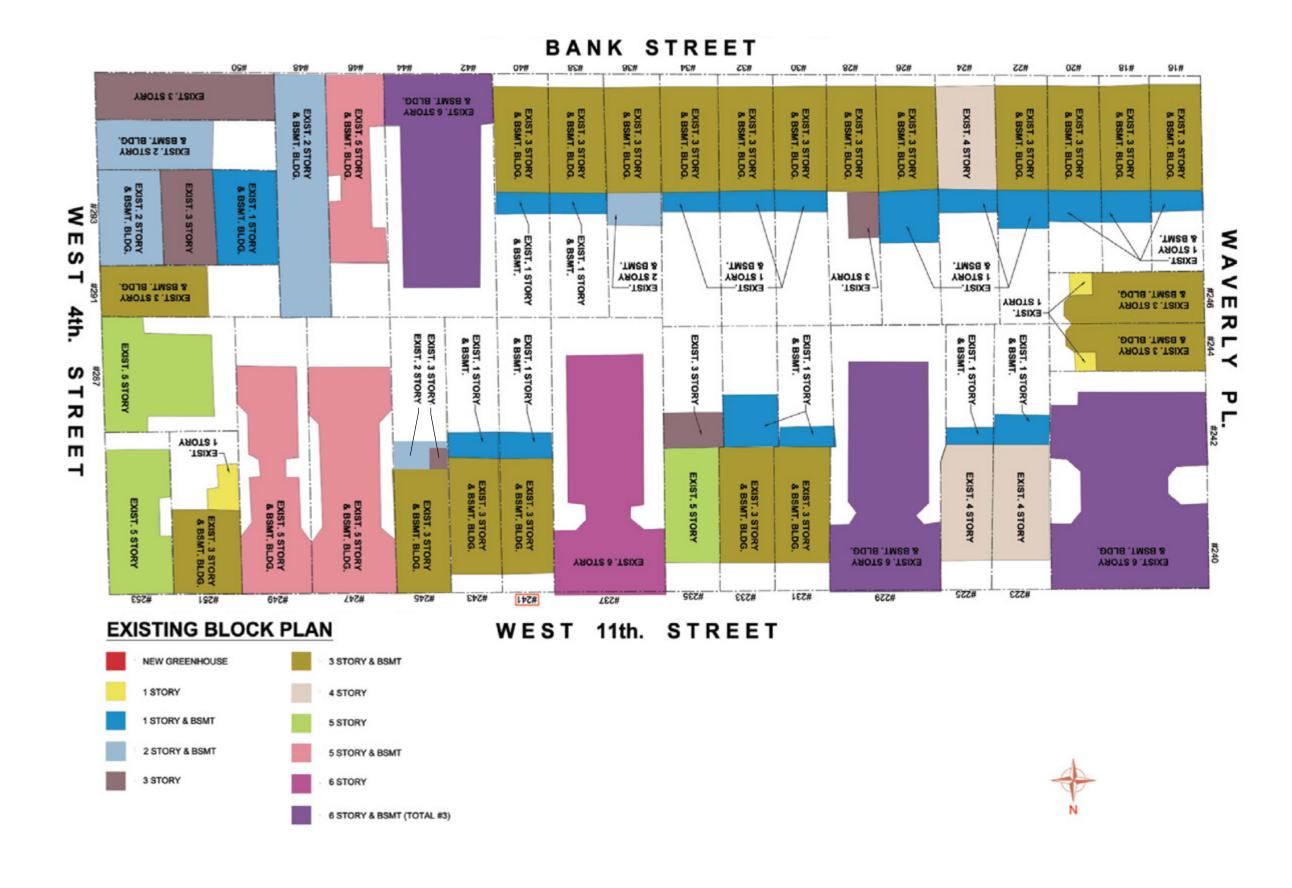
**BLOCK PLAN** Existing Footprint and Heights

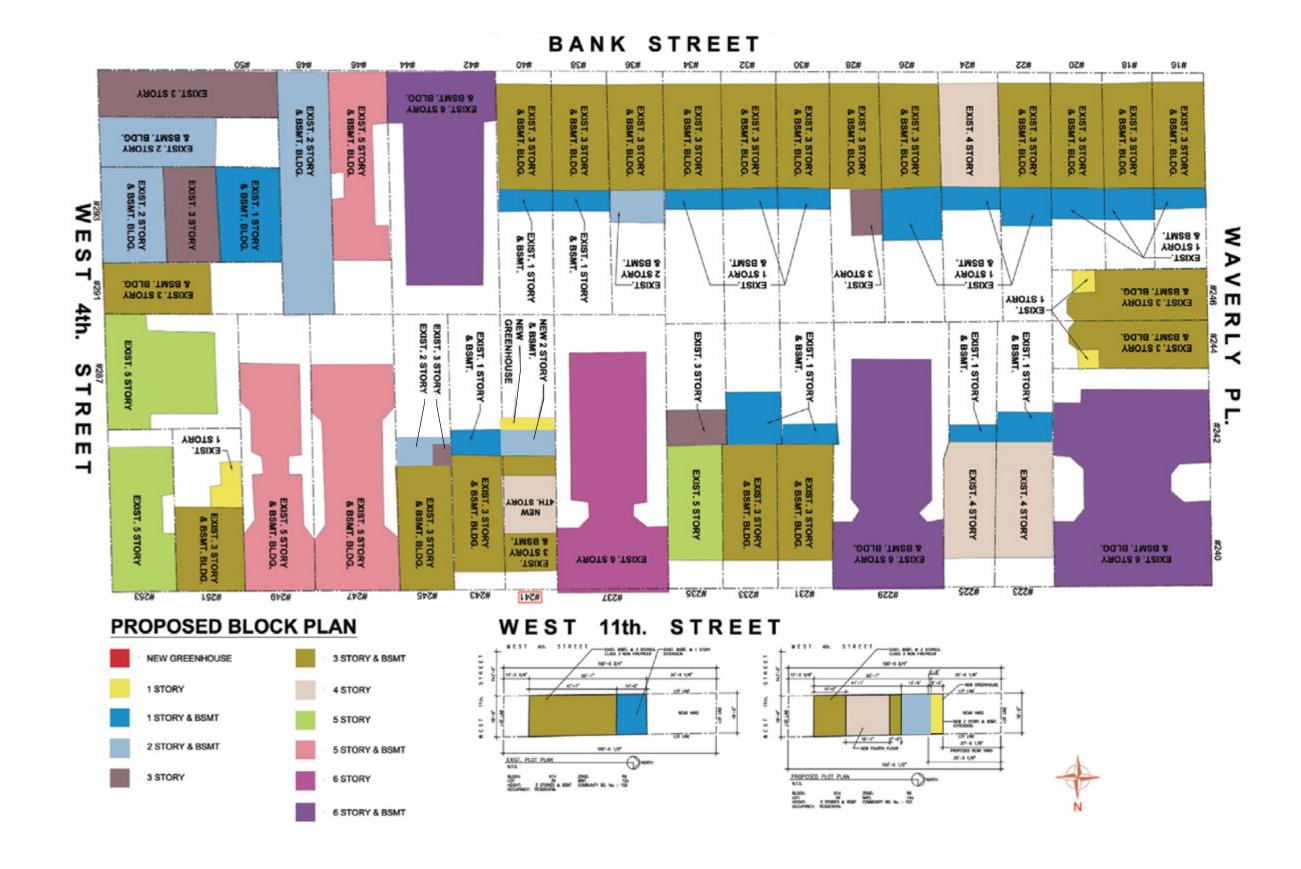
**BLOCK PLAN** Proposed Footprint and Heights

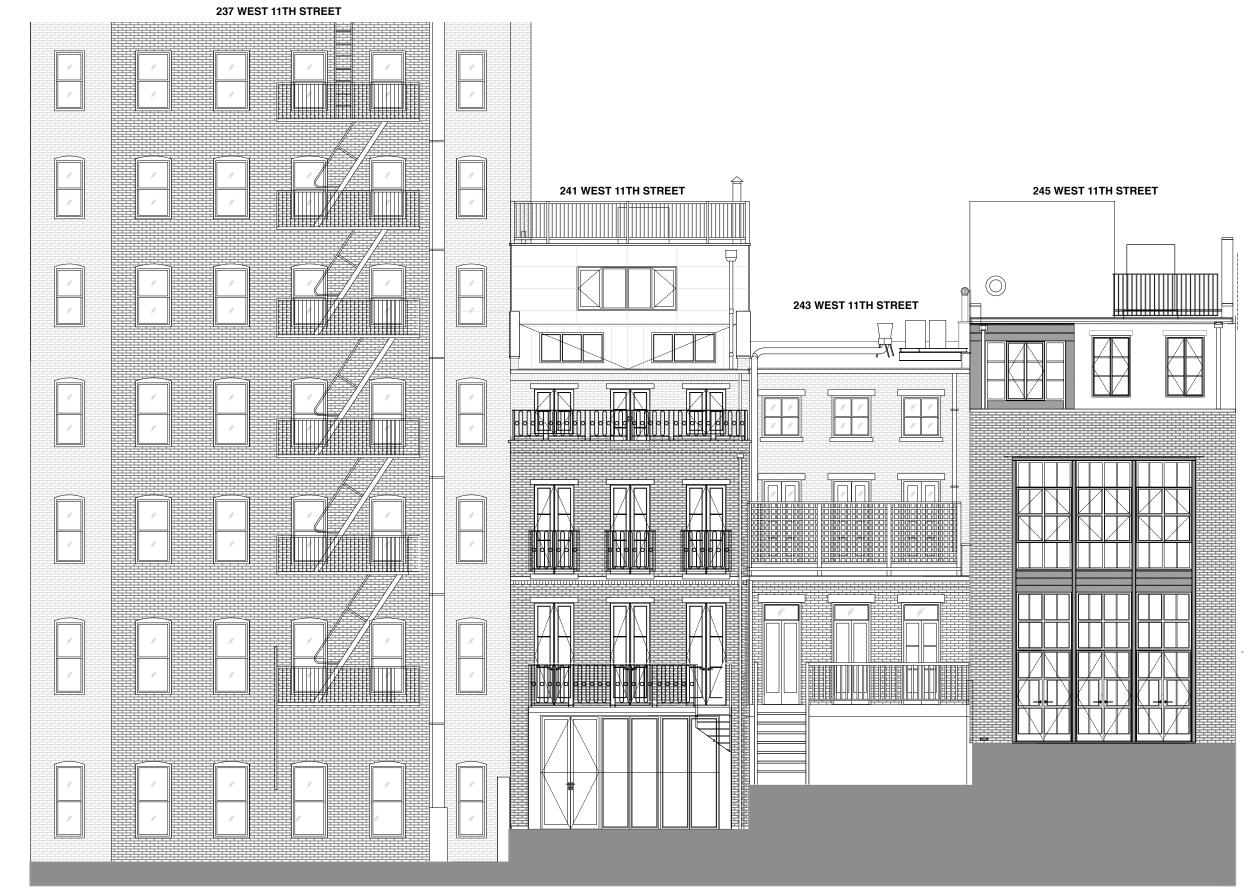
NORTH (REAR) ELEVATION Proposed Ammendment

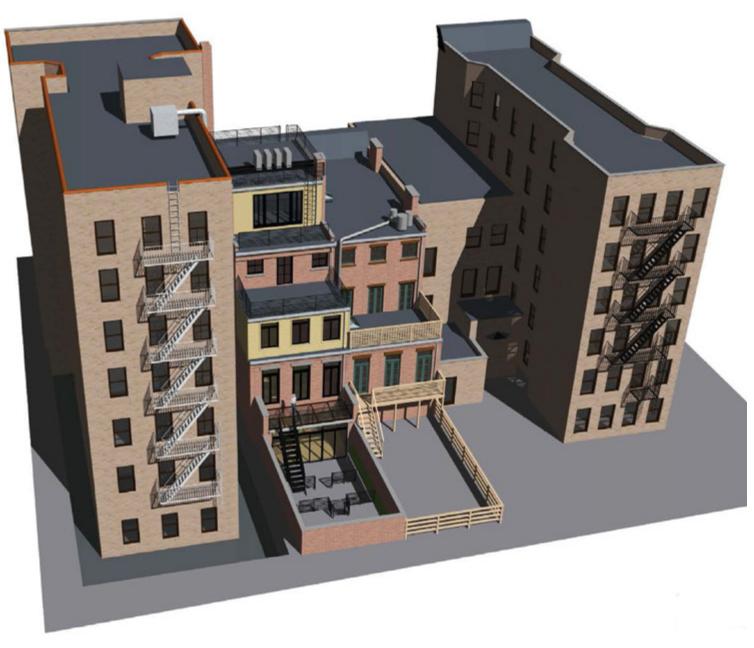
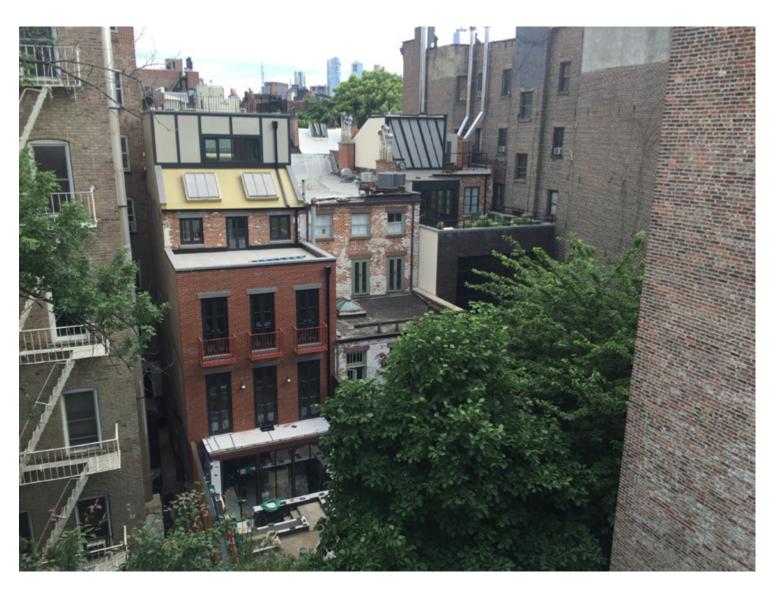
NORTH (REAR) PERSPECTIVE LPC COFA #: 14-4486, 2012 Feb. 12

NORTH (REAR) PERSPECTIVE Construction in Progress
