NYC DOB-ALTERATION TYPE II-INTERIOR REPAIR WORK

PHASE TWO DEMO PLAN: FOURTH FLOOR & ROOF DEMO PLAN
SCALE: AS NOTED

**PHASE TWO SECOND FLOOR & THIRD FLOOR PLAN**  
 SCALE: AS NOTED

PHASE TWO  
 FOURTH FLOOR & ROOF PLAN  
 SCALE: AS NOTED

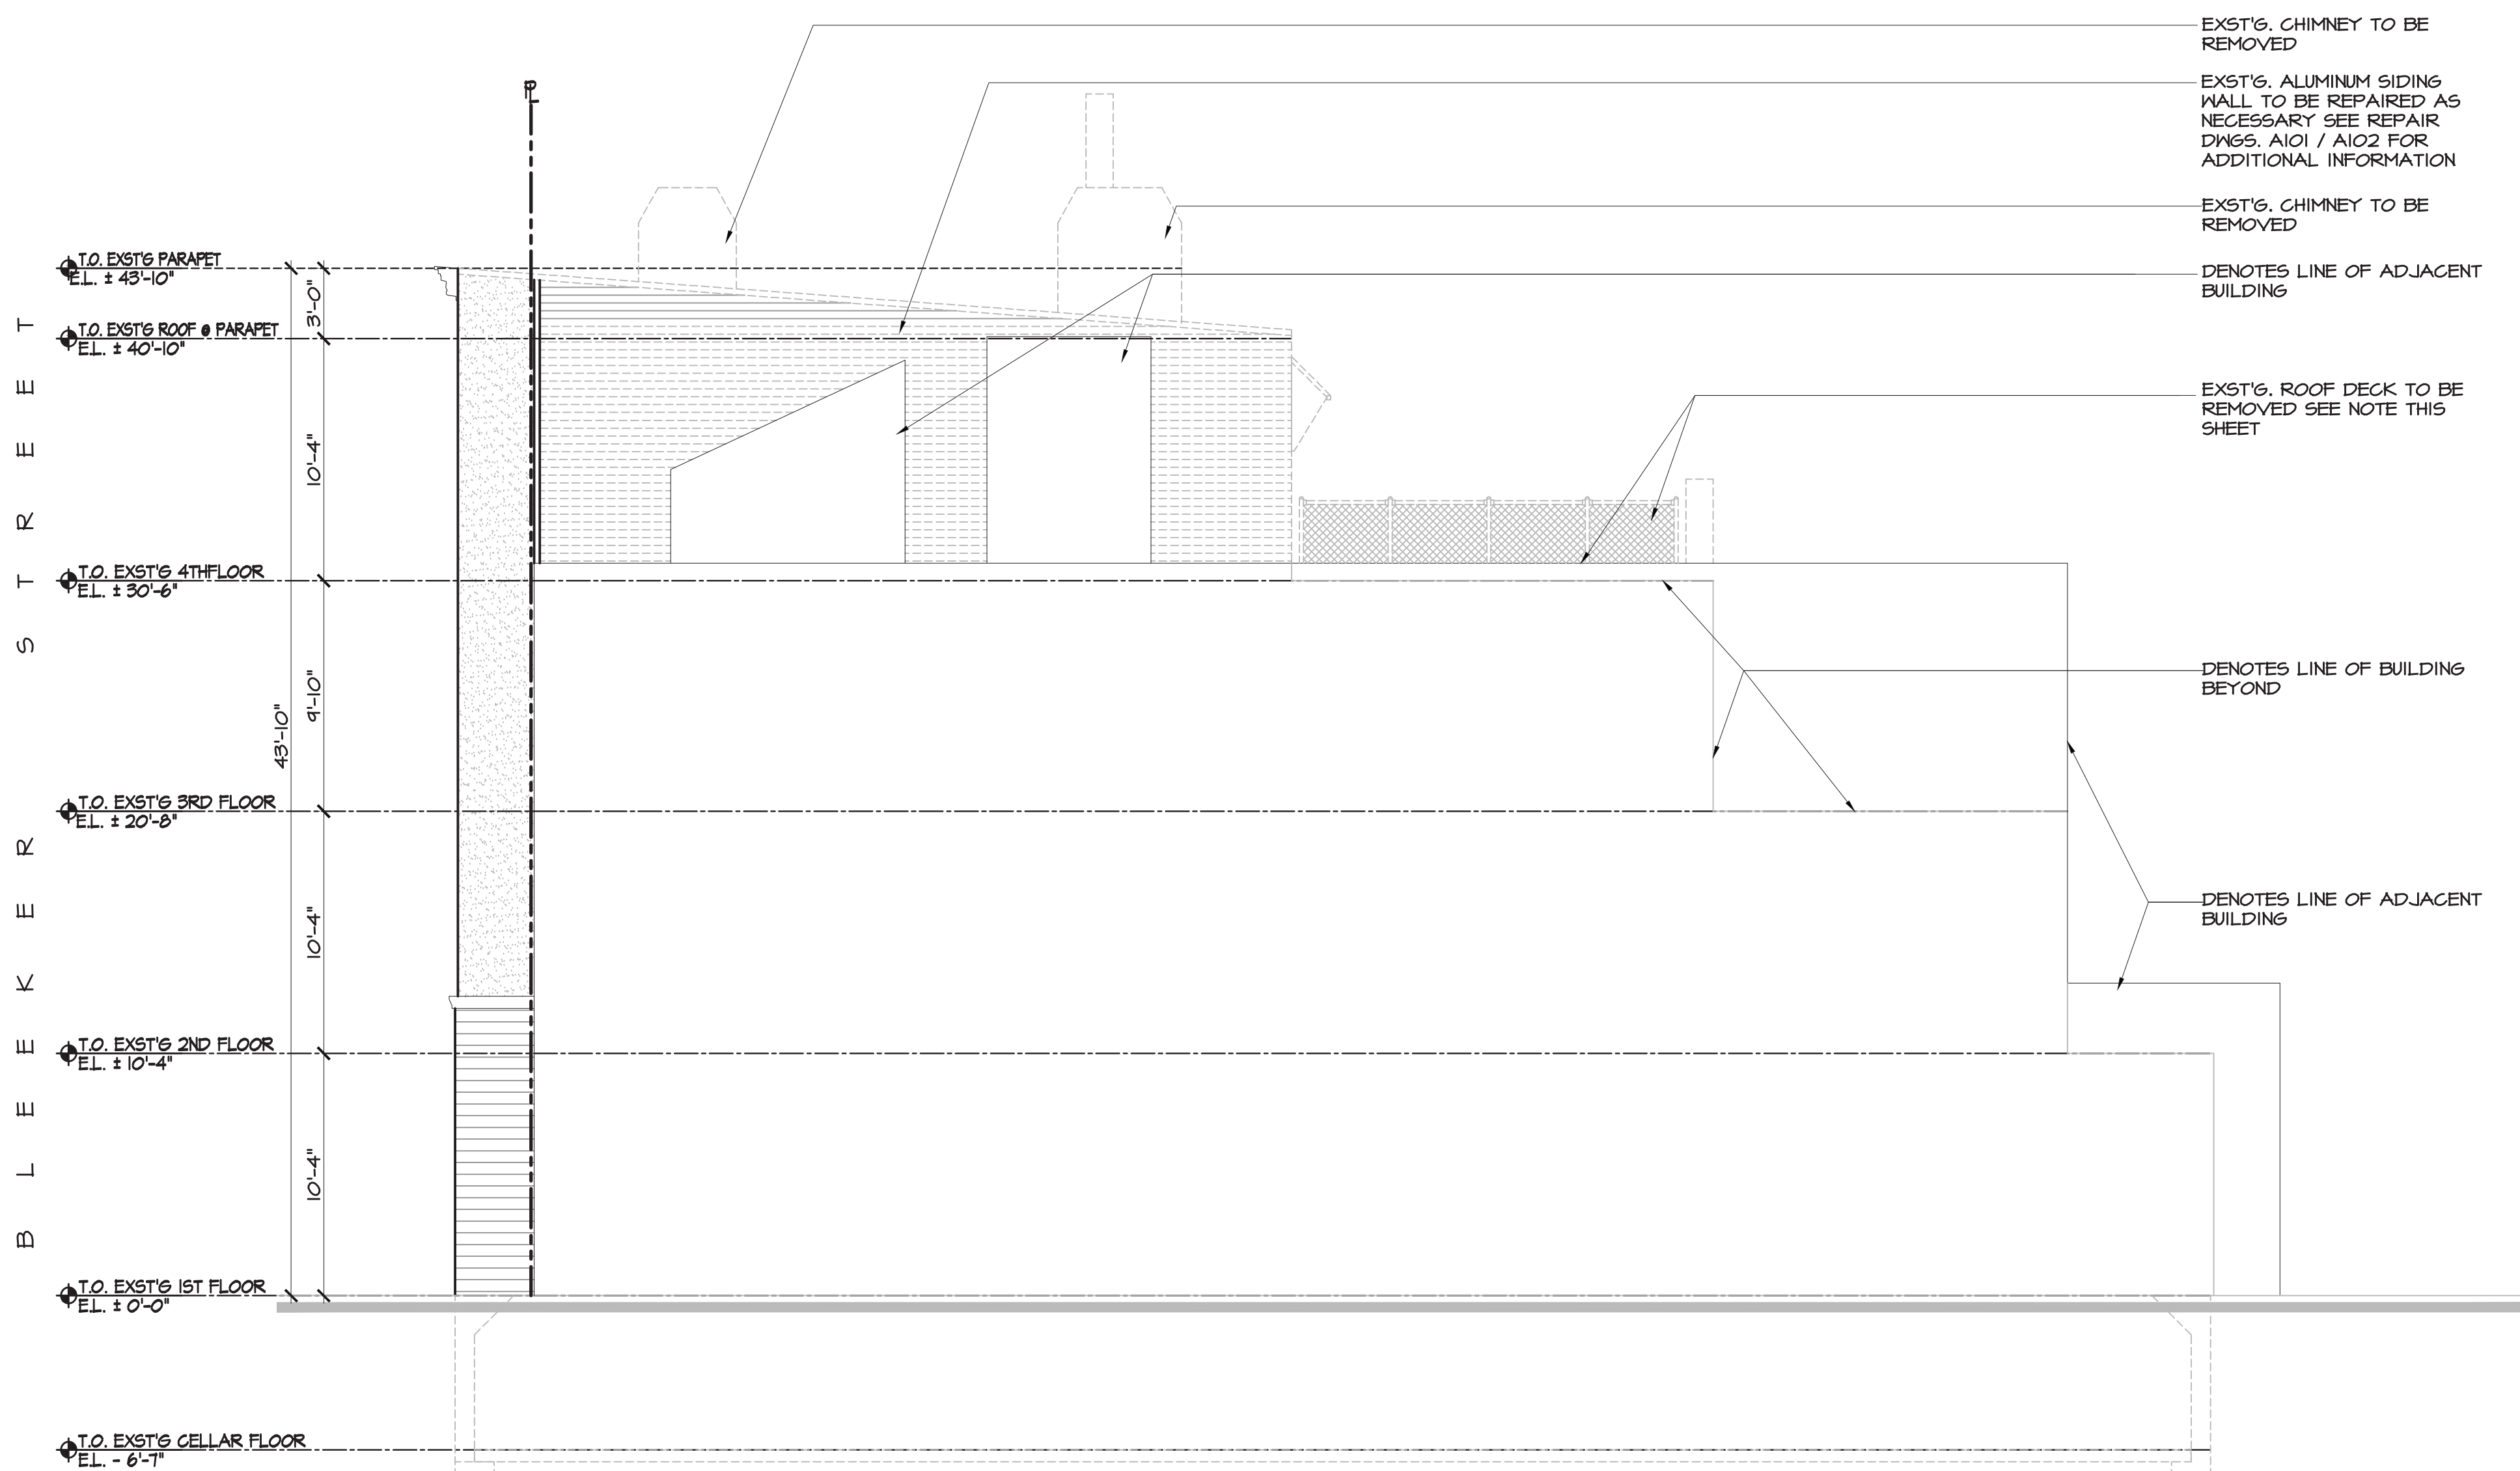
EXIST'G. CHIMNEY TO BE REMOVED

EXIST'G. ALUMINUM SIDING WALL TO BE REPAIRED AS NECESSARY SEE REPAIR DNSS. A101 / A102 FOR ADDITIONAL INFORMATION

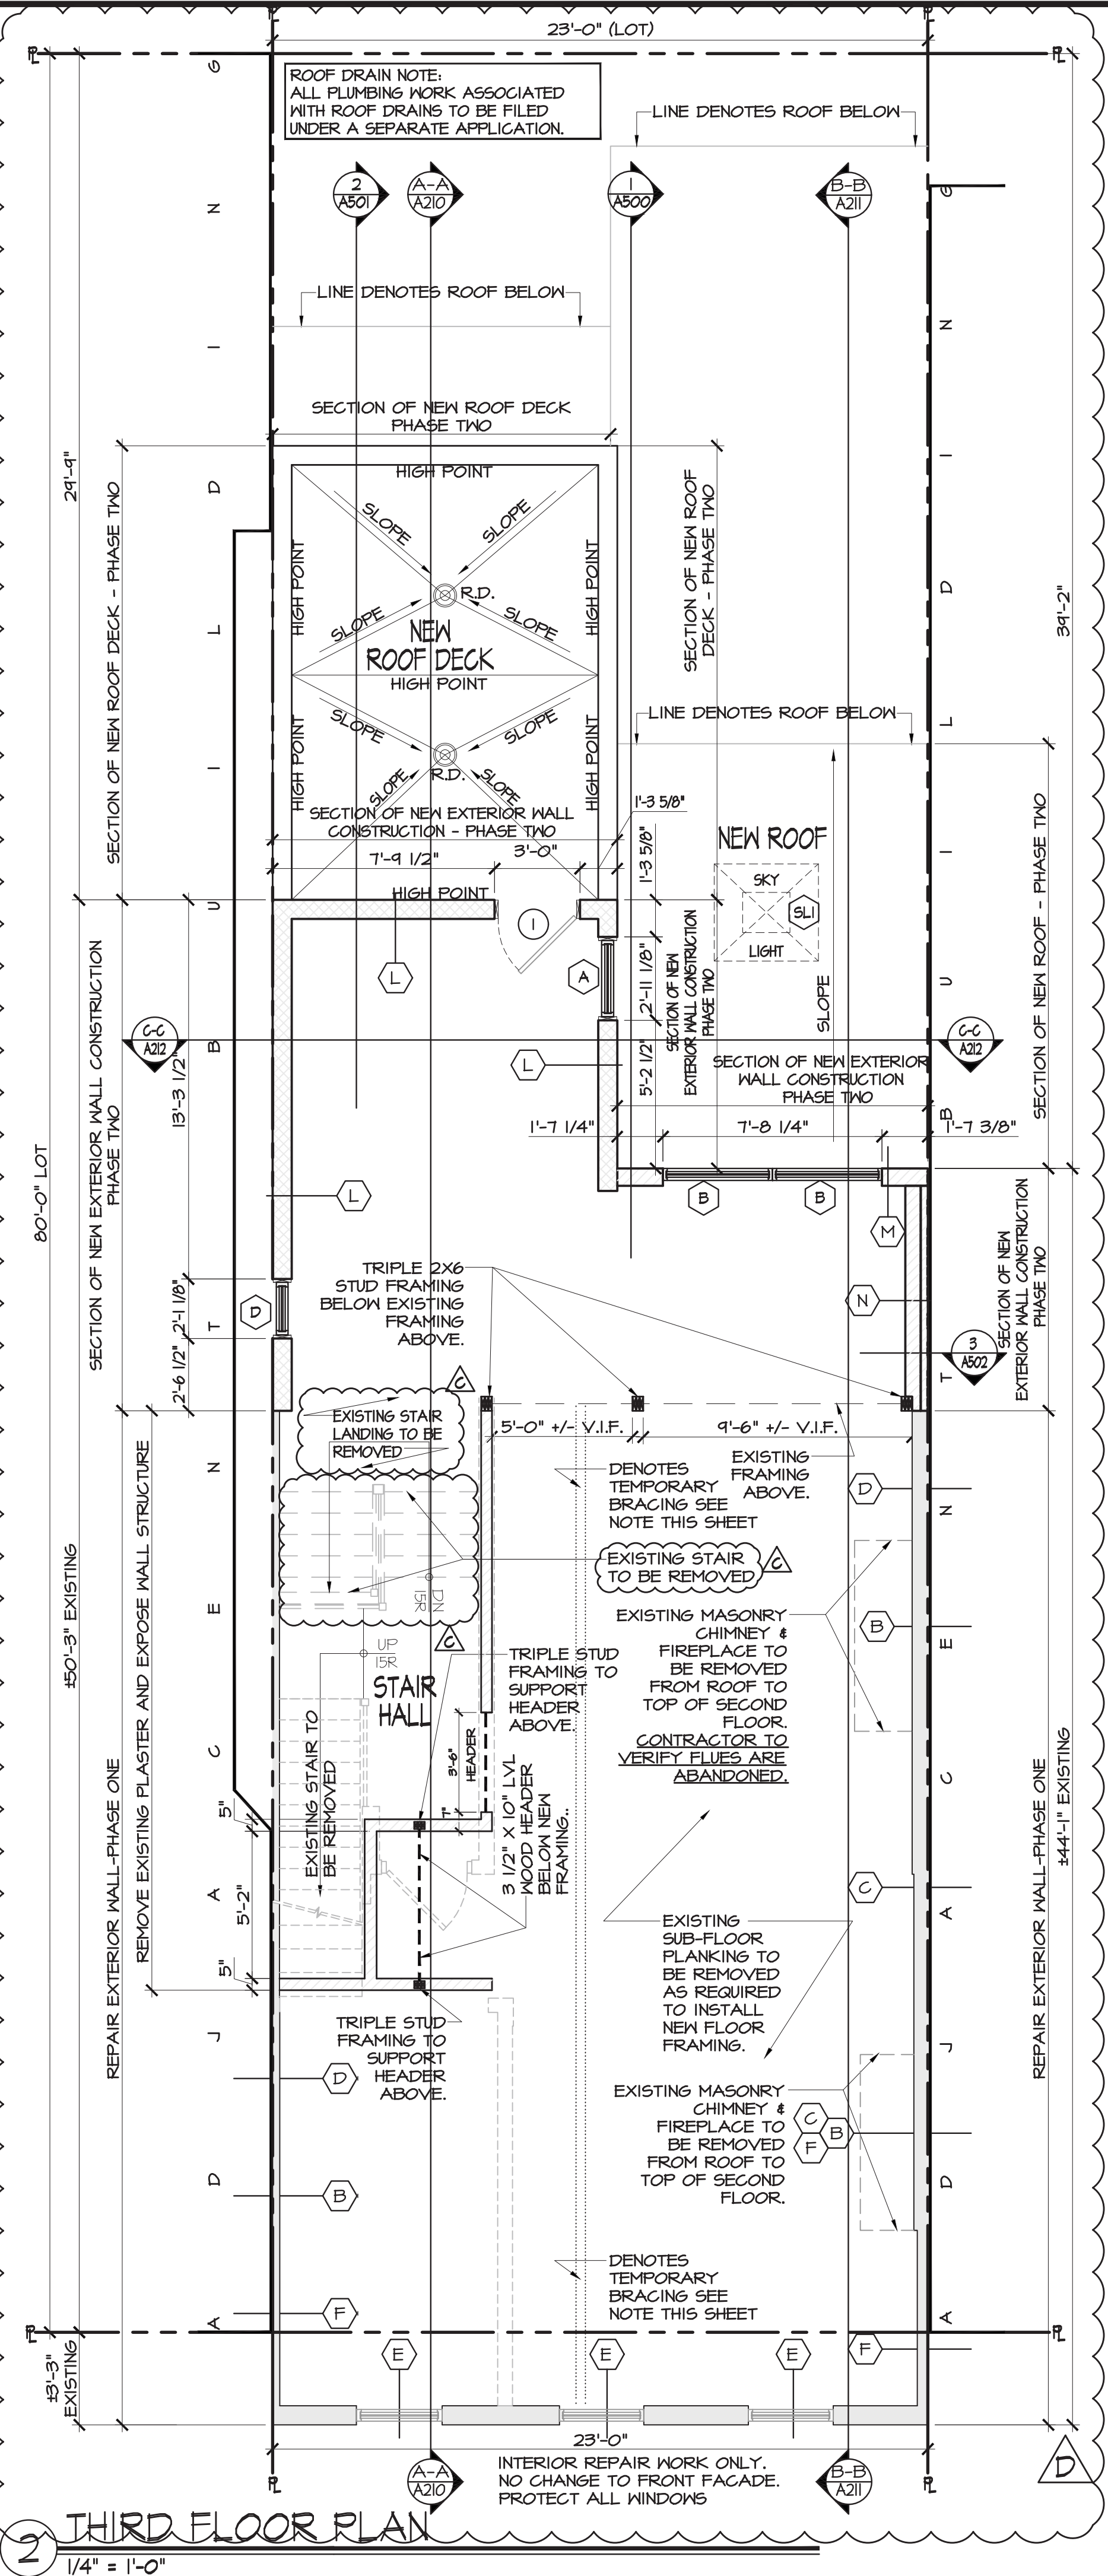
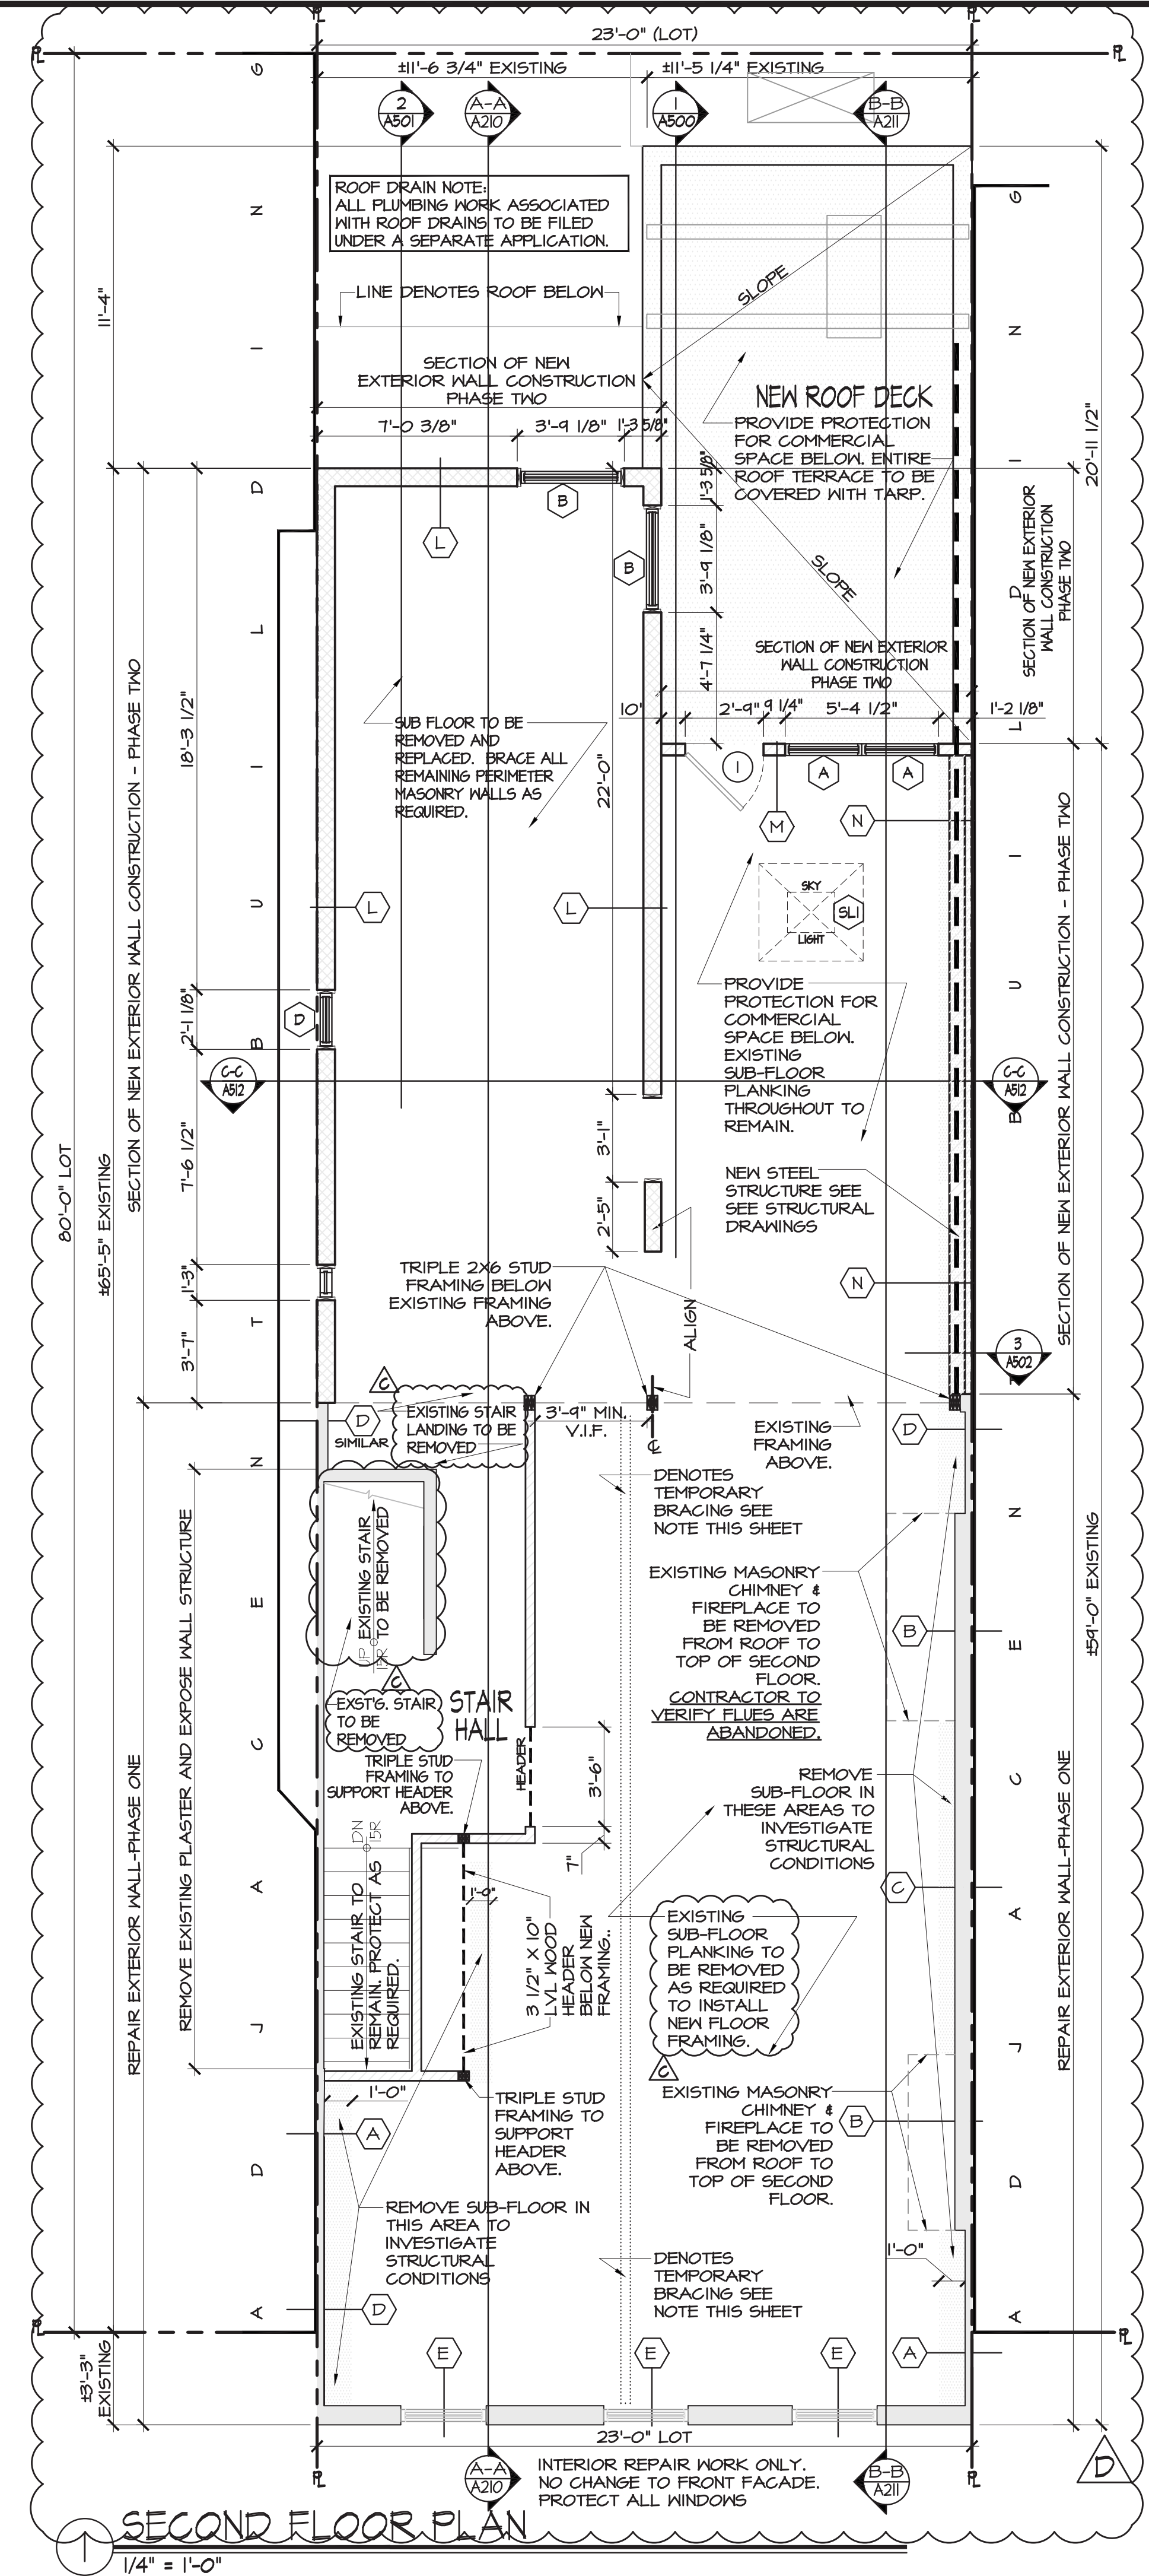
EXISTING WOOD FRAMED WALLS WITH MASONRY NOGGING TO BE REPAIRED AND/OR EXISTING FRAMING TO REMAIN.

TAG INDICATES REPAIR DETAILS AS FOLLOWS:  
 TAG "A": DRAWINGS 1-2/A-610  
 TAG "B": DRAWINGS 1-2/A-611  
 TAG "C": DRAWINGS 1-2/A-612  
 TAG "D": DRAWINGS 1-2/A-613  
 TAG "E": DRAWINGS 1-2/A-614  
 TAG "F": DRAWINGS 1-2/A-615  
 TAG "G": DRAWINGS 1-2/A-616  
 TAG "H": DRAWINGS 1-2/A-617  
 TAG "I": DRAWINGS 1-2/A-618  
 TAG "J": DRAWINGS 1-2/A-619

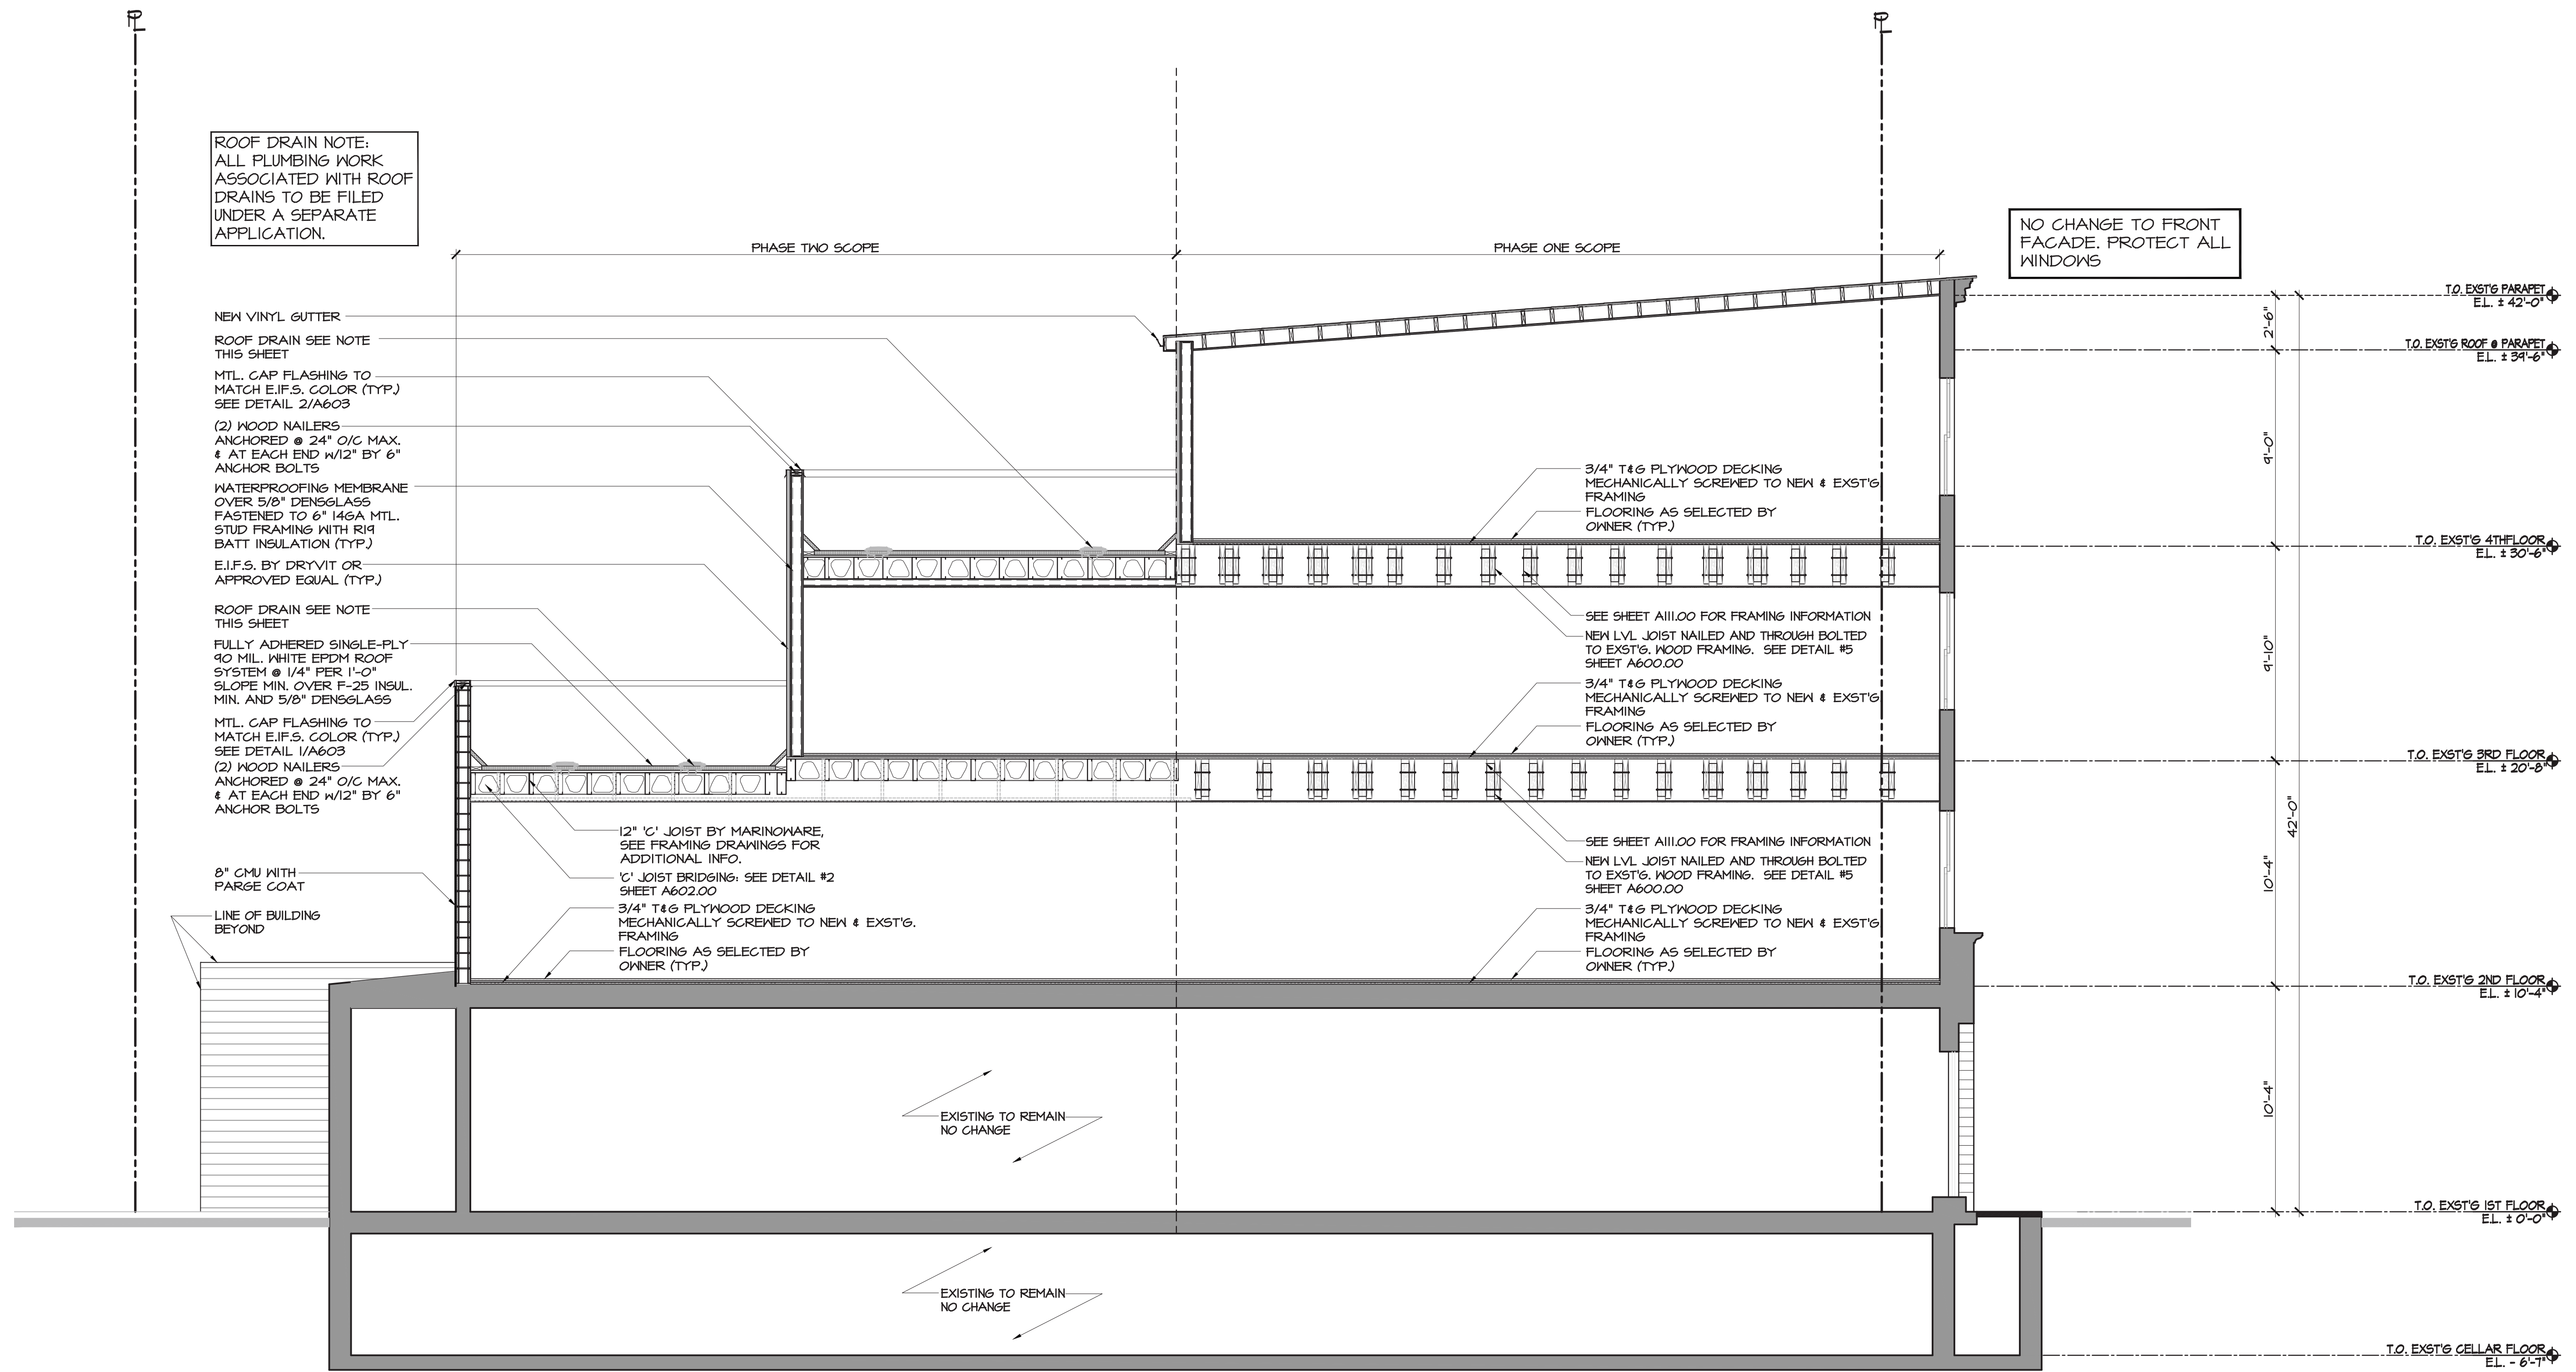
**LONGITUDINAL SECTION A-A**  
 SCALE: 1/4" = 1'-0"

NO CHANGE TO FRONT  
 FACADE. PROTECT ALL  
 WINDOWS

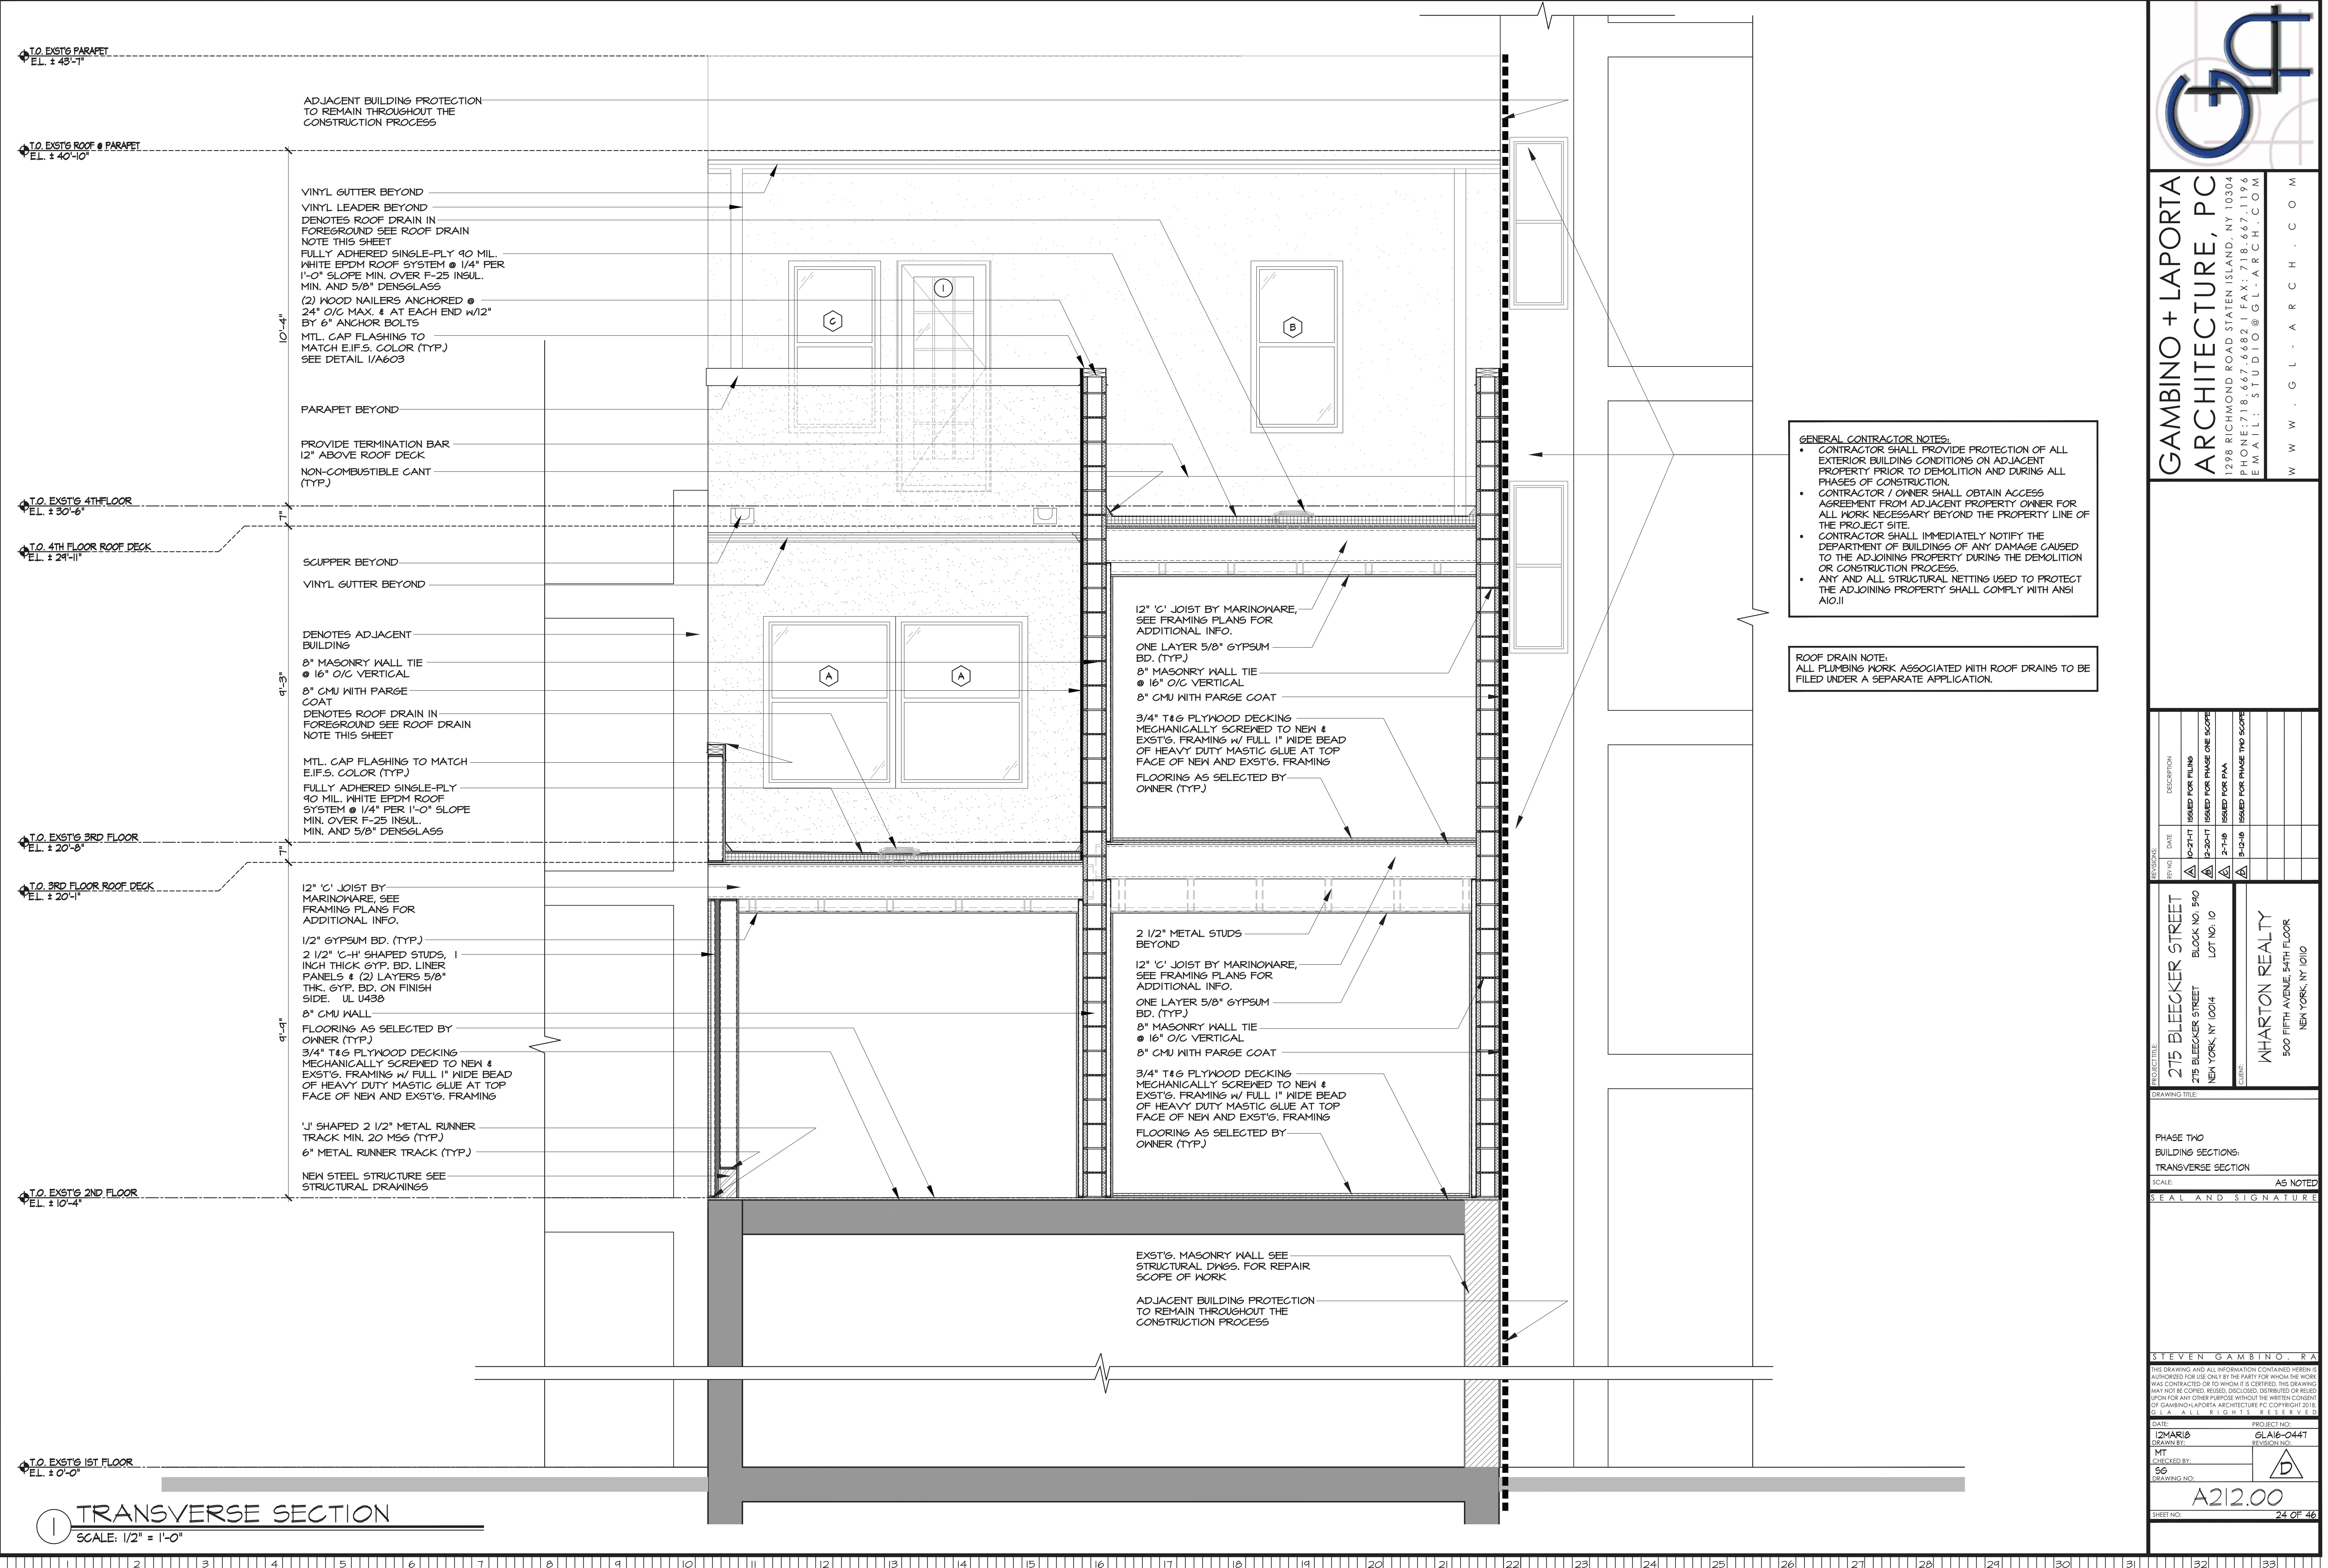
**PHASE TWO**  
 BUILDING SECTIONS:  
 TRANSVERSE SECTION  
 SCALE: AS NOTED

ADJACENT BUILDING PROTECTION TO REMAIN THROUGHOUT THE CONSTRUCTION PROCESS

VINYL GUTTER BEYOND  
 VINYL LEADER BEYOND  
 DENOTES ROOF DRAIN IN FOREGROUND SEE ROOF DRAIN NOTE THIS SHEET  
 FULLY ADHERED SINGLE-PLY 90 MIL. WHITE EPDM ROOF SYSTEM @ 1/4" PER 1'-0" SLOPE MIN. OVER F-25 INSUL. MIN. AND 5/8" DENSGLASS  
 (2) WOOD NAILERS ANCHORED @ 24" O/C MAX. & AT EACH END W/12" BY 6" ANCHOR BOLTS  
 MTL. CAP FLASHING TO MATCH E.I.F.S. COLOR (TYP.) SEE DETAIL 1/A603

EXST'G. MASONRY WALL SEE STRUCTURAL DNGS. FOR REPAIR SCOPE OF WORK

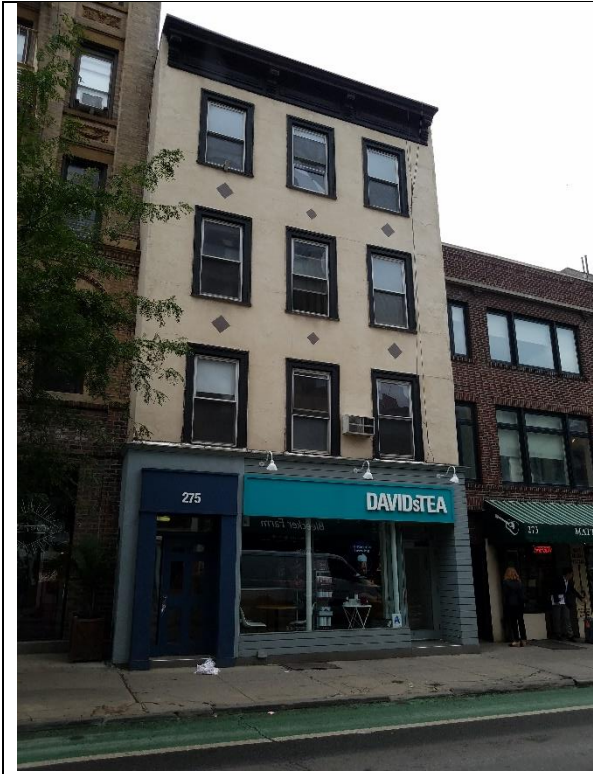
275 BLEECKER FRONT FAÇADE IN GOOD CONDITIONS

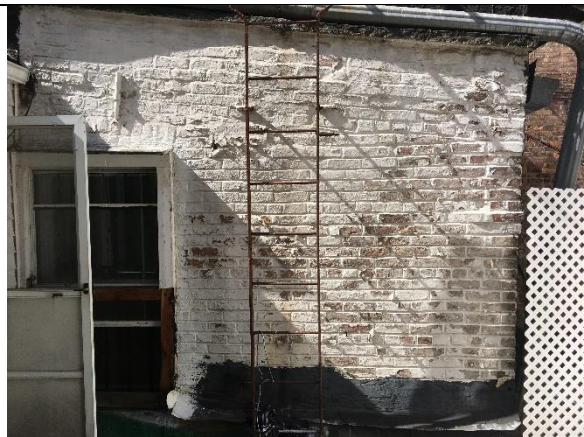
REAR FAÇADE EXTERIOR WALL SEPARATING EASTERN AND WESTERN PORTION EXHIBITING DETERIORATION AT WINDOW

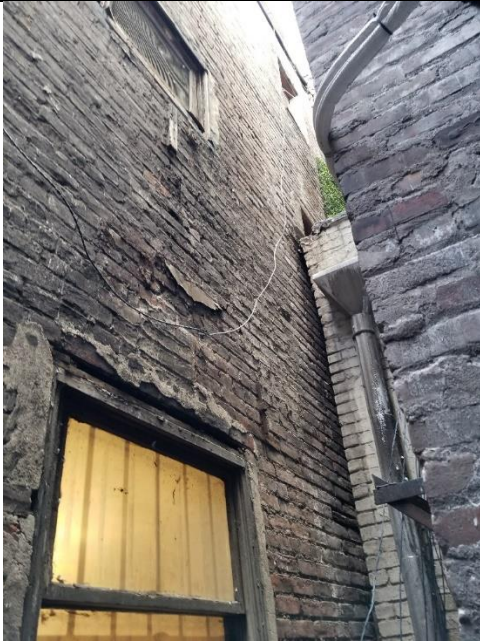
BRICKS BETWEEN TWO WINDOWS ARE WATER DAMAGED AT 275 REAR SIDE FAÇADE

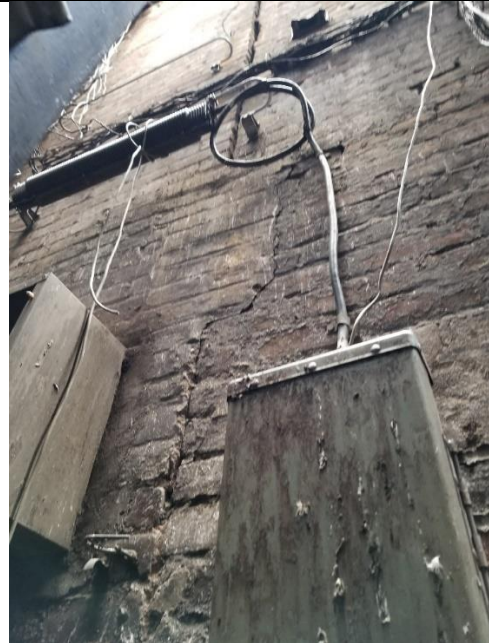
VERTICAL MEDIUM CRACK AT 275 BLEECKER SIDE FAÇADE

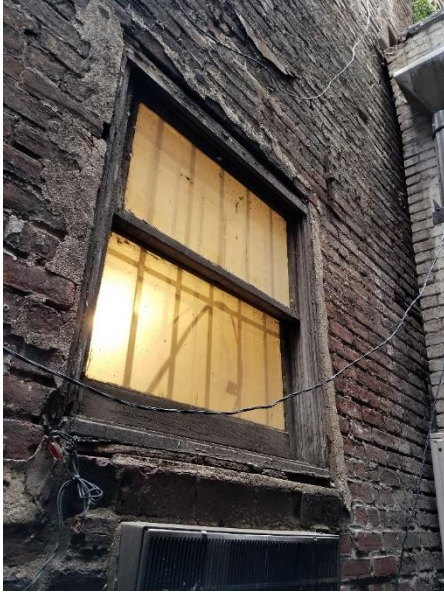
SILL AND LINTEL IN VERY POOR CONDITIONS AT BOTTOM WINDOW SIDE FAÇADE

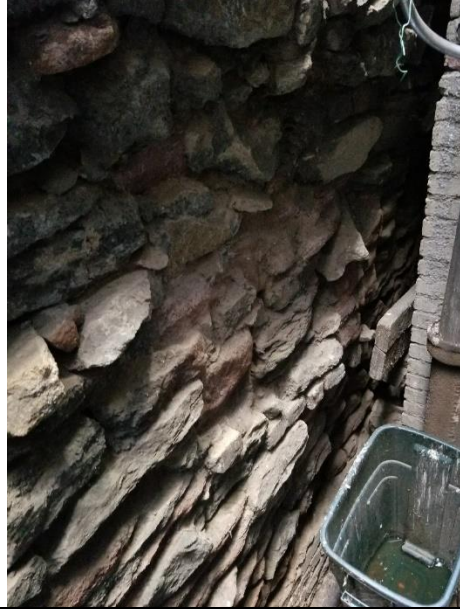
275 BLEECKER FOUNDATION WALL OUTSIDE FACE IN GOOD CONDITIONS

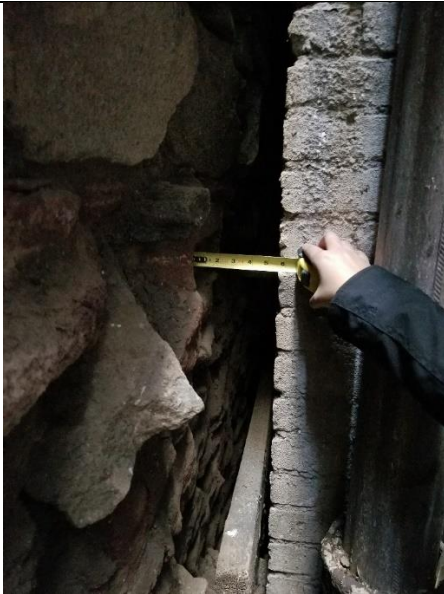
6" GAP BETWEEN 275 BLEECKER FOUNDATION WALL AND 277 FOUNDATION WALL.

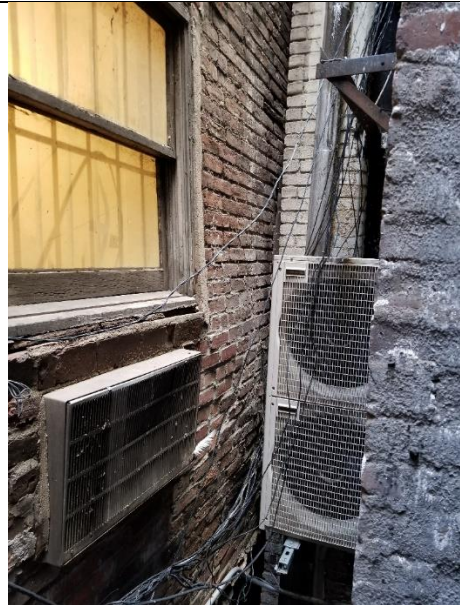
275 BLEECKER SIDE FAÇADE IS LEANING AT VARIOUS LOCATIONS

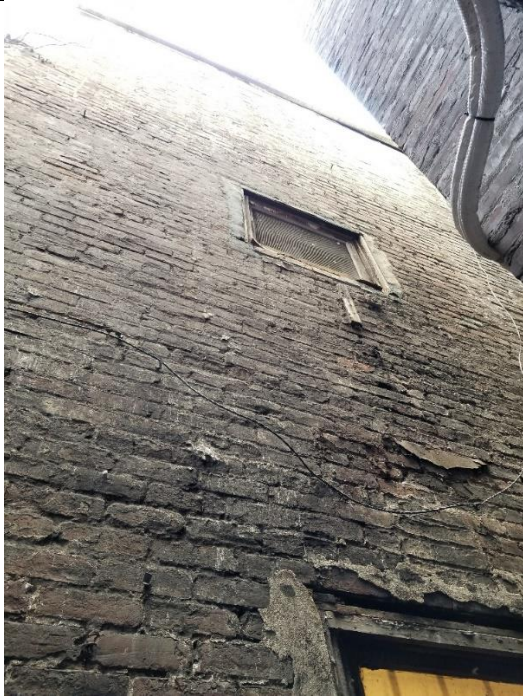
DISINTEGRATED LOOSE MORTAR BETWEEN BRICKS

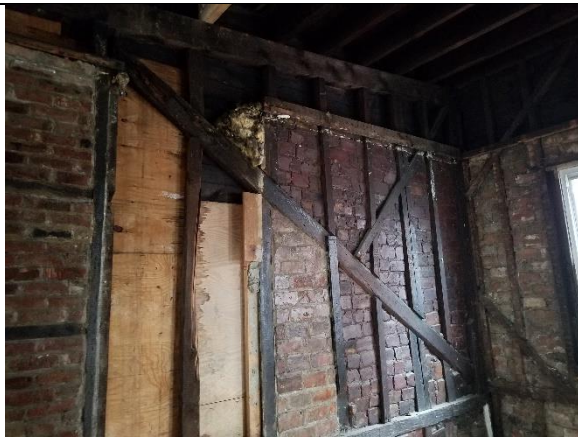
FRONT PORTION INTERIOR NOGGIN WALL  
EXHIBITING GAPS IN MASONRY INFILL

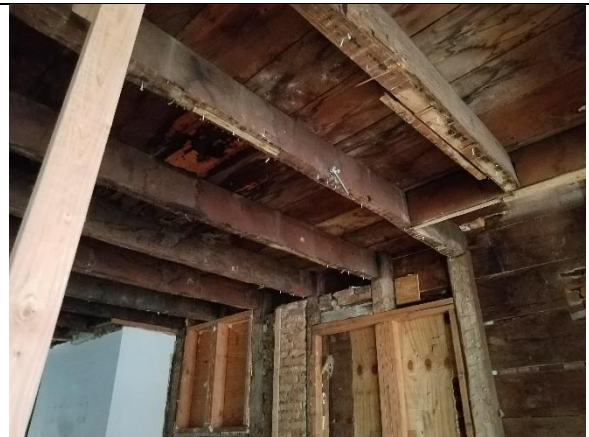
FRONT PORTION JOISTS IN POOR CONDITION

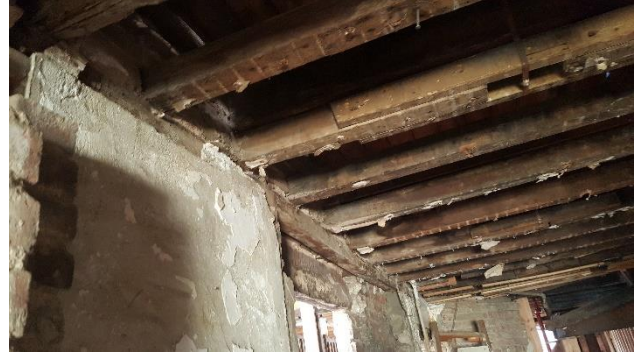
JOISTS OVER OPENING WITHOUT LINTEL.  
DEFLECTION OF SILL BEAM

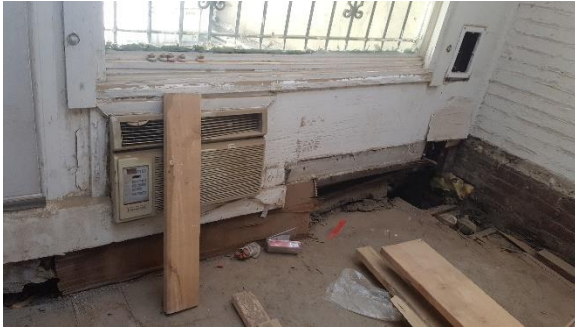
REAR EASTERN PORTION OF WOOD FRAMING,  
DAMAGE/DISPLACEMENT AT WALL FLOOR  
INTERFACE

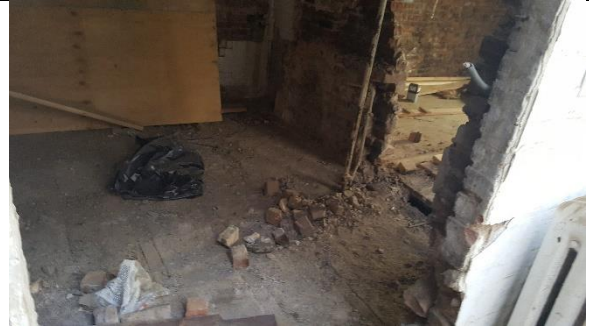
REAR WESTERN PORTION OF MASONRY  
STRUCTURE, EXHIBITING DAMAGE TO SUBFLOOR

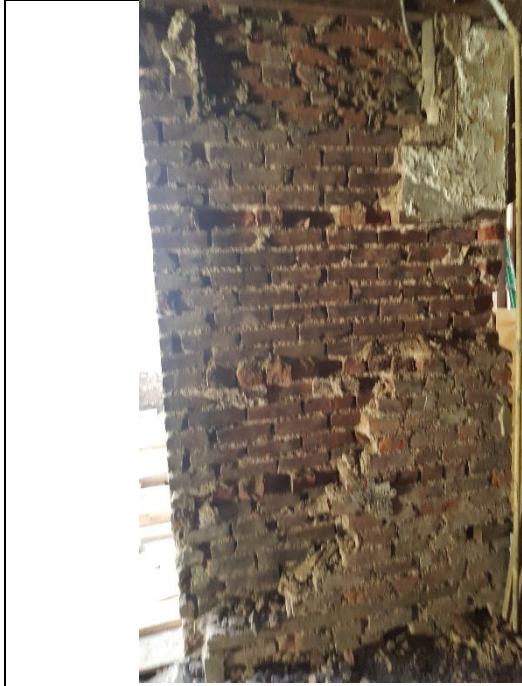
MASONRY WALL WITH EXTENSIVE LOSS OF MASONRY, ONE WYTHE COLLAPSE

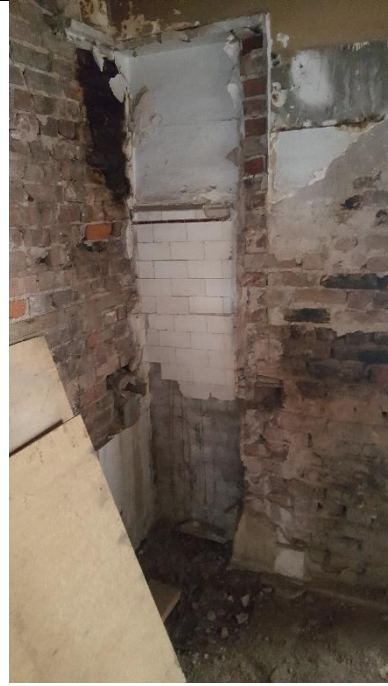
MASONRY WALL EXHIBTING DETERIORATION

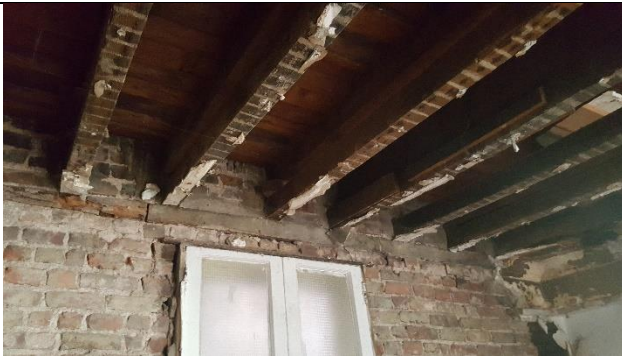
JOISTS FRAMING INTO MASONRY IN POOR CONDITION, MASONRY IN POOR CONDITION
