769 GREENWICH STREET

PROPOSAL FOR RELOCATING ROOFTOP BULKHEAD AND ADDING GLAZED ENCLOSURE TO THE THIRD FLOOR BALCONY

APRIL 2011

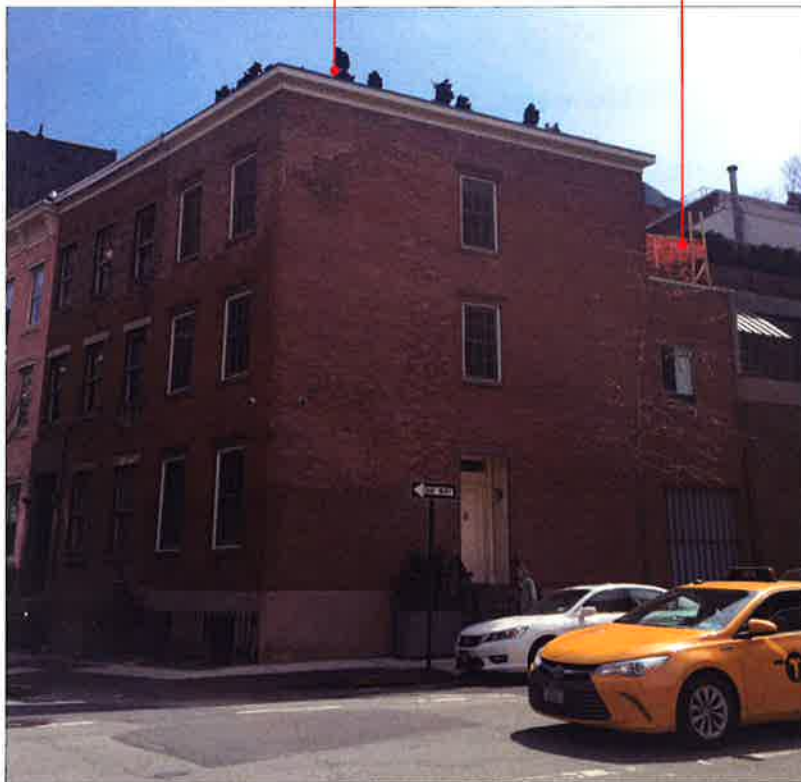
Proposed Glass Enclosure at Third Floor Balcony, with frosted glass louvers to match existing louvers at street level below

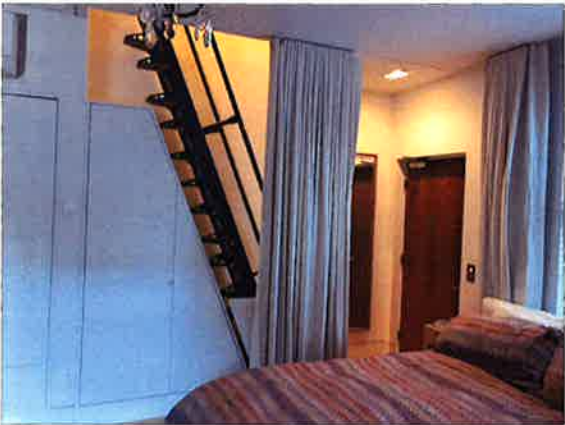
The existing steel Lapere Staircase is very steep and it's nearly impossible to climb up or down safely without holding both handrails. The rise of the steps is too tall for the children to be able to use the stairs and carrying them would be unsafe given the tight width of the steps and the steep climb. The owners currently don't utilize this wonderful space because it is in accessible for their children and very difficult to bring anything up or down the stairs. To make this roofdeck a functional exterior space, the elevator shaft can be extended up one more floor (9'-3") to provide safe and convenient access to the roof.

Photos of Existing Staircase to the Roof and Elevator Door in Master Bedroom

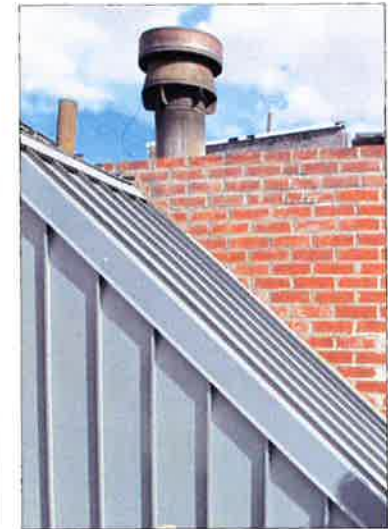
PROPOSED ELEVATIONS OF NEW BULKHEAD AND ROOF HATCH

Materials: New bulkhead to have the same zinc cladding as the existing elevator shaft and bulkhead. Brick chimney to remain as-is.
