Presentation to the
New York City
Landmarks Preservation
Commission

85-89 Jane Street

Greenwich Village Historic District

11 October 2016

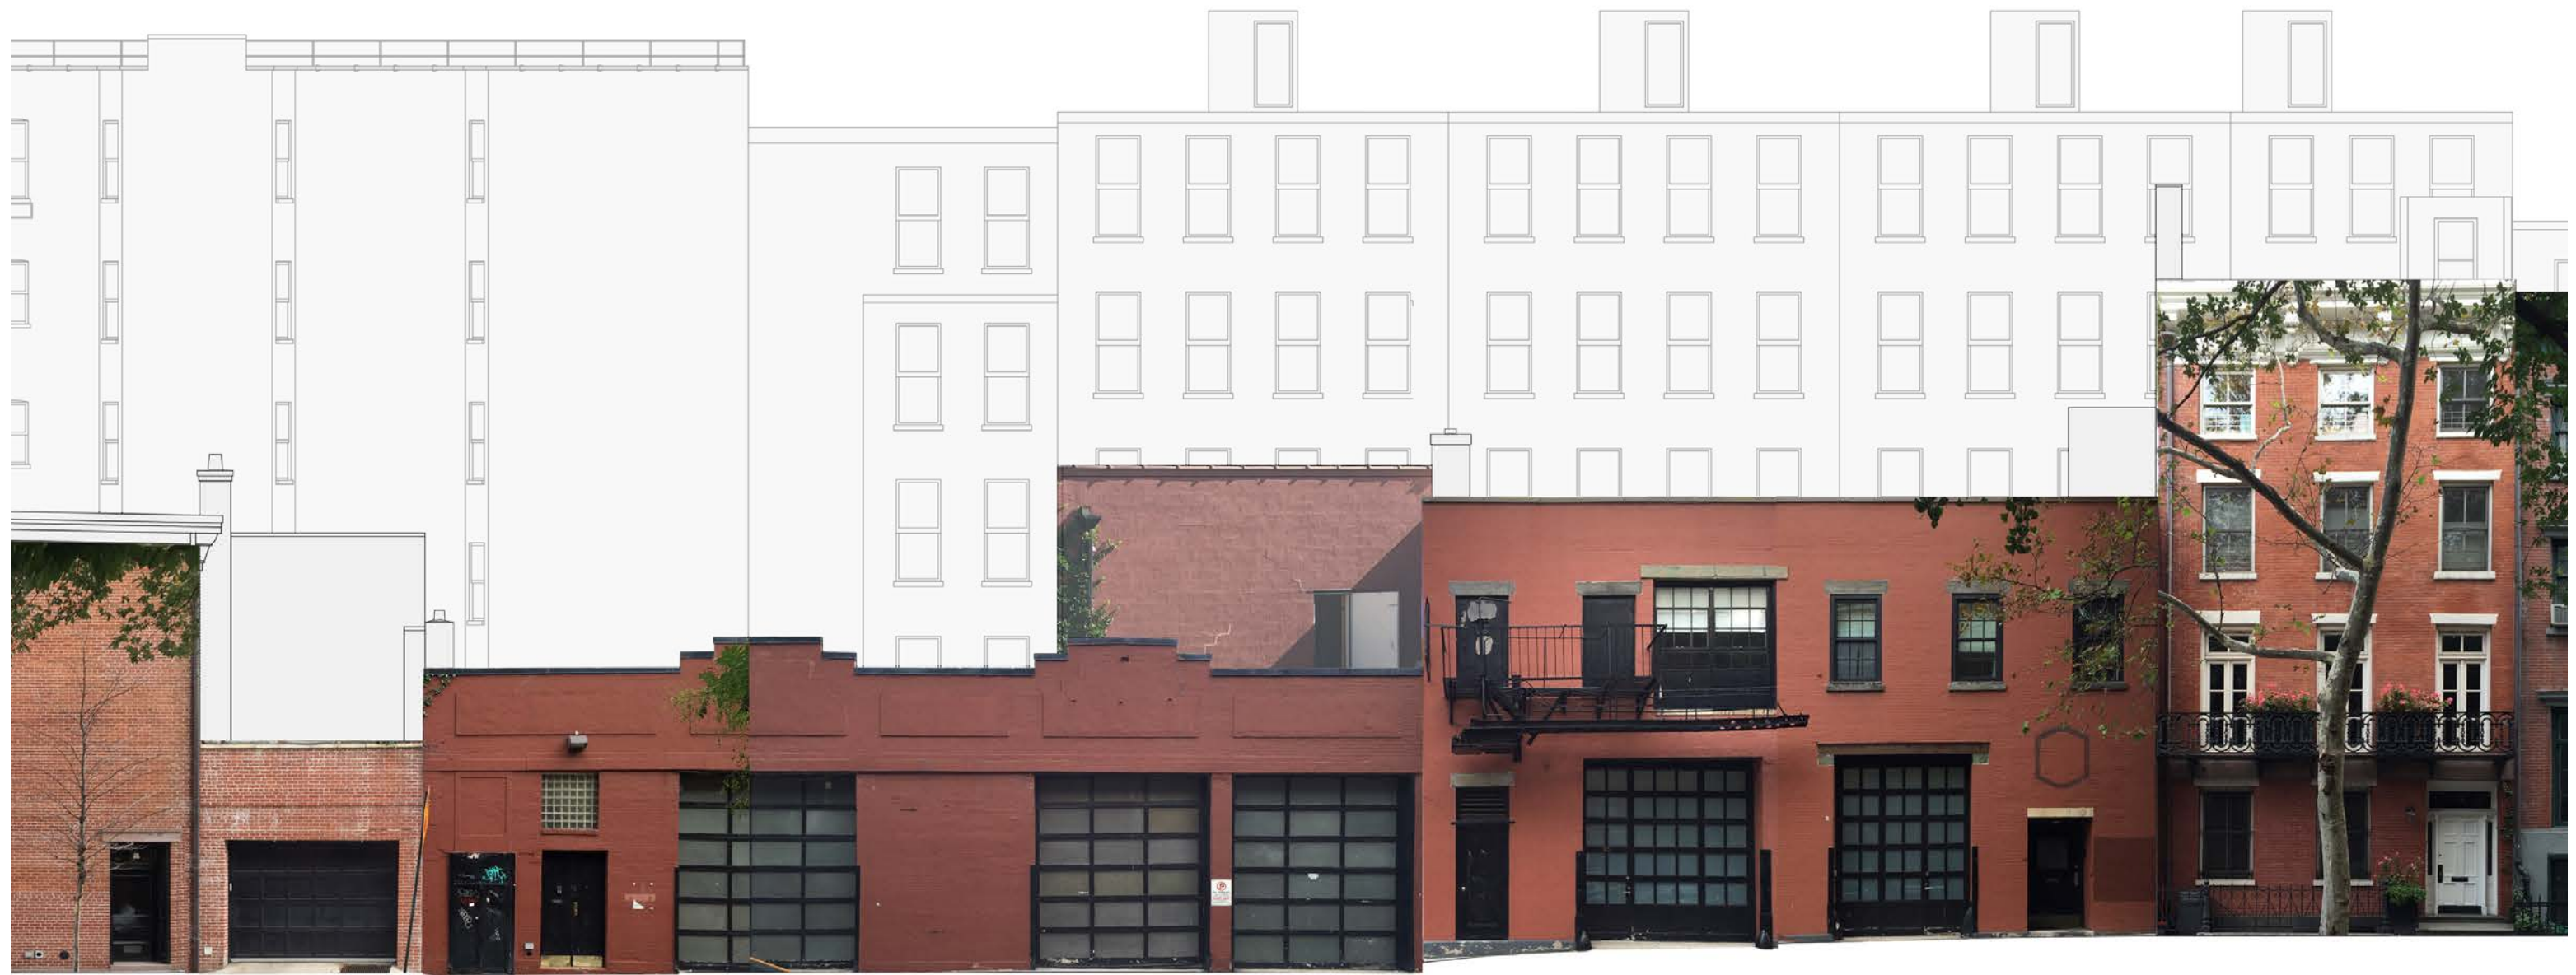
← 89-93 Jane Street ✂ 85-87 Jane Street →

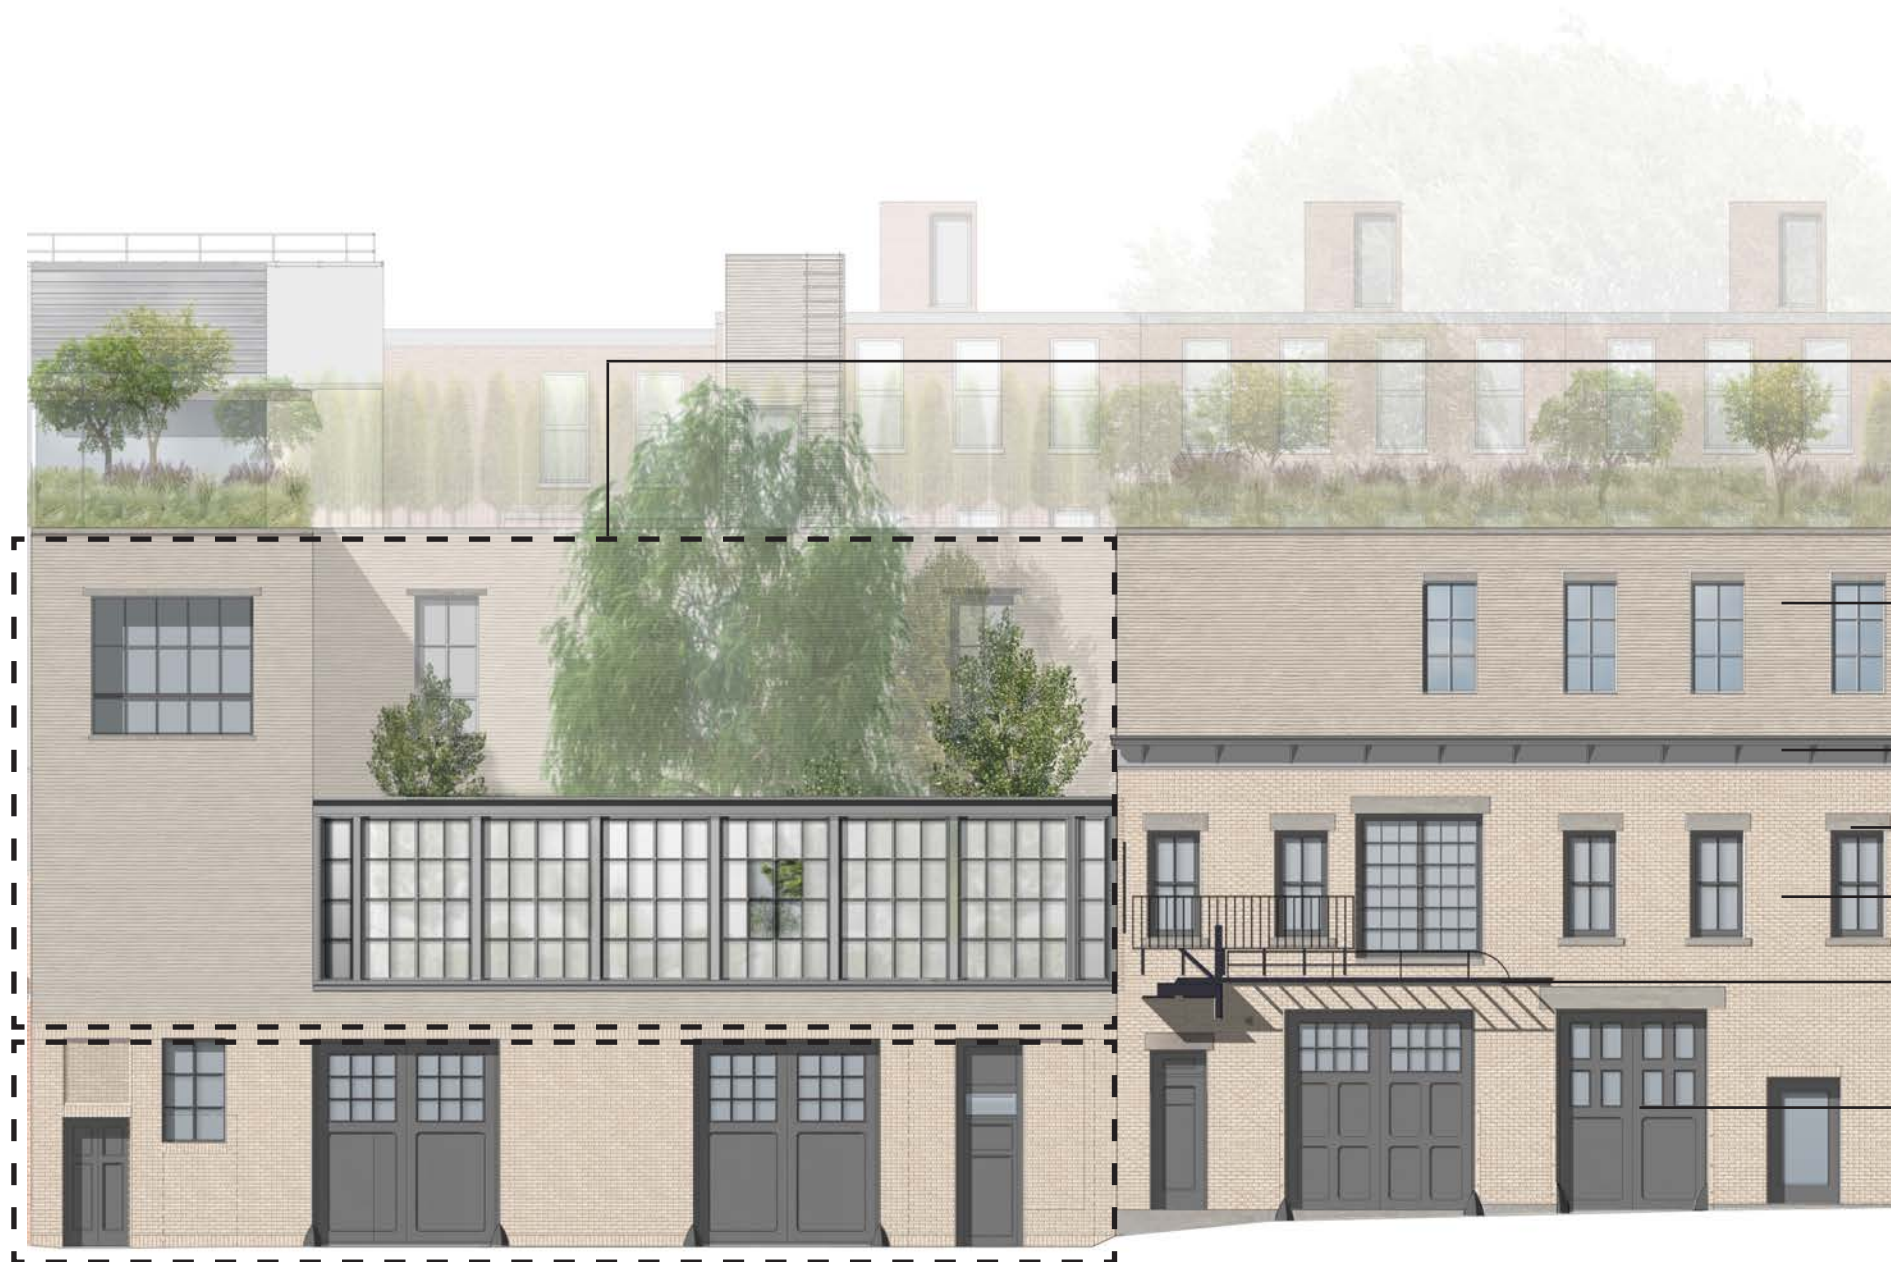
Addition of steel windows and Roman brick masonry

Addition of steel windows and Roman brick facade to align with townhouses

Restoration of missing cornice

Restoration of sills and lintels

Restoration of buff brick

Restoration of fire escape

Replacement of doors and windows with historically accurate units

Patching later door addition and restoration of facade

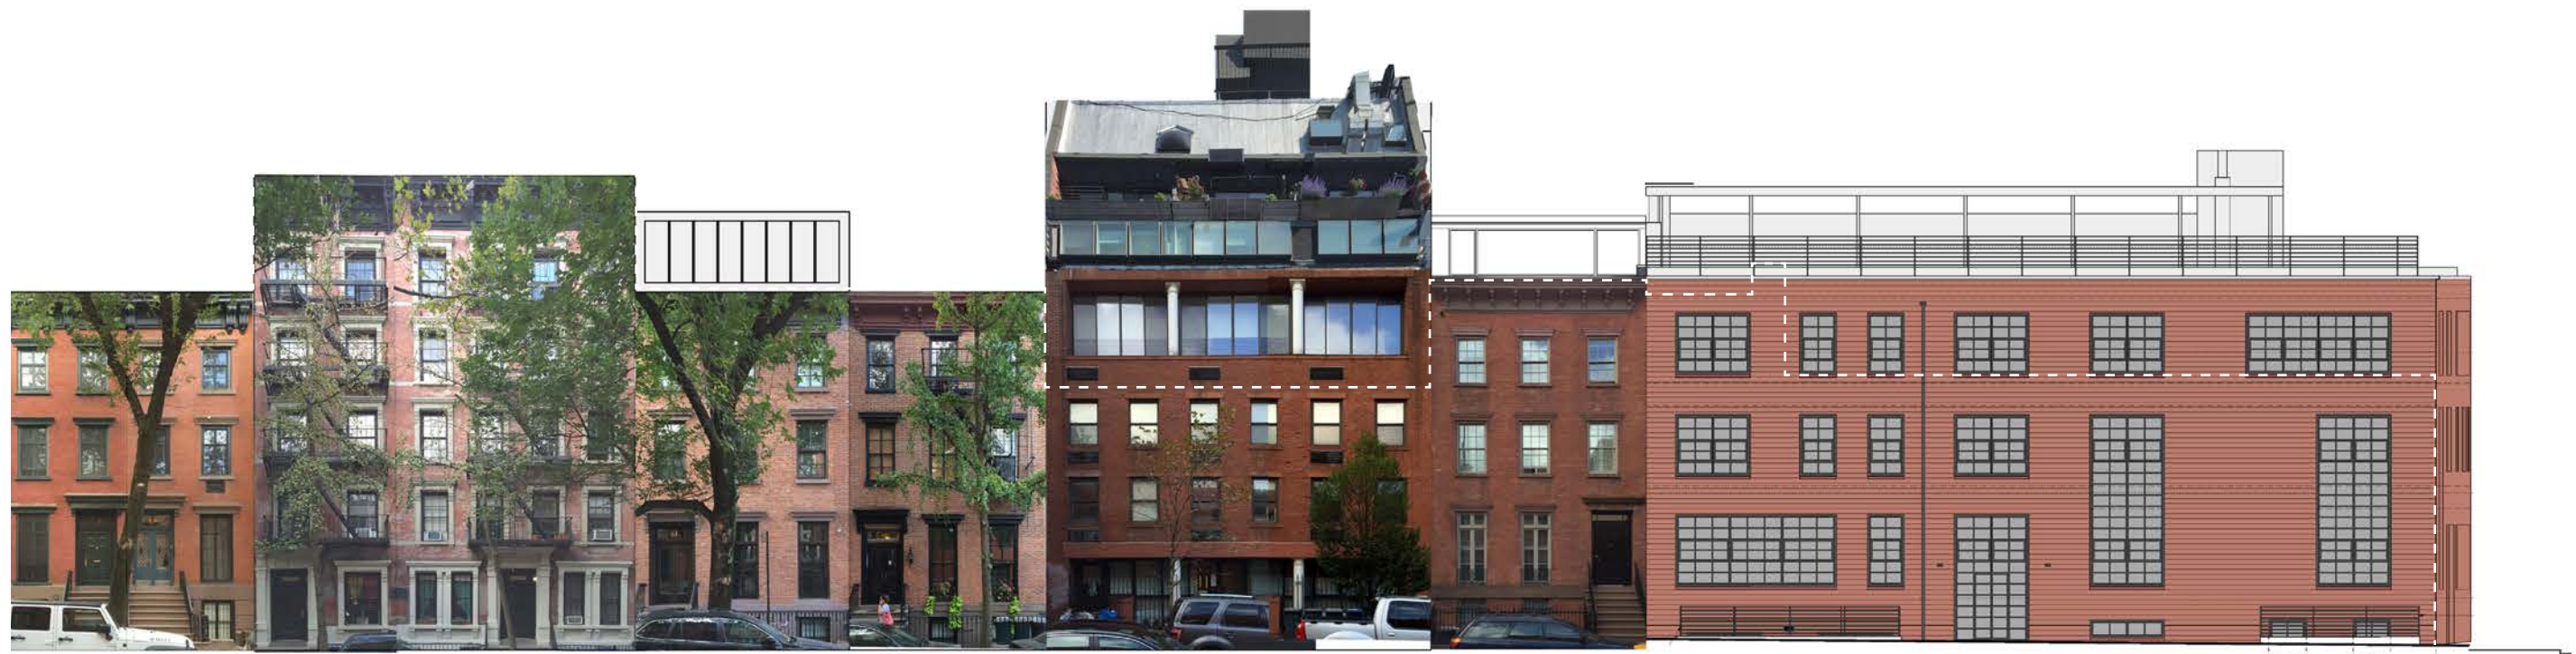
--- Building profile at 1969 designation
