**311 W4TH STREET  
NEW YORK, NY 10014  
YEAR BUILT: 1836**

**NYC LANDMARKS AND PRESERVATION COMMISSION  
SUBMISSION  
FEBRUARY, 12 2015**

REAR YARD AND ROOFTOP ADDITIONS  
NYC LPC APPLICATION  
311 W 4TH STREET, NEW YORK, NY 10014

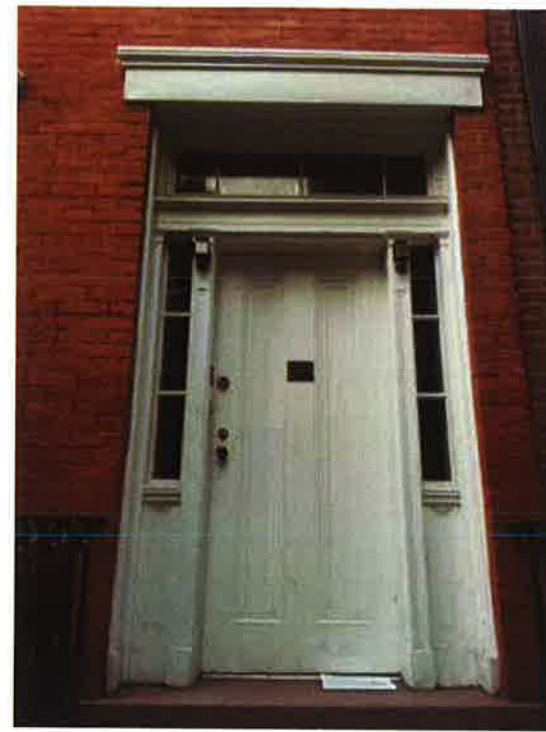
2 - EXISTING DOOR  
RESTORE DOOR AND LIGHTING TO ORIGINAL CONDITION

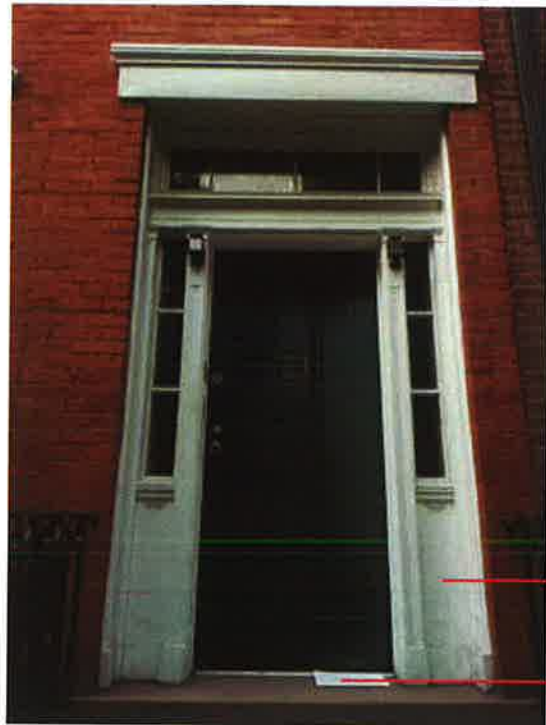
2 - EXISTING DOOR  
RESTORE DOOR AND LIGHTING TO ORIGINAL CONDITION

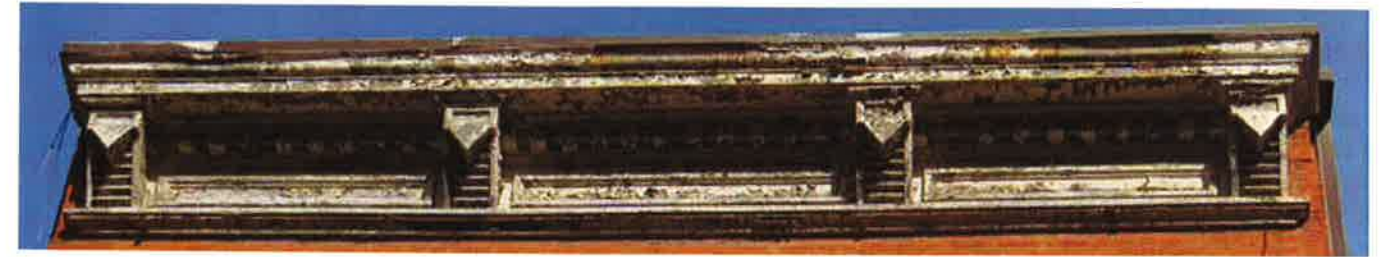
5 - EXISTING CORNICE

PATCH, PAINT AND RESTORE CORNICE TO ORIGINAL CONDITION

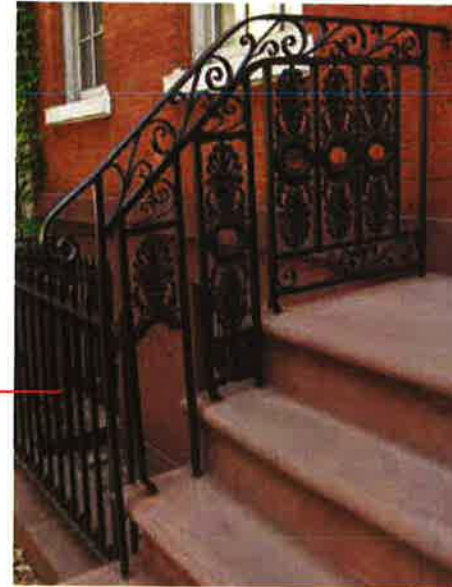
3 - EXISTING RAILING  
PATCH, PAINT AND RESTORE IRONWORK TO ORIGINAL CONDITION

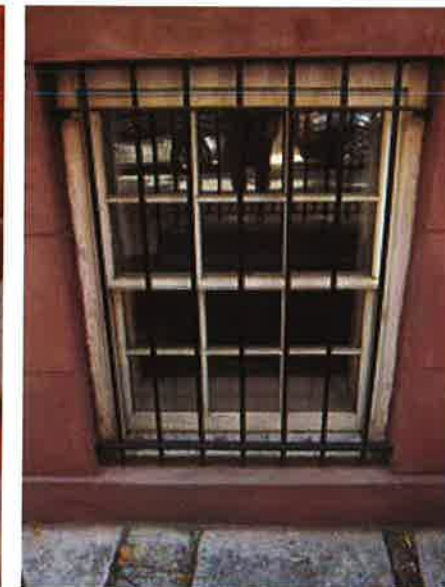
3 - EXISTING WINDOW BARS  
REMOVE EXISTING BARS

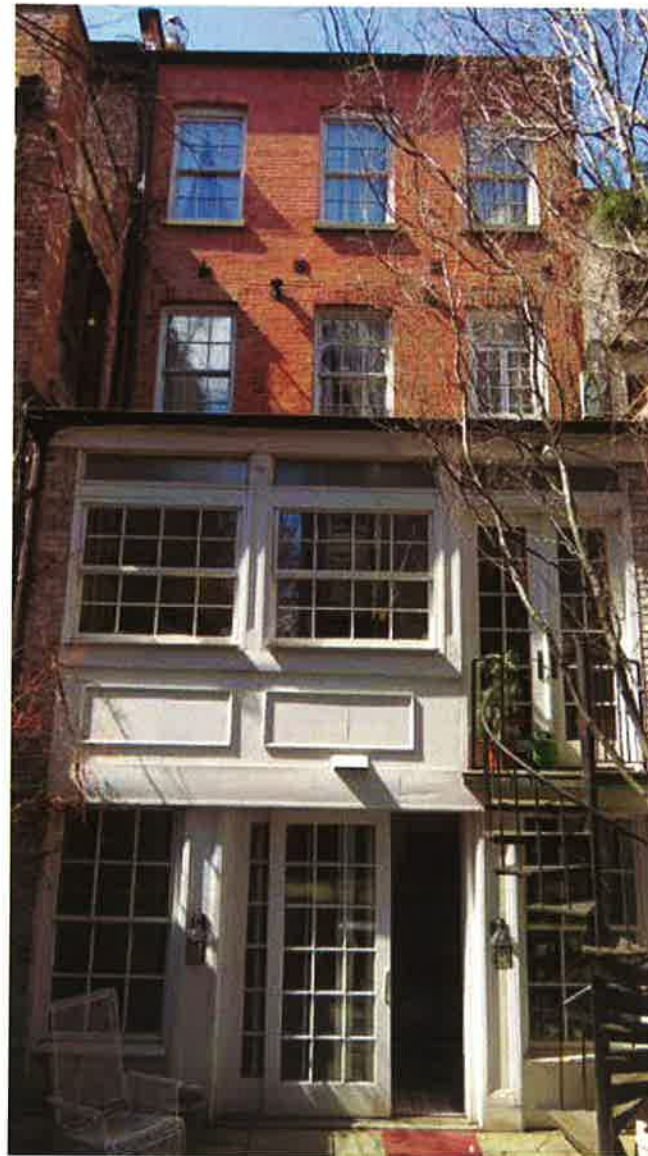
**3 - 311 W 4TH**

EXISTING FACADE  
MODERN WINDOWS AND DOORS THROUGHOUT  
MODERN PLYWOOD CLADDING AND TRIM THROUGHOUT  
MODERN STAIRCASE

HISTORIC BRICK SIDE WALLS  
FOOTPRINT/ 2 STORY VOLUME

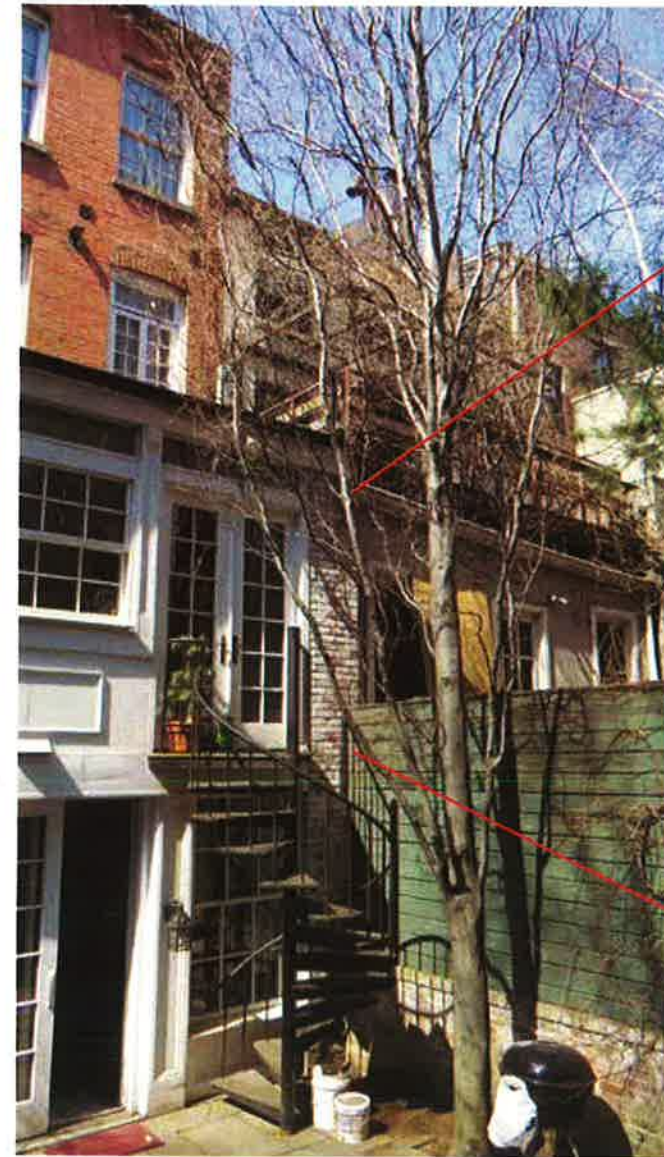
**4 - 311-313 W 4TH ADJACENCY**

EXISTING FACADE  
2 STORY STRUCTURE SHOWING NO HISTORIC  
ELEMENTS

HISTORIC FOOTPRINT AND MASSING

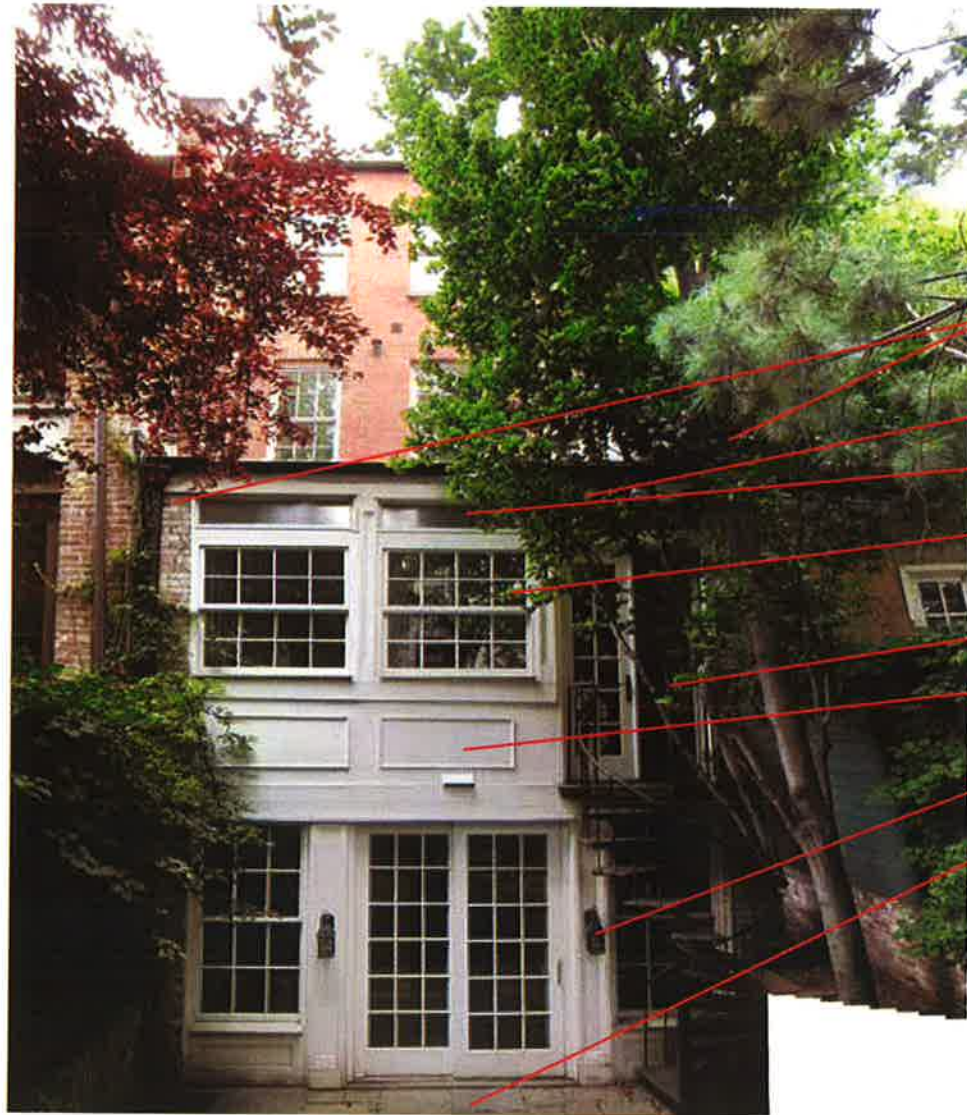
1 - EXISTING REAR FACADE

- ca. Unknown - STRUCTURAL BRICK WALL (NORTH AND SOUTH SIDES )
- ca. 1993 - ROOFING AND GUTTER
- ca. 1993 - CLERESTORY WINDOW
- ca. 1993 - WINDOWS AND DOORS THROUGH OUT
- ca. 1993 - SPIRAL STAIRCASE
- ca. 1993 - PLYWOOD SIDING AND TRIM THROUGHOUT
- ca. 1993 - LIGHTING
- ca. 1993 - BLUE STONE PATIO

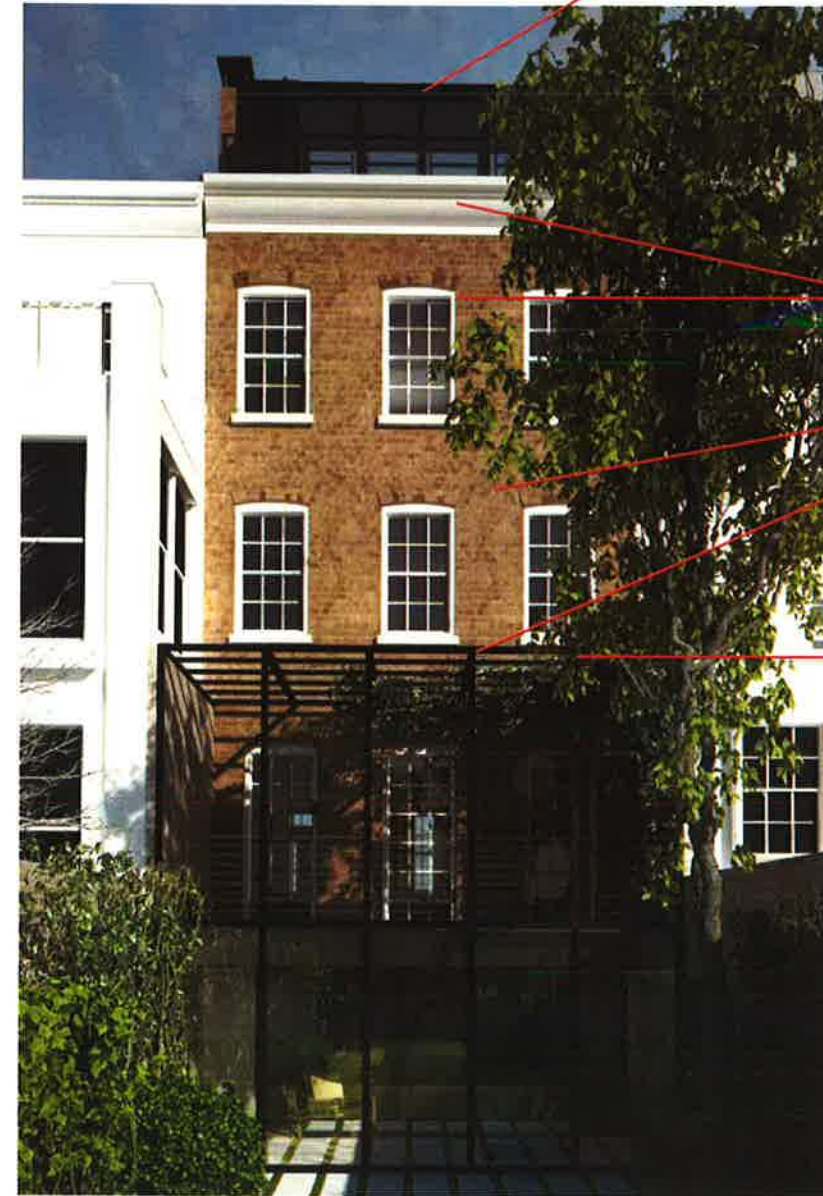
2 - PROPOSED DESIGN RENDERING

FARROW & BALL  
PITCH BLACK No.256  
(Metal Work, Typ.)

RESTORE EXISTING FACADE

NEW REAR YARD STRUCTURE IN  
EXISTING LOCATION

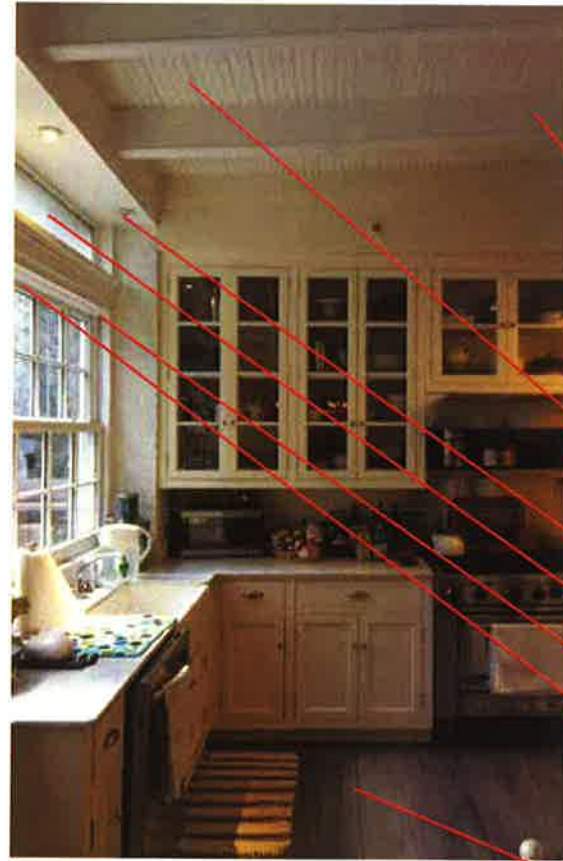
- ca. UNKNOWN - JOISTS
- ca. unknown- STRUCTURAL BRICK WALL (NORTH AND SOUTH SIDES )
- ca. 1920's - BEADBOARD CEILING THROUGHOUT
- ca. 1993 - SOFFIT AND LIGHTING
- ca. 1993 - CLERESTORY WINDOW
- ca. 1993 - WINDOWS AND DOORS THROUGH OUT
- ca. 1993 - PLYWOOD SIDING AND TRIM THROUGHOUT
- ca. 1993 - OAK FLOORING
- ca. 1993 - RECESSED LIGHTING
- ca. 1920's - BEADBOARD CEILING THROUGHOUT
- ca. 1993 - RECLAIMED WOOD TRIM ON MODERN COLUMNS
- ca. 1993 - BLUE STONE FLOORING

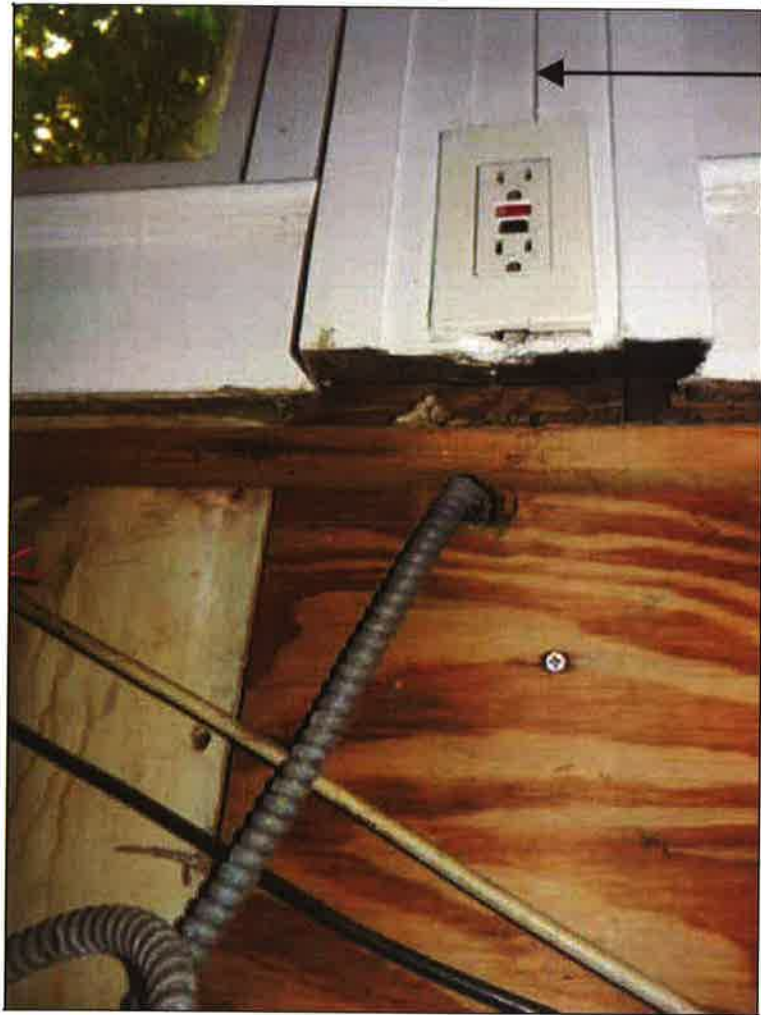
Recycled older moldings

Figure 6: Historic wood column trim is applied over wall board

1 - EXERPT FROM JABLONSKI BUILDING CONSERVATION REPORT SHOWING NEW INTERIOR CONSTRUCTION

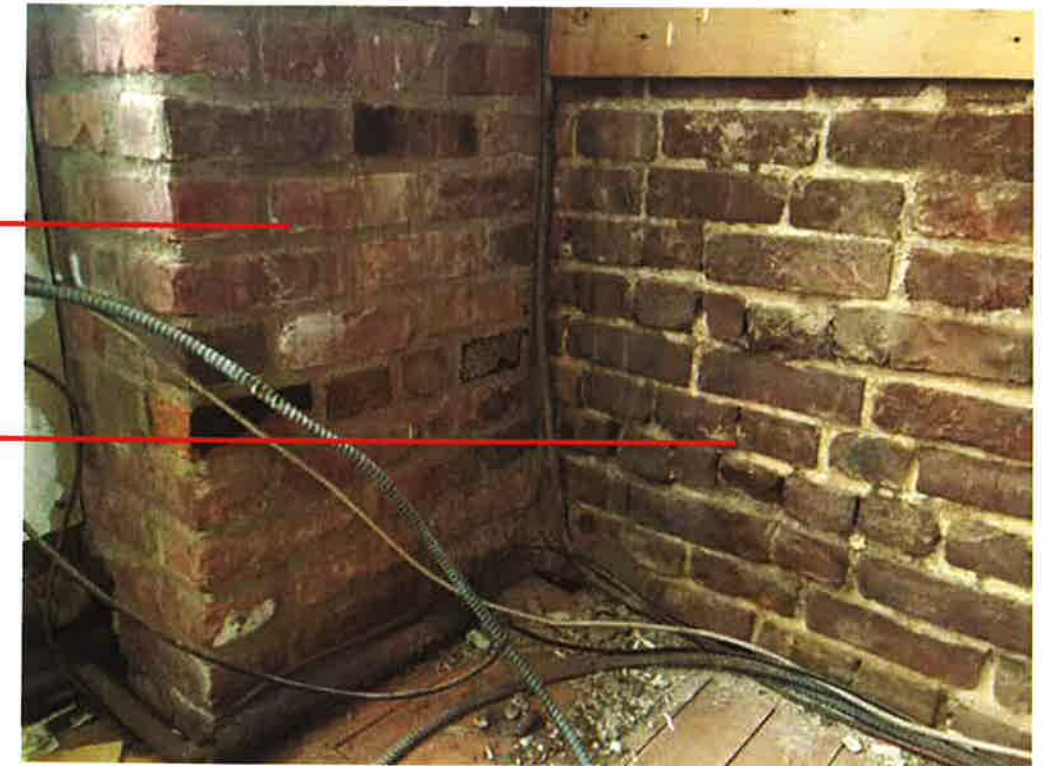
MODERN BRICK WALL

HISTORIC BRICK WALL

2 - BRICK CONDITION AT REAR YARD EXTENSION AT 1ST FLOOR

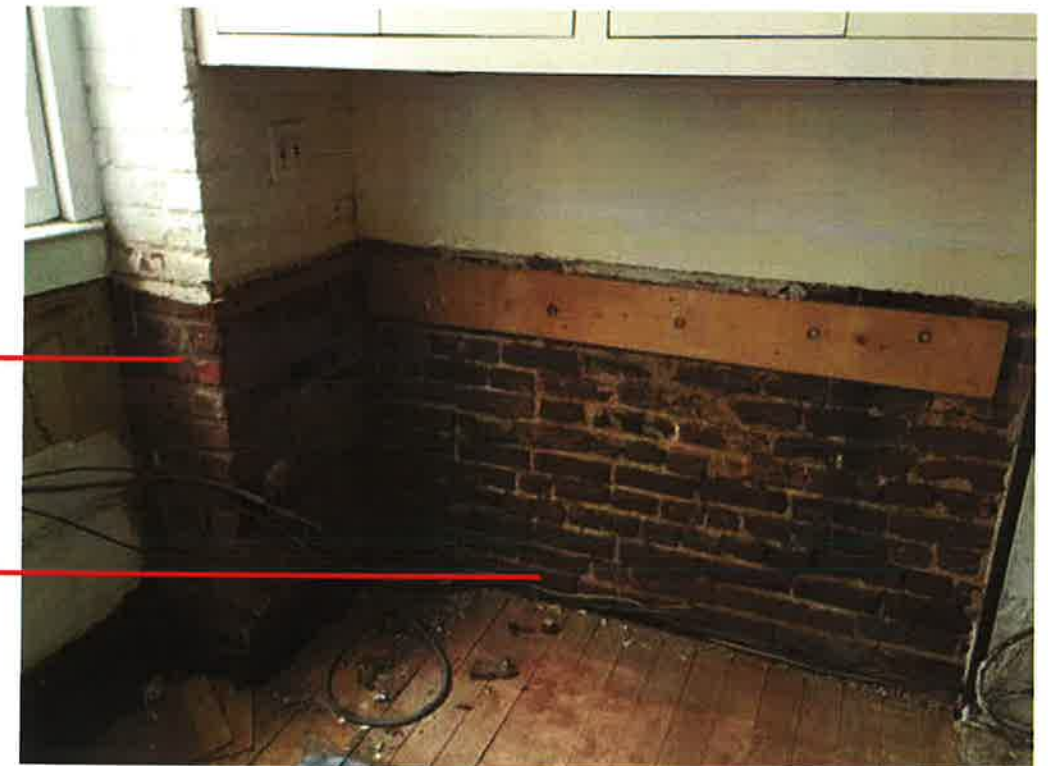
MODERN BRICK WALL

HISTORIC BRICK WALL

3 - BRICK CONDITION AT REAR YARD EXTENSION 1ST FLOOR

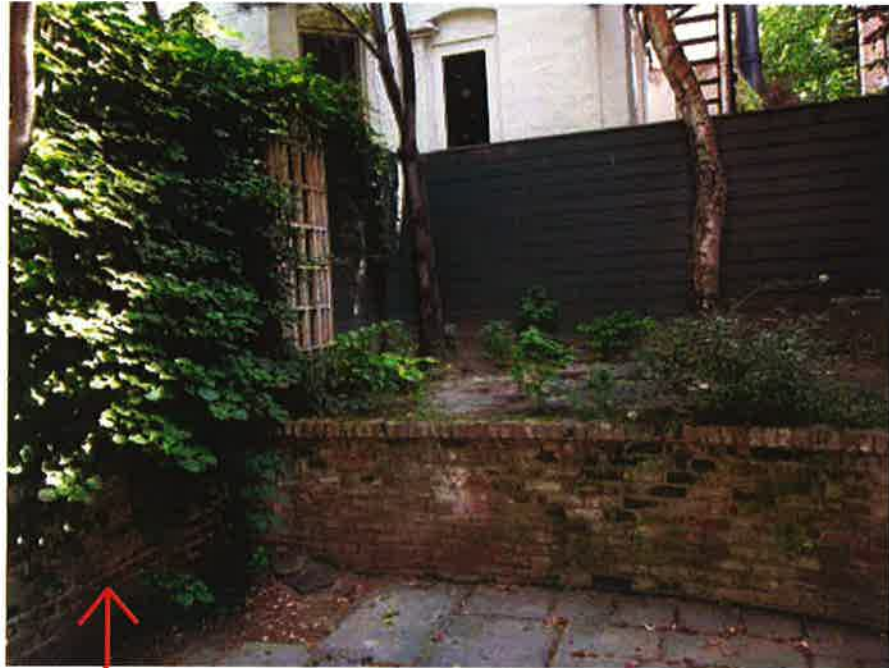
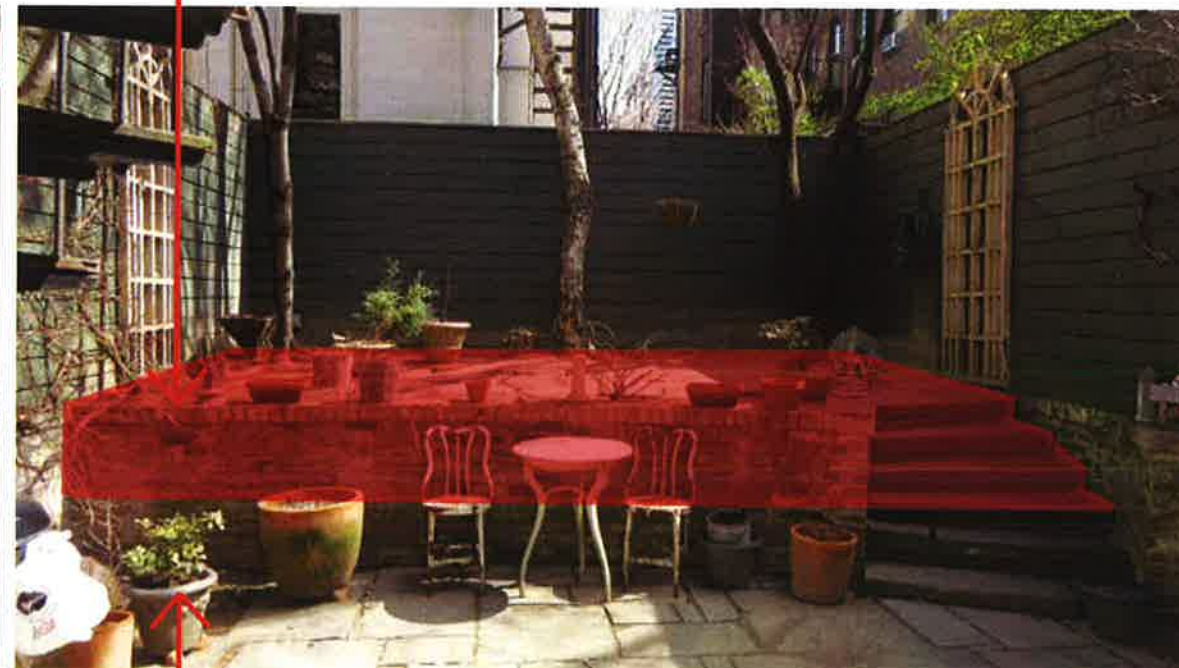
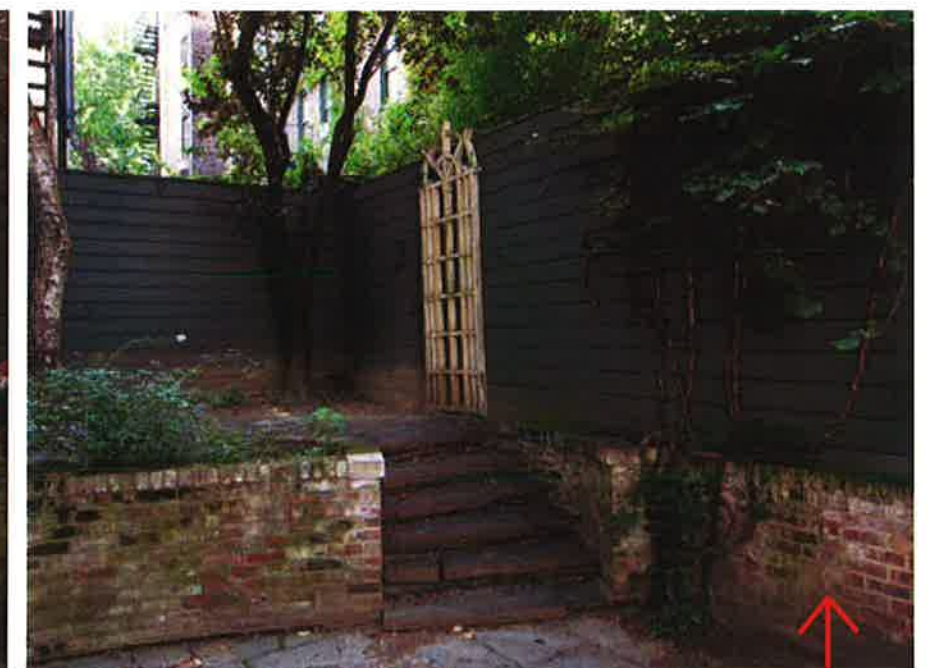
1 - EXISTING YARD (VIEW FROM EXTENSION)  
NTS

BRICK RETAINING WALL AT  
PROPERTY LINE TO REMAIN

12" PORTION OF BRICK RETAIN-  
ING WALL TO REMAIN

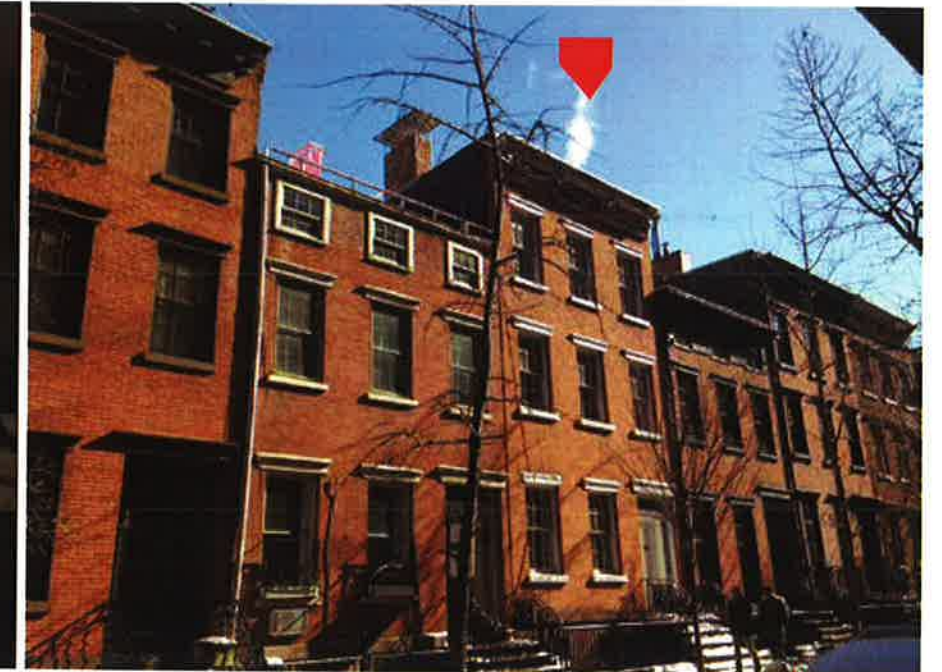
VIEW 2 - MOCK-UP VISIBILITY STUDY  
(MINIMAL VISIBILITY)

RAILING MOCK-UP (MINIMAL VISIBILITY)

CHIMNEY EXTENSION MOCK-UP  
(MINIMAL VISIBILITY)
