200 PRINCE STREET AND 202 AVE. OF THE AMERICAS
NEW YORK, NY 10012

LANDMARKS PRESERVATION COMMISSION

12/14/2018

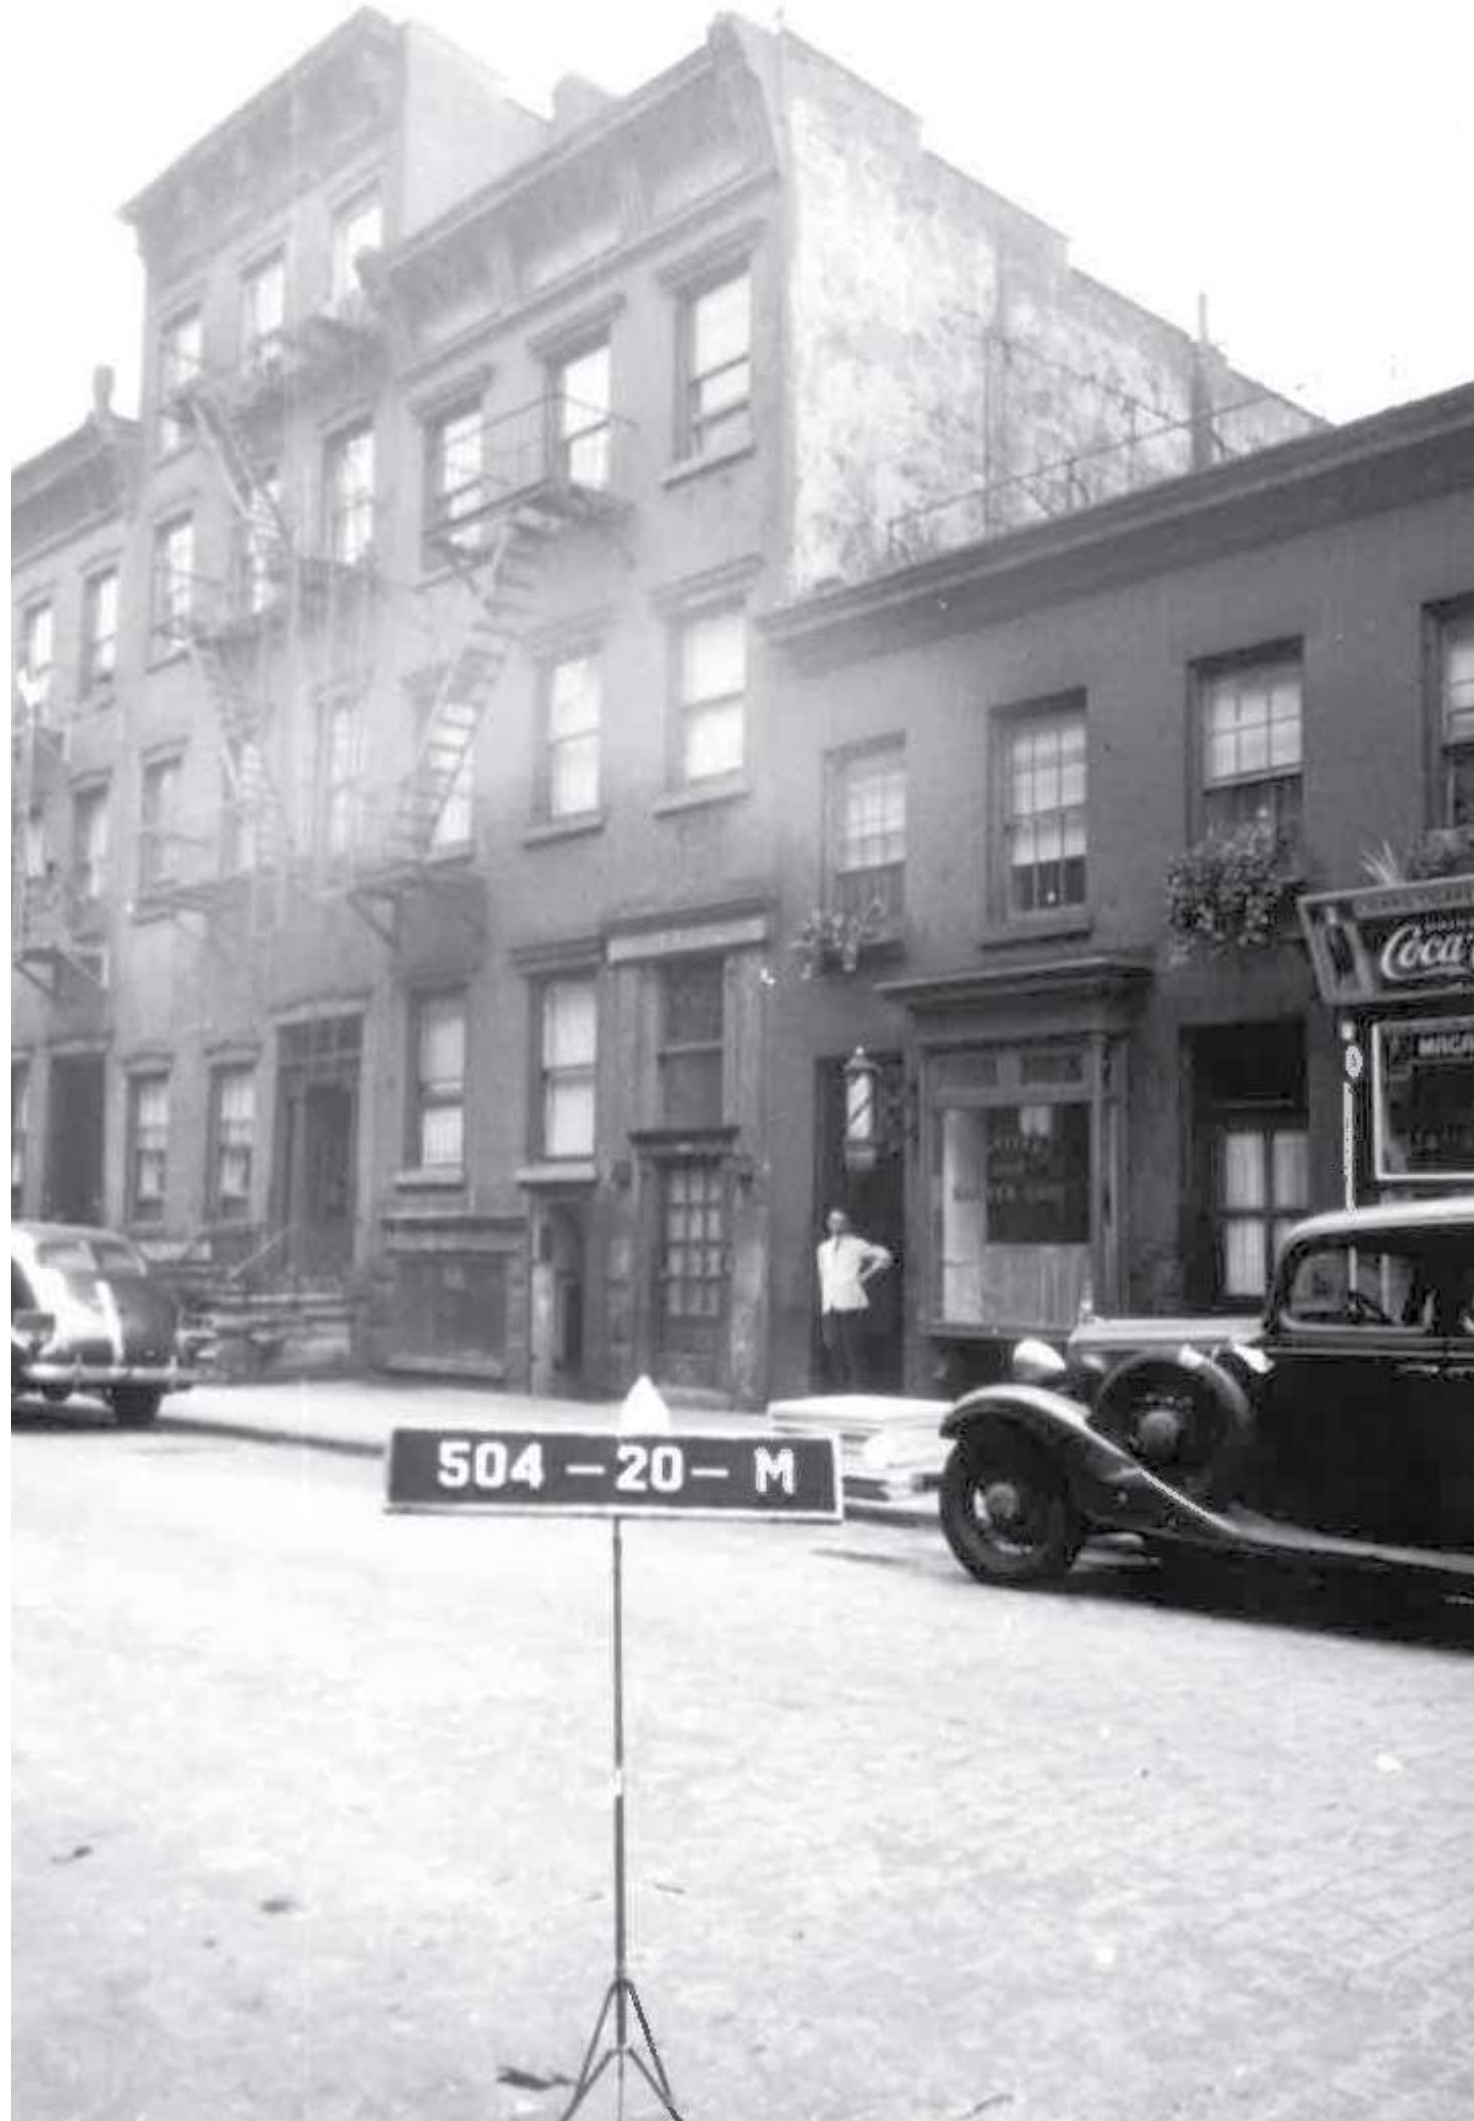
As seen on the left image, the building that was later demolished is still standing in the 40's. This unusually small two stories structure, with its alternating door/projecting storefront elements had a great impact on the predominantly commercial aspect of the Street.

200 PRINCE STREET - 1940 TAX LOT PHOTO

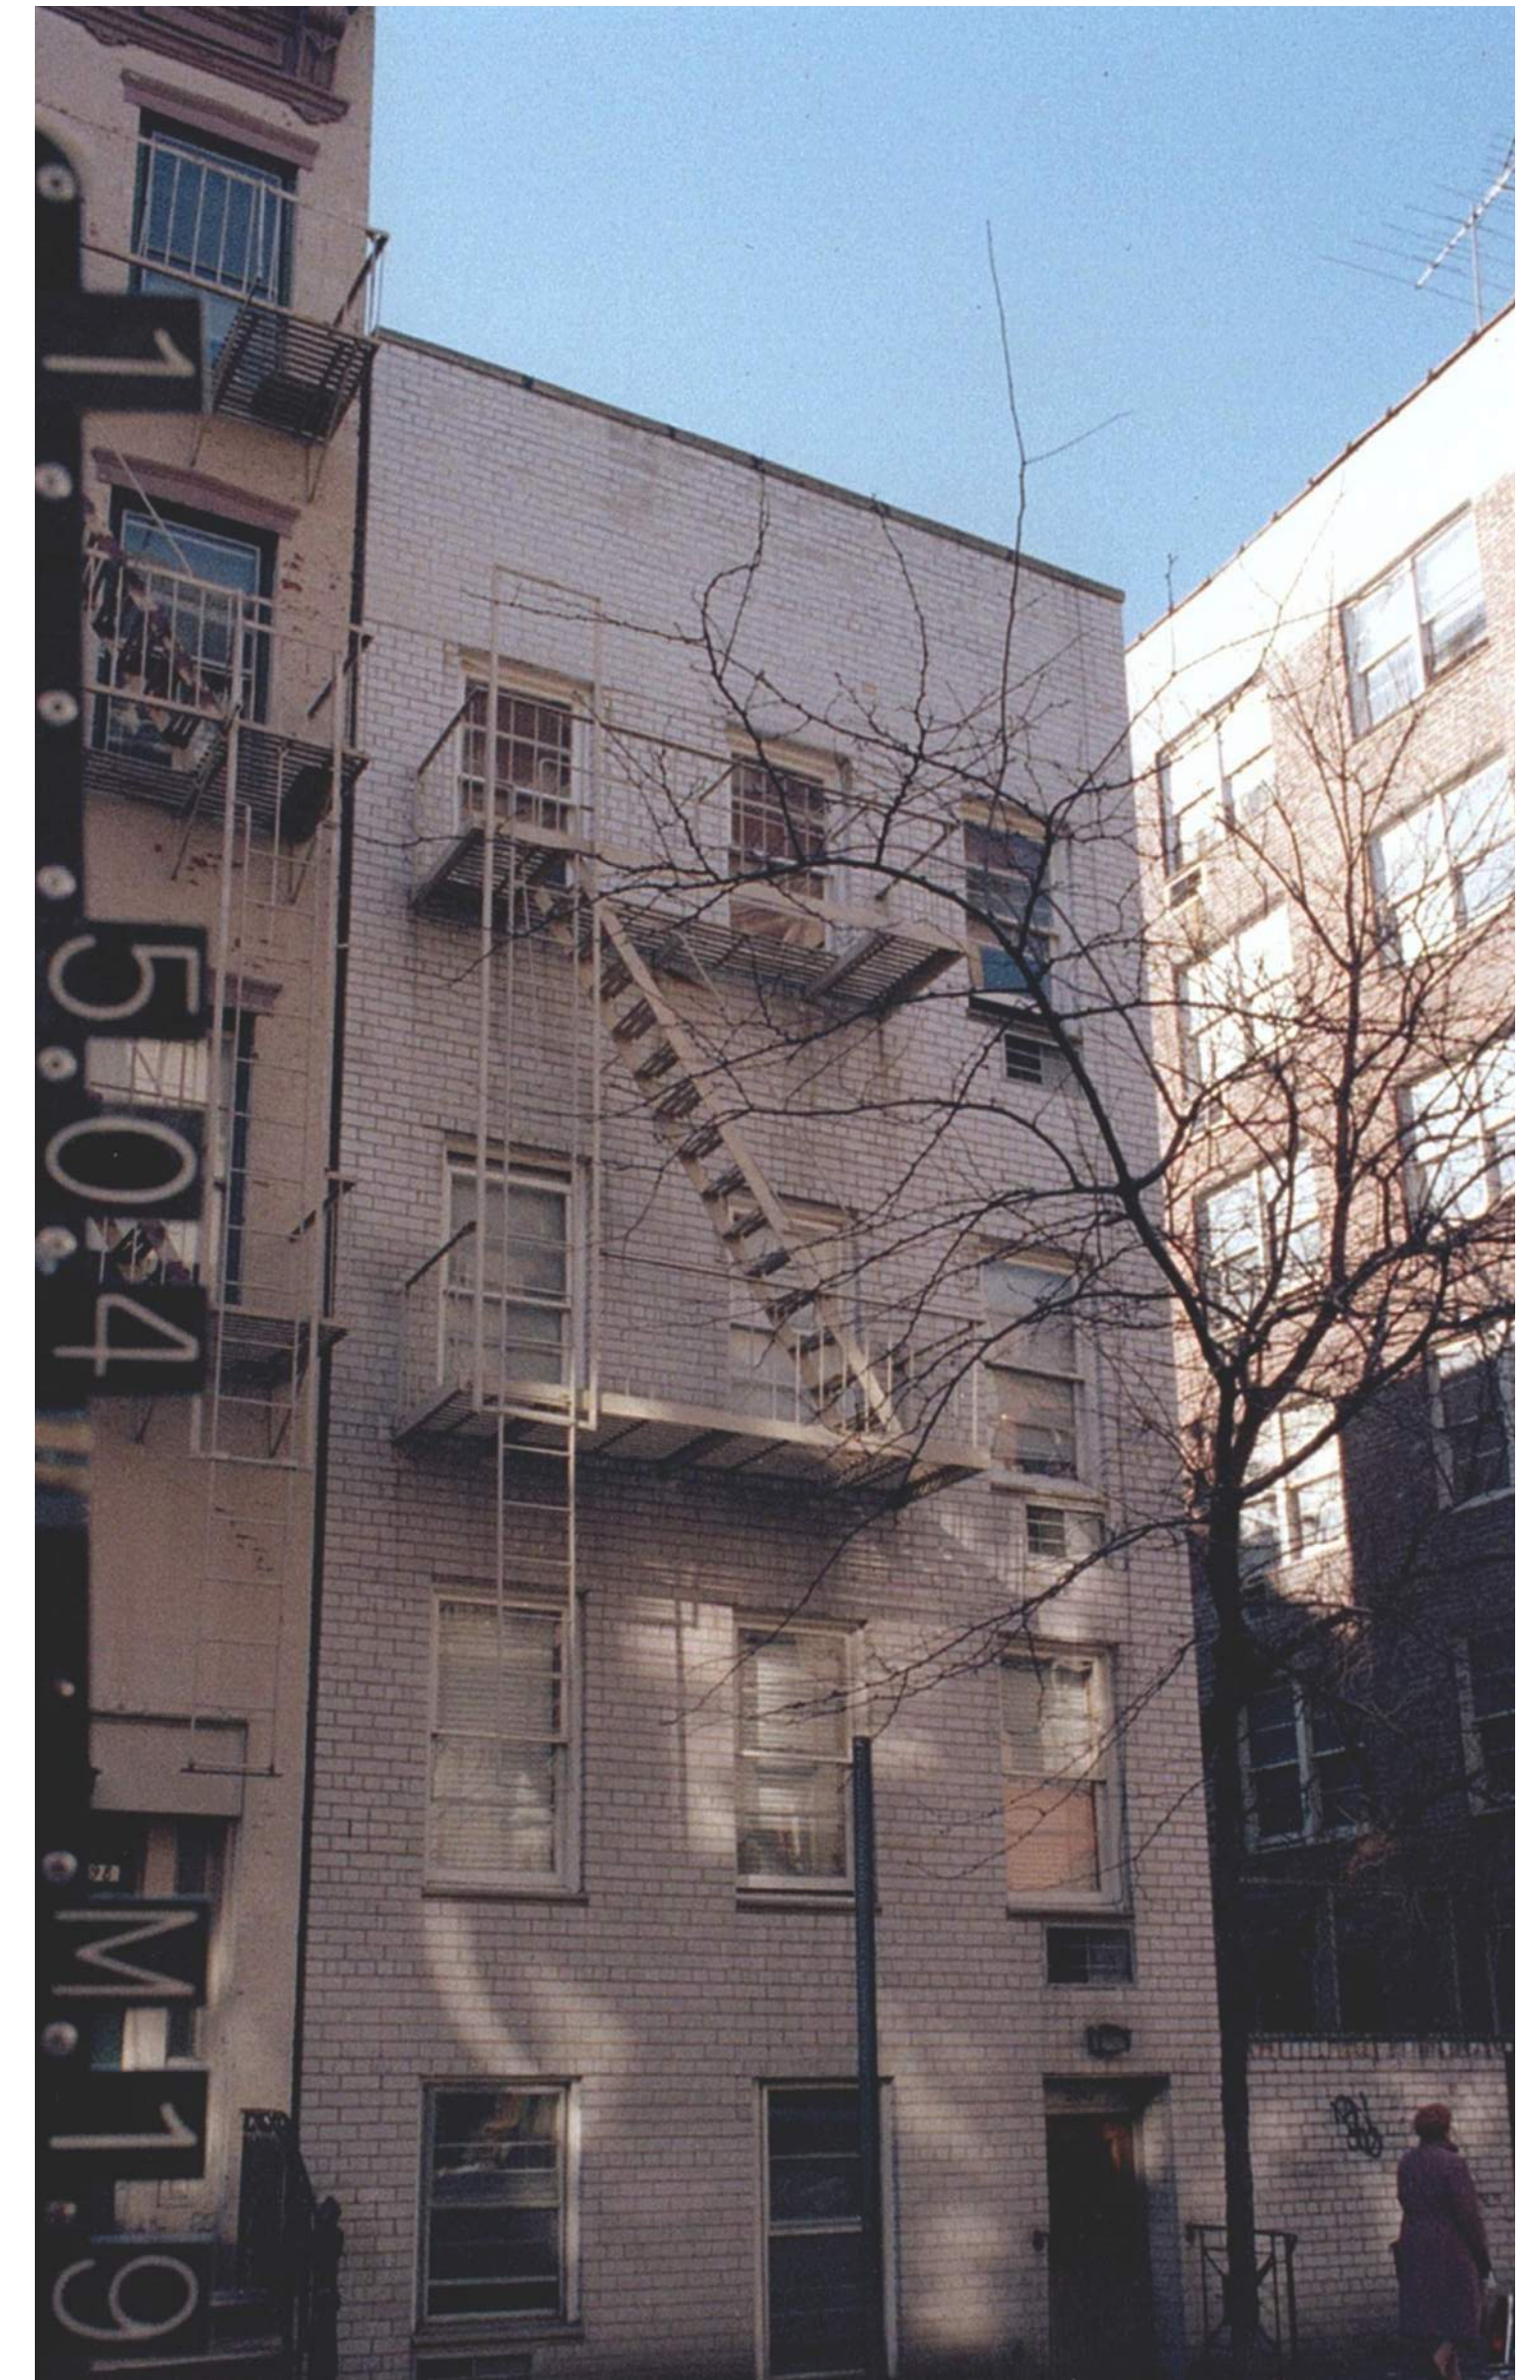
200 PRINCE STREET - 1980 TAX LOT PHOTO

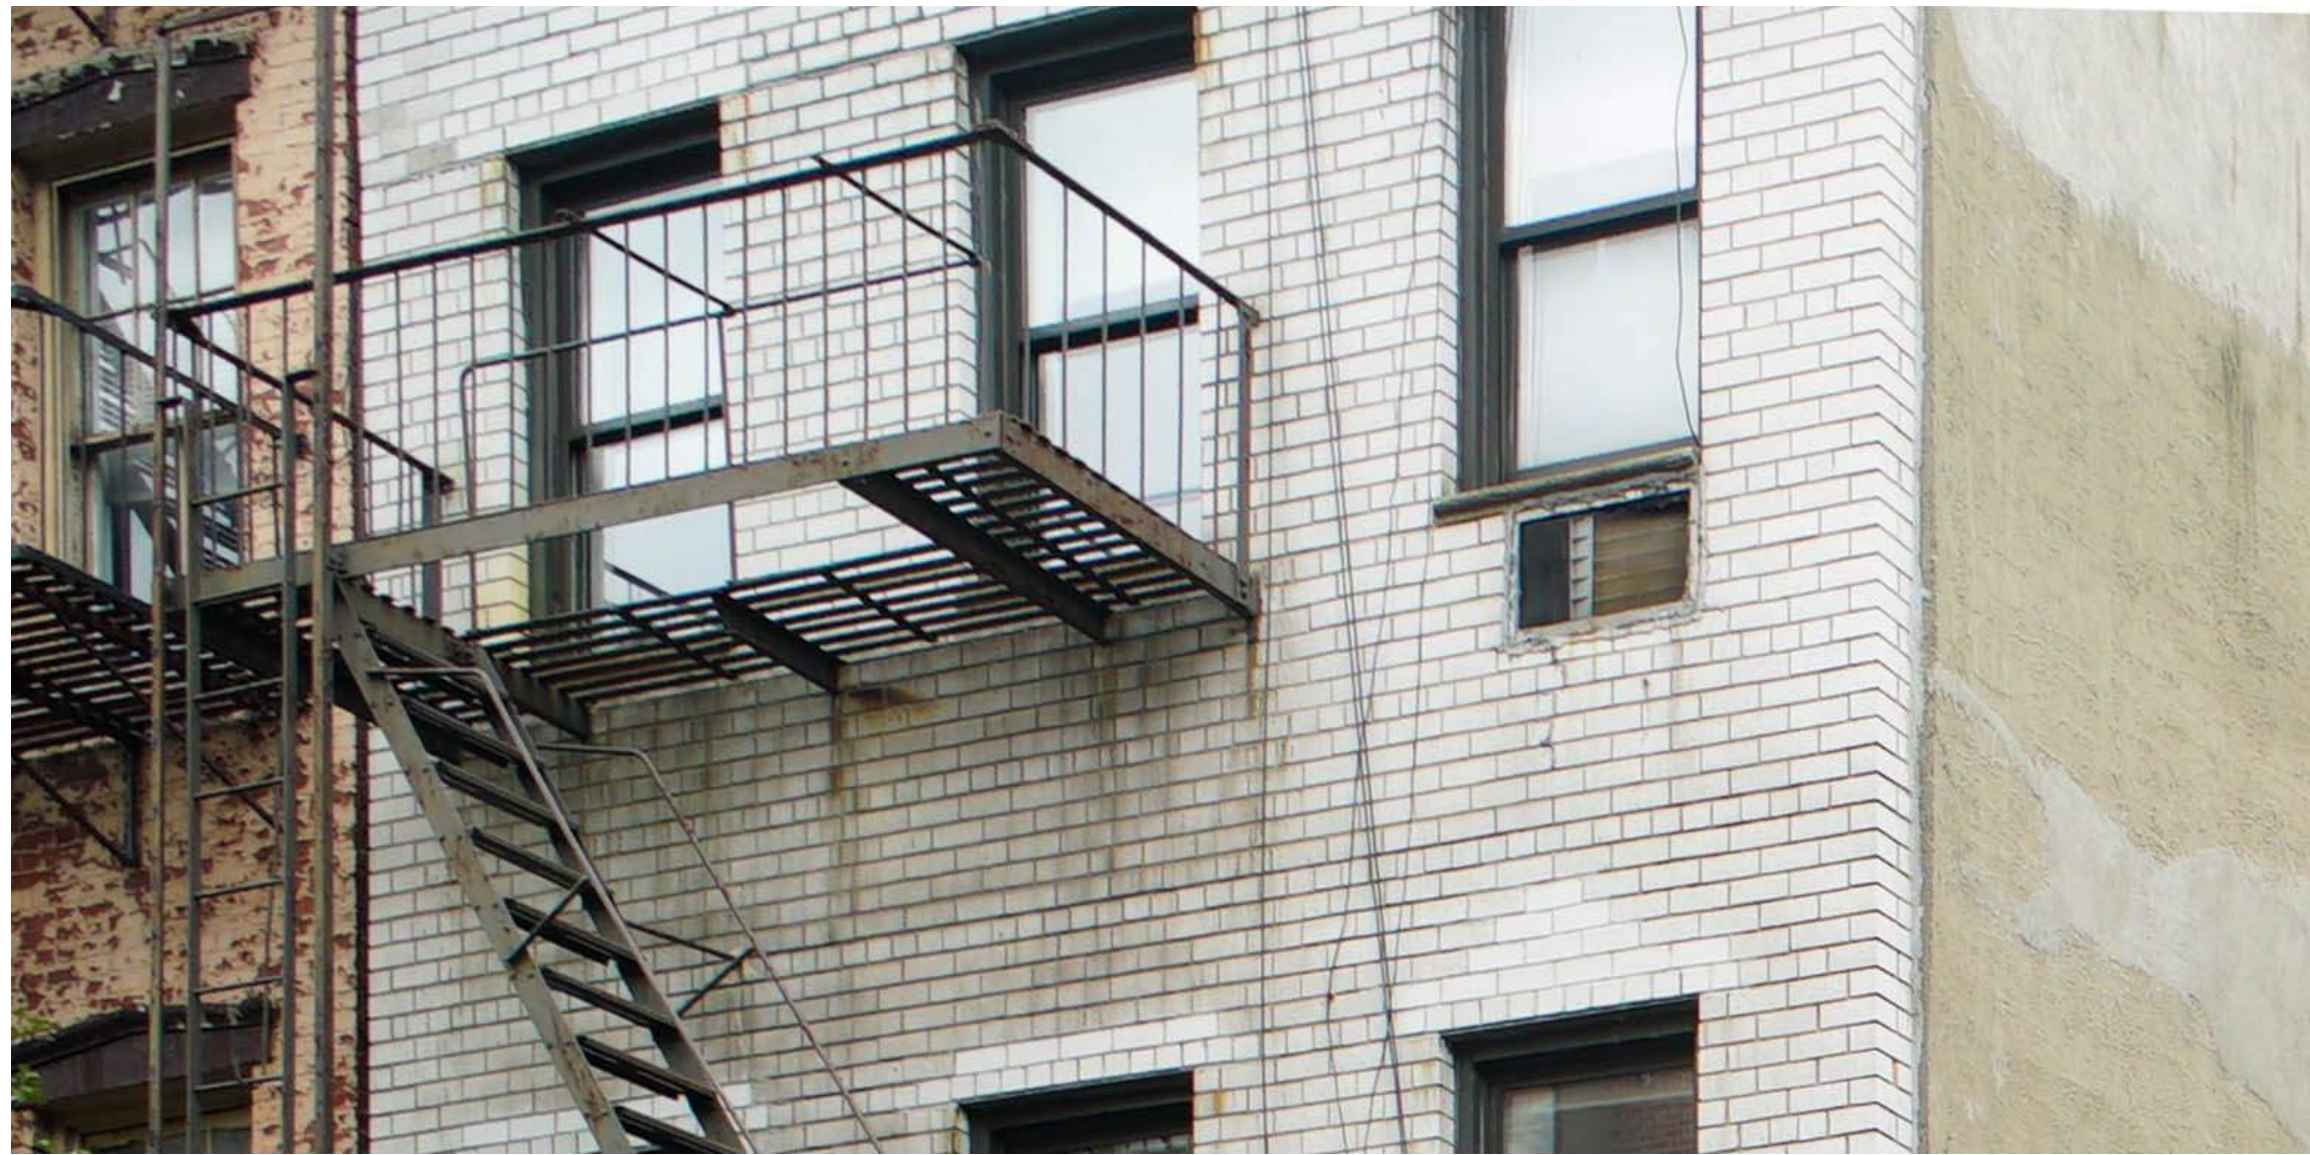
1 - DAMAGED/ CRACKED BRICK IS SEEN ON THE EXTERIOR WALL. RENDERED CEMENT HAS BEEN APPLIED TO SIDE WALL

The close-up photos illustrate the delapidated condition of both buildings on site, which results from several inconsequential interventions over time for remedial preservation of the building facade or change of use (such as the change of doctor practices to retail spaces). Today, aluminum window frames are in poor conditions, air conditioning units populate the facades, and an attempt to frame the access to the residential lobby is disconnected from any overarching design theme.

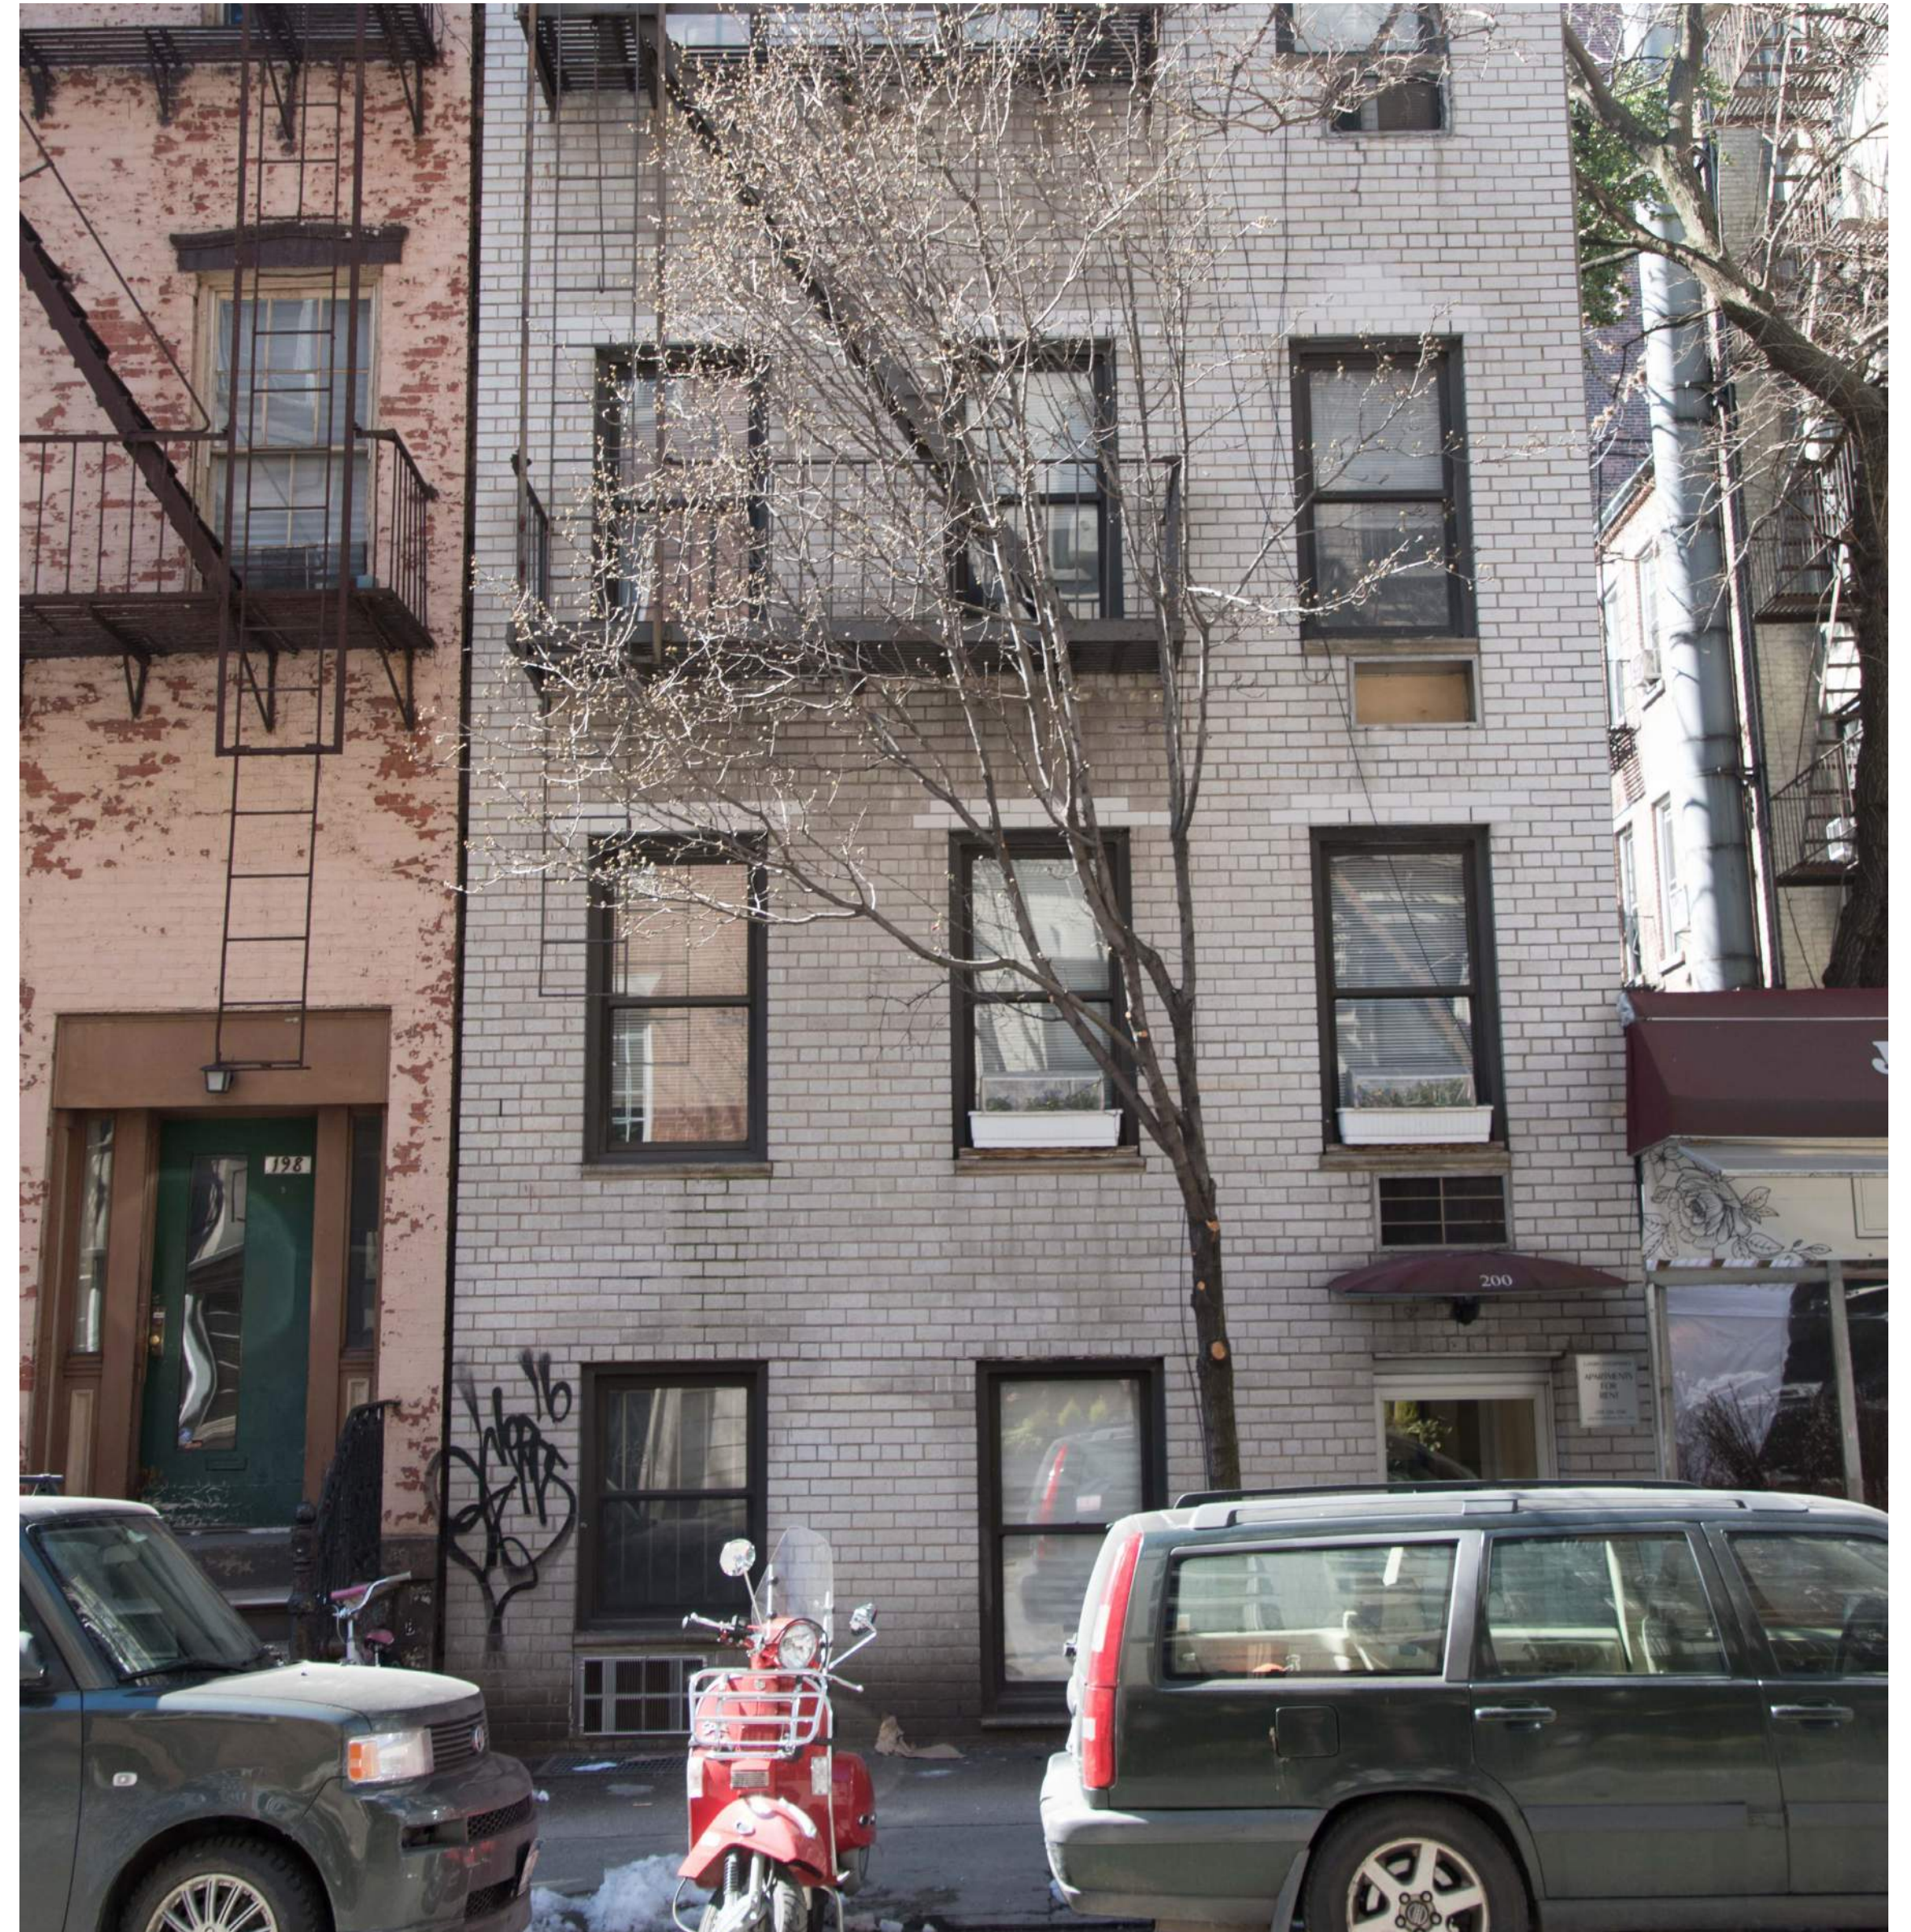
3- AC WINDOW UNITS HAVE BEEN RANDOMLY INTRODUCED INTO THE BRICK WALL

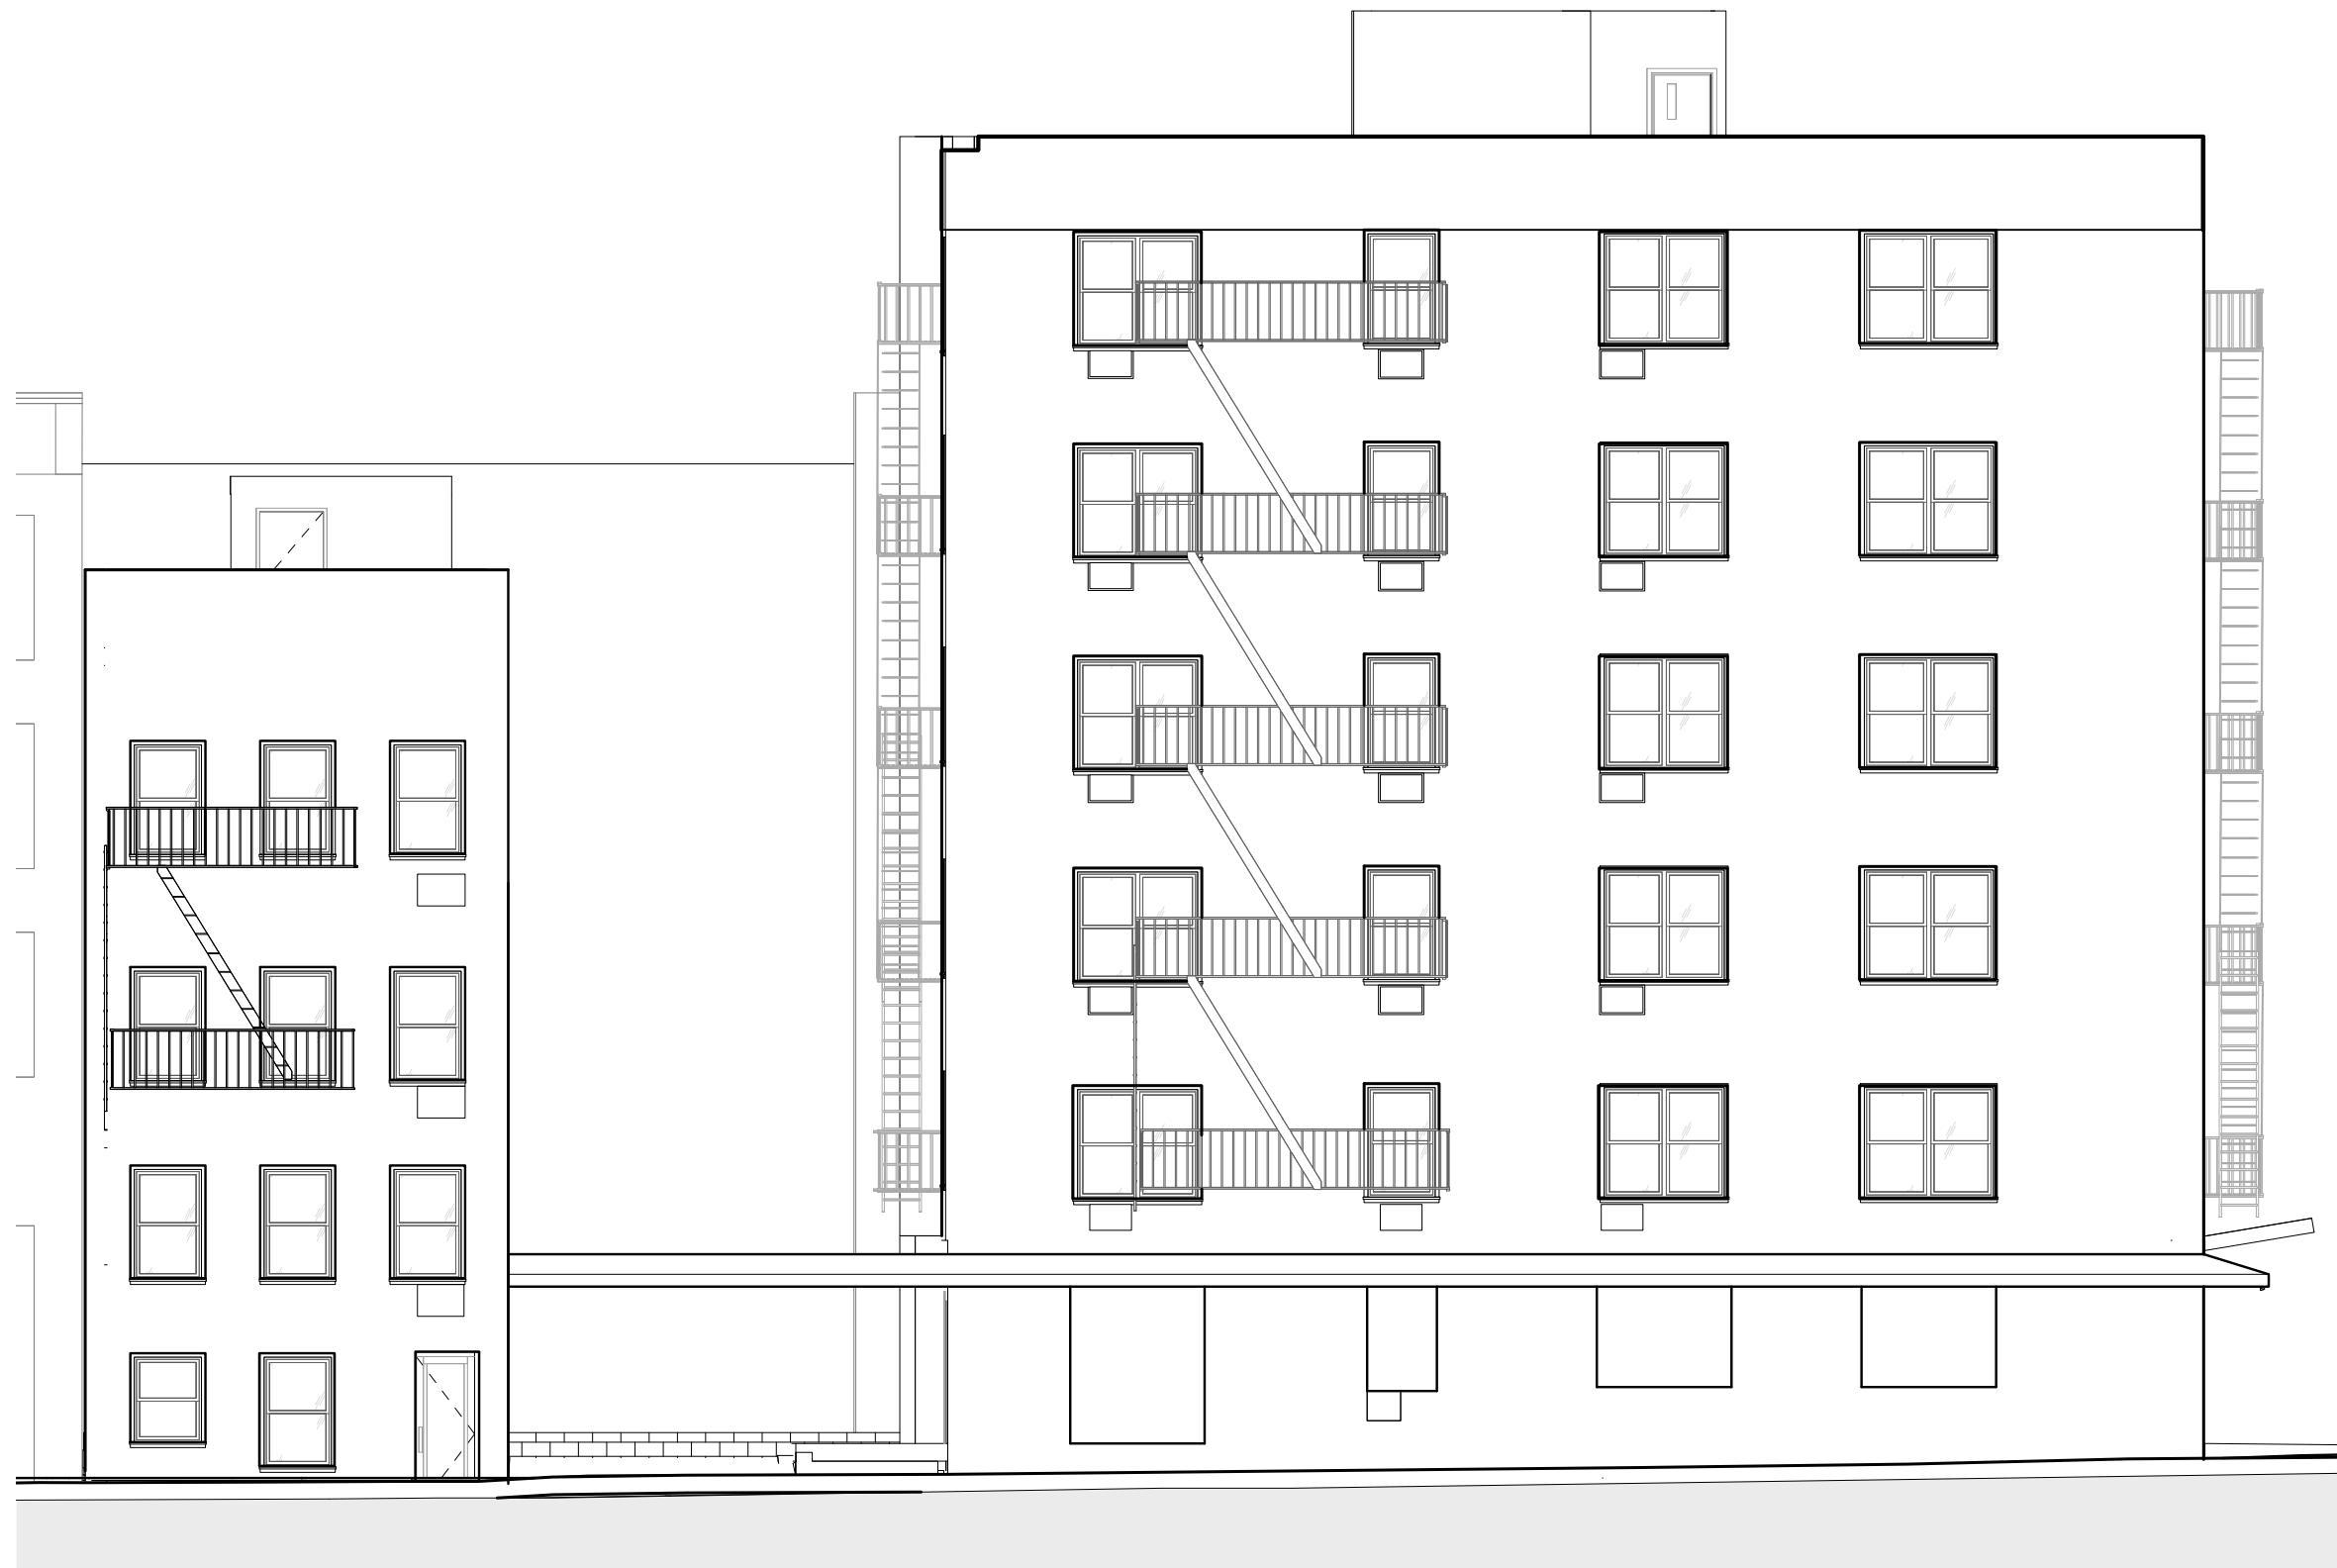
PRINCE STREET ELEVATION- EXISTING

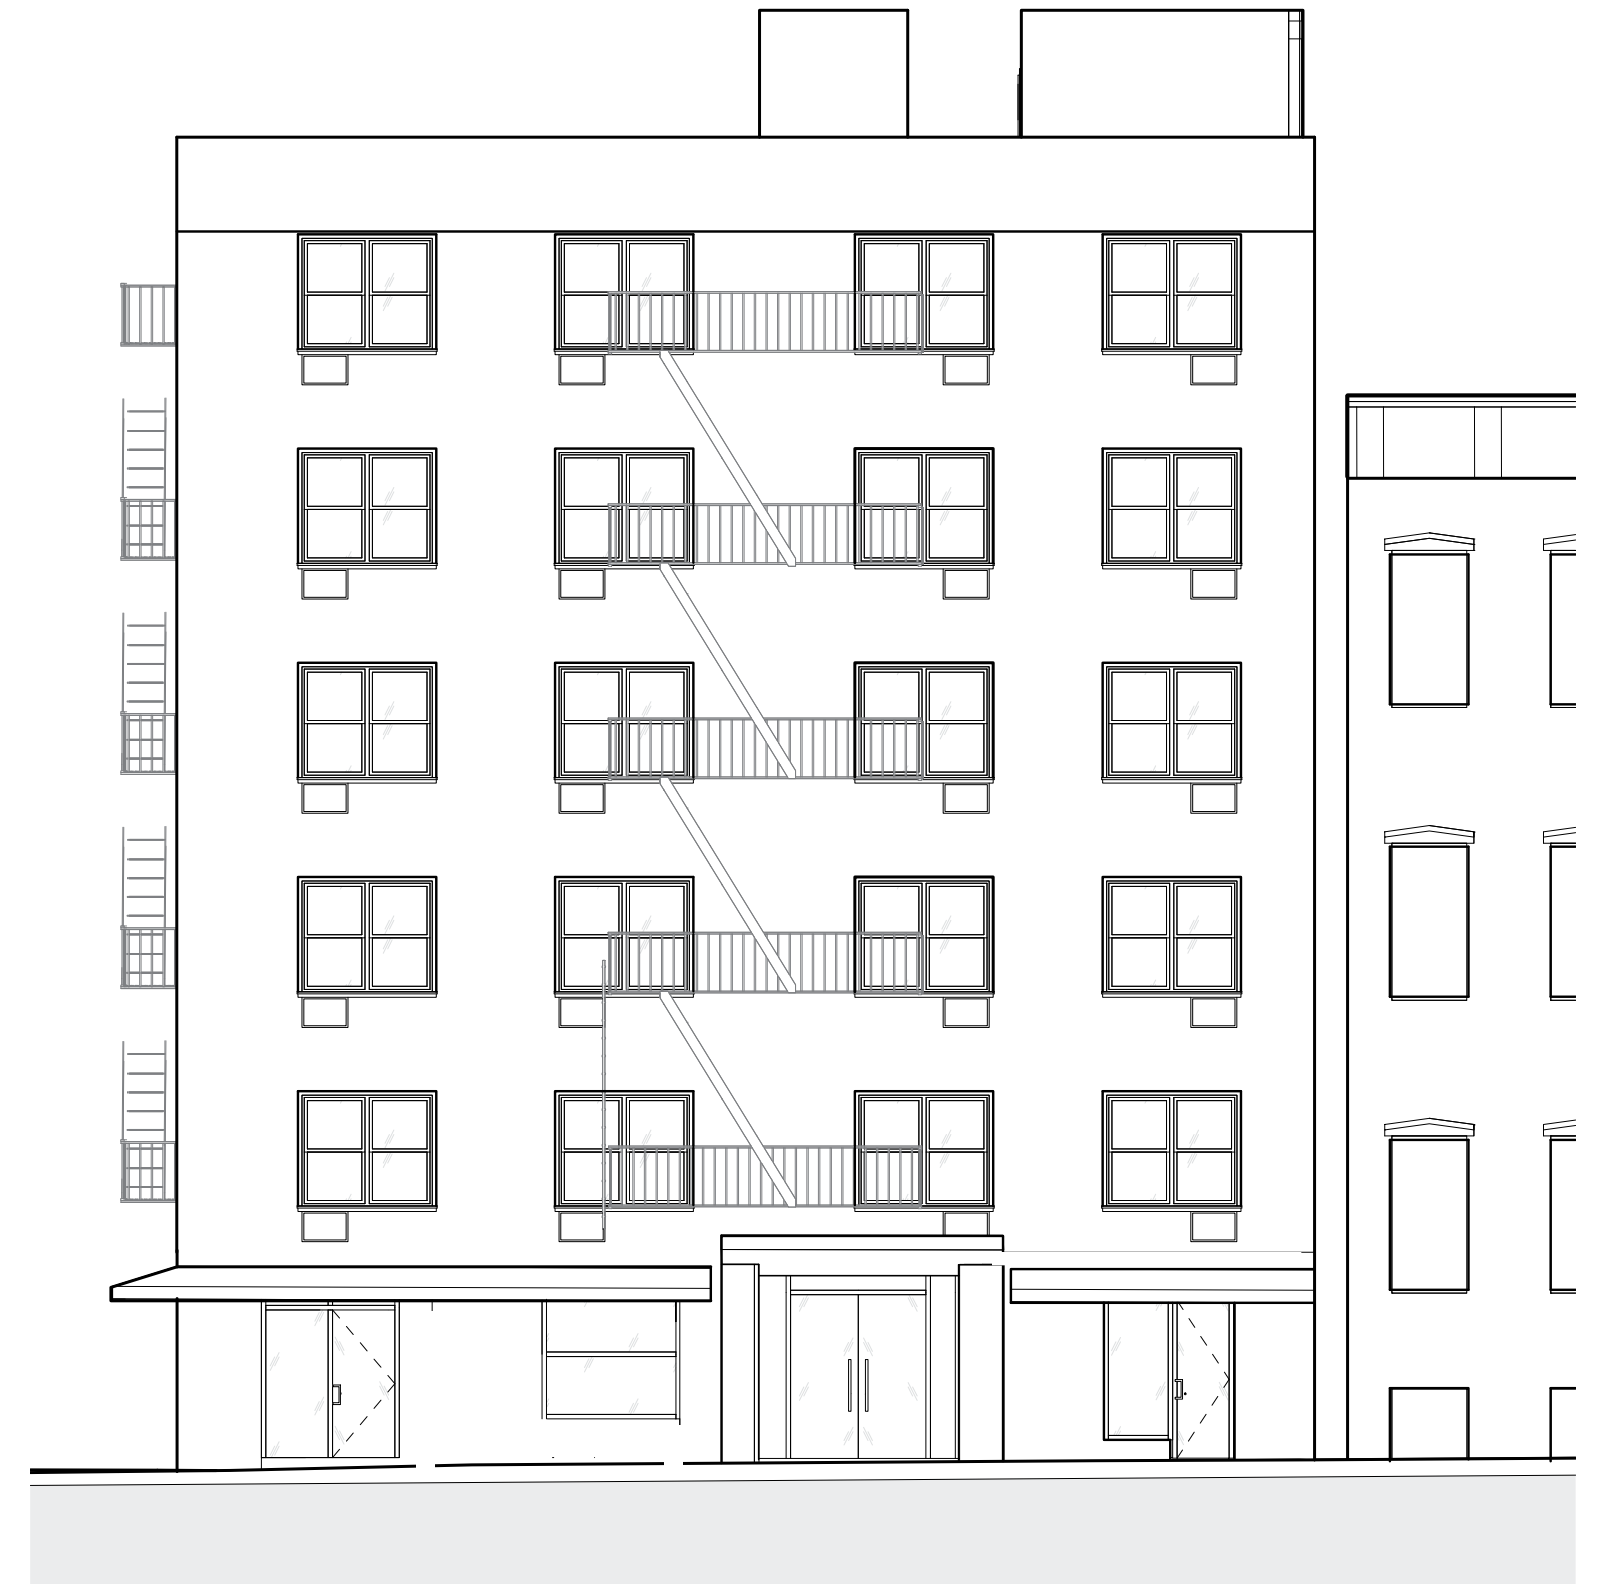
AVE. OF THE AMERICAS ELEVATION - EXISTING

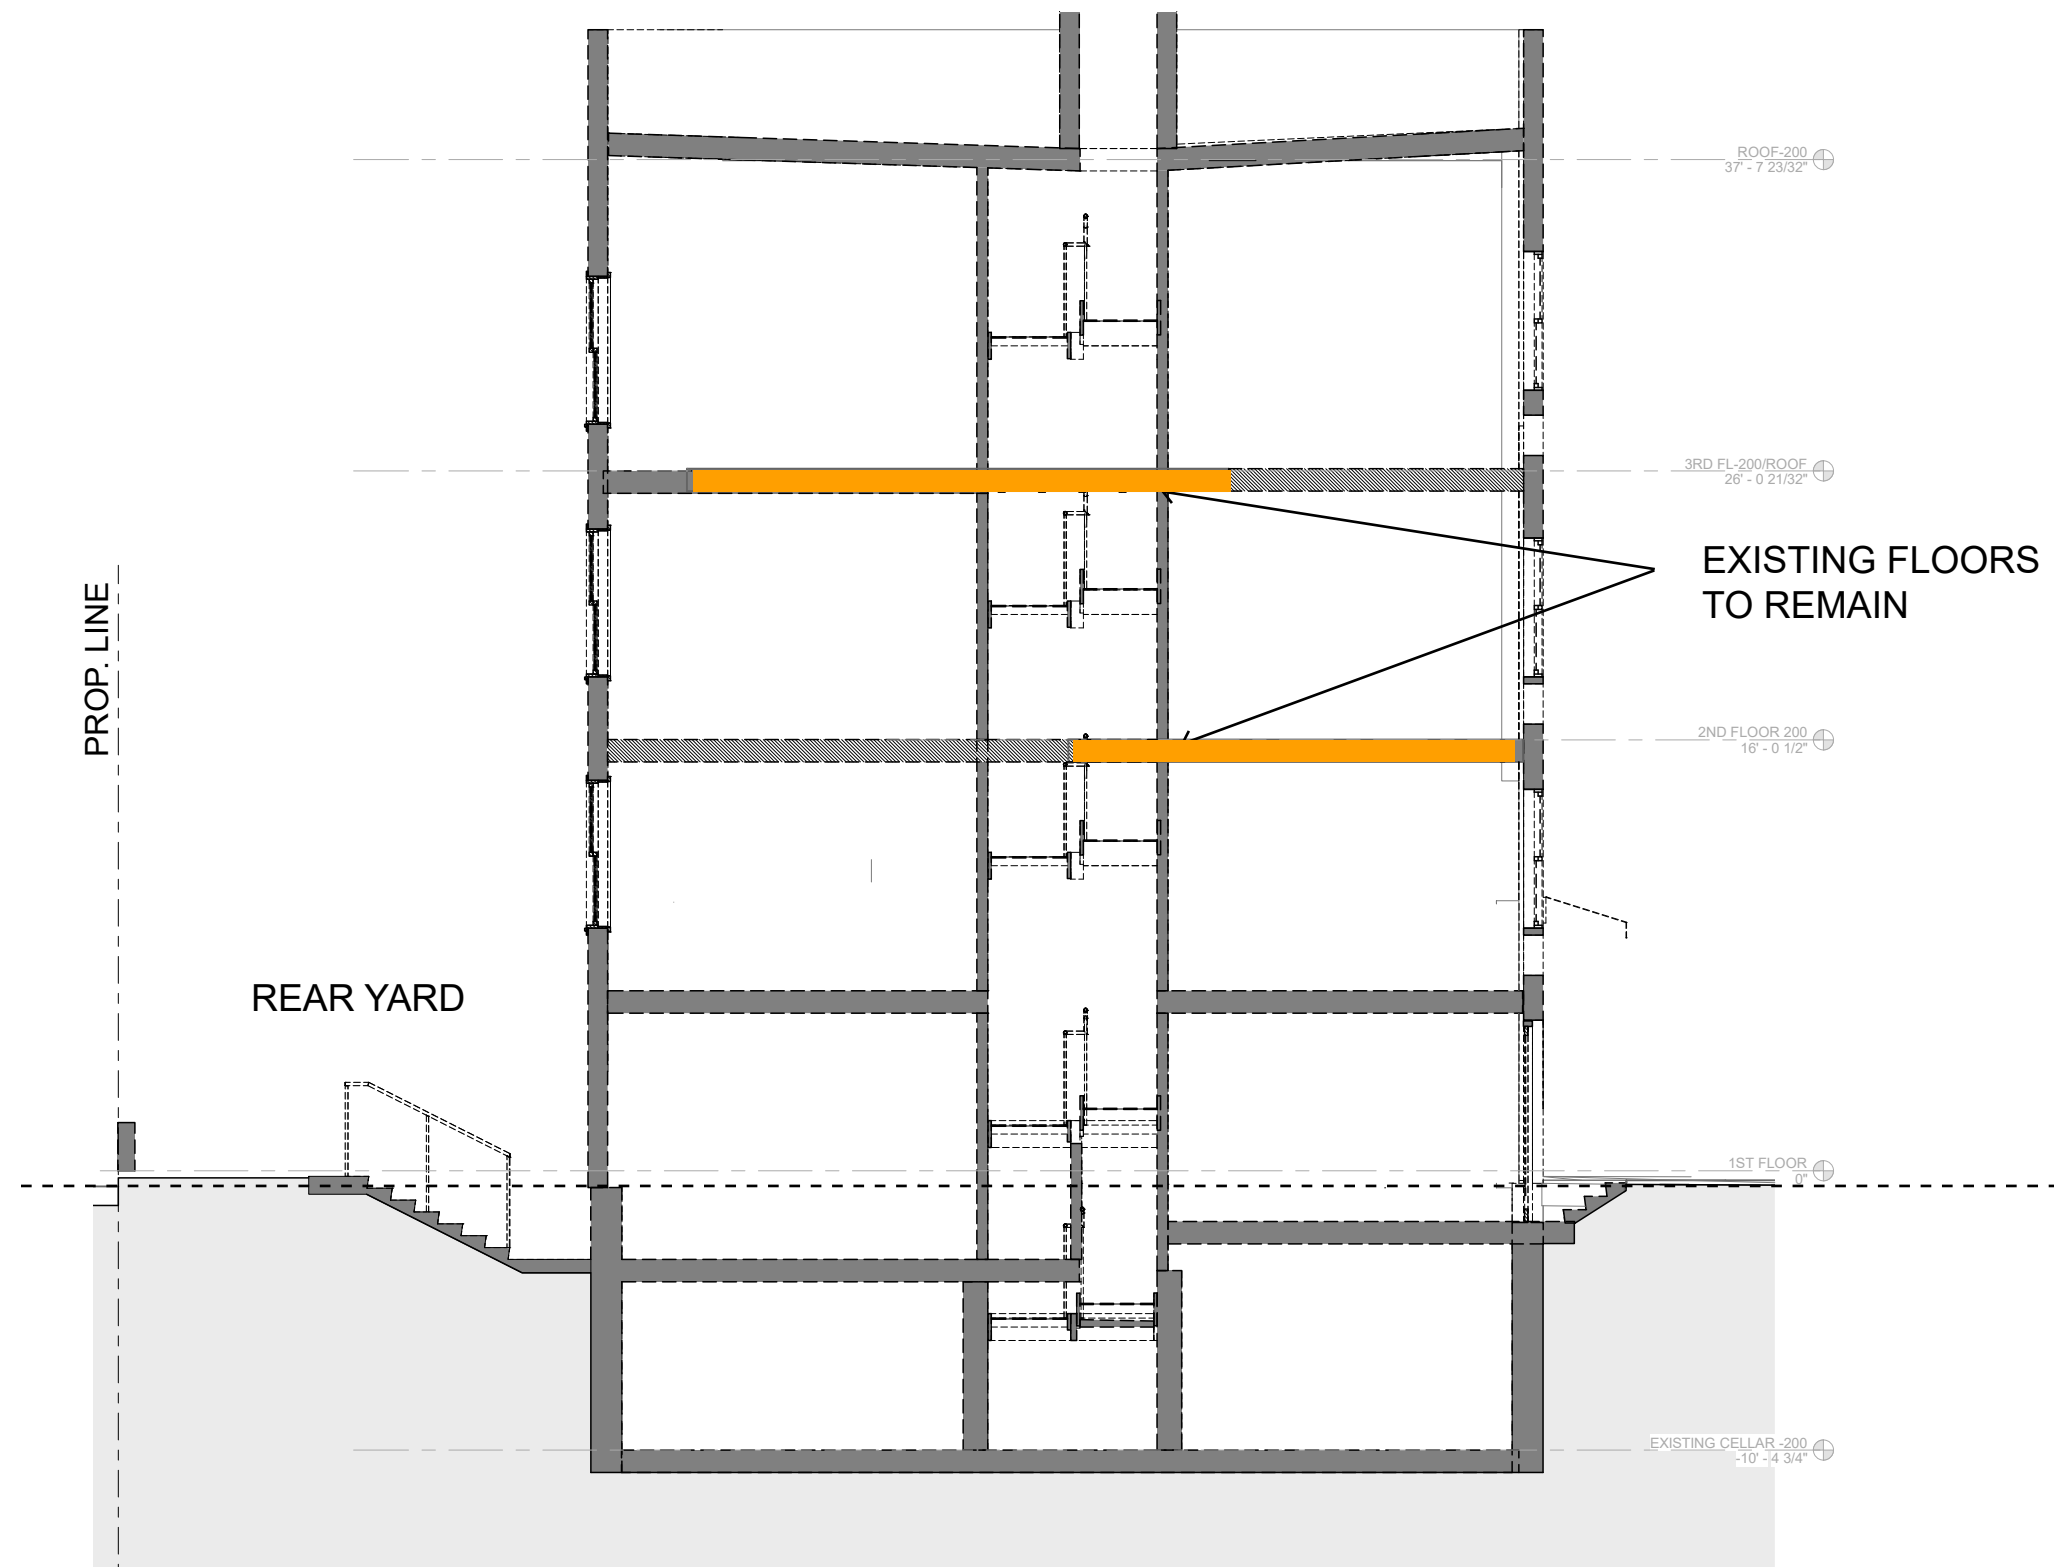
BUILDING SECTION- EXISTING

Since the lot is overbuilt, the bulk of the complex has to be maintained to retain the grandfathering of the built square footage, specifically, since the Sixth Avenue building maintains its massing, a minimum of 25% of the existing floor plates have to be maintained. The task is further complicated by the fact that the current basement level is approximately 36" below grade, so that level could not be maintained due to accessibility requirements.
