200 PRINCE STREET AND 202 AVE. OF THE AMERICAS
NEW YORK, NY 10012

LANDMARKS PRESERVATION COMMISSION

12/14/2018

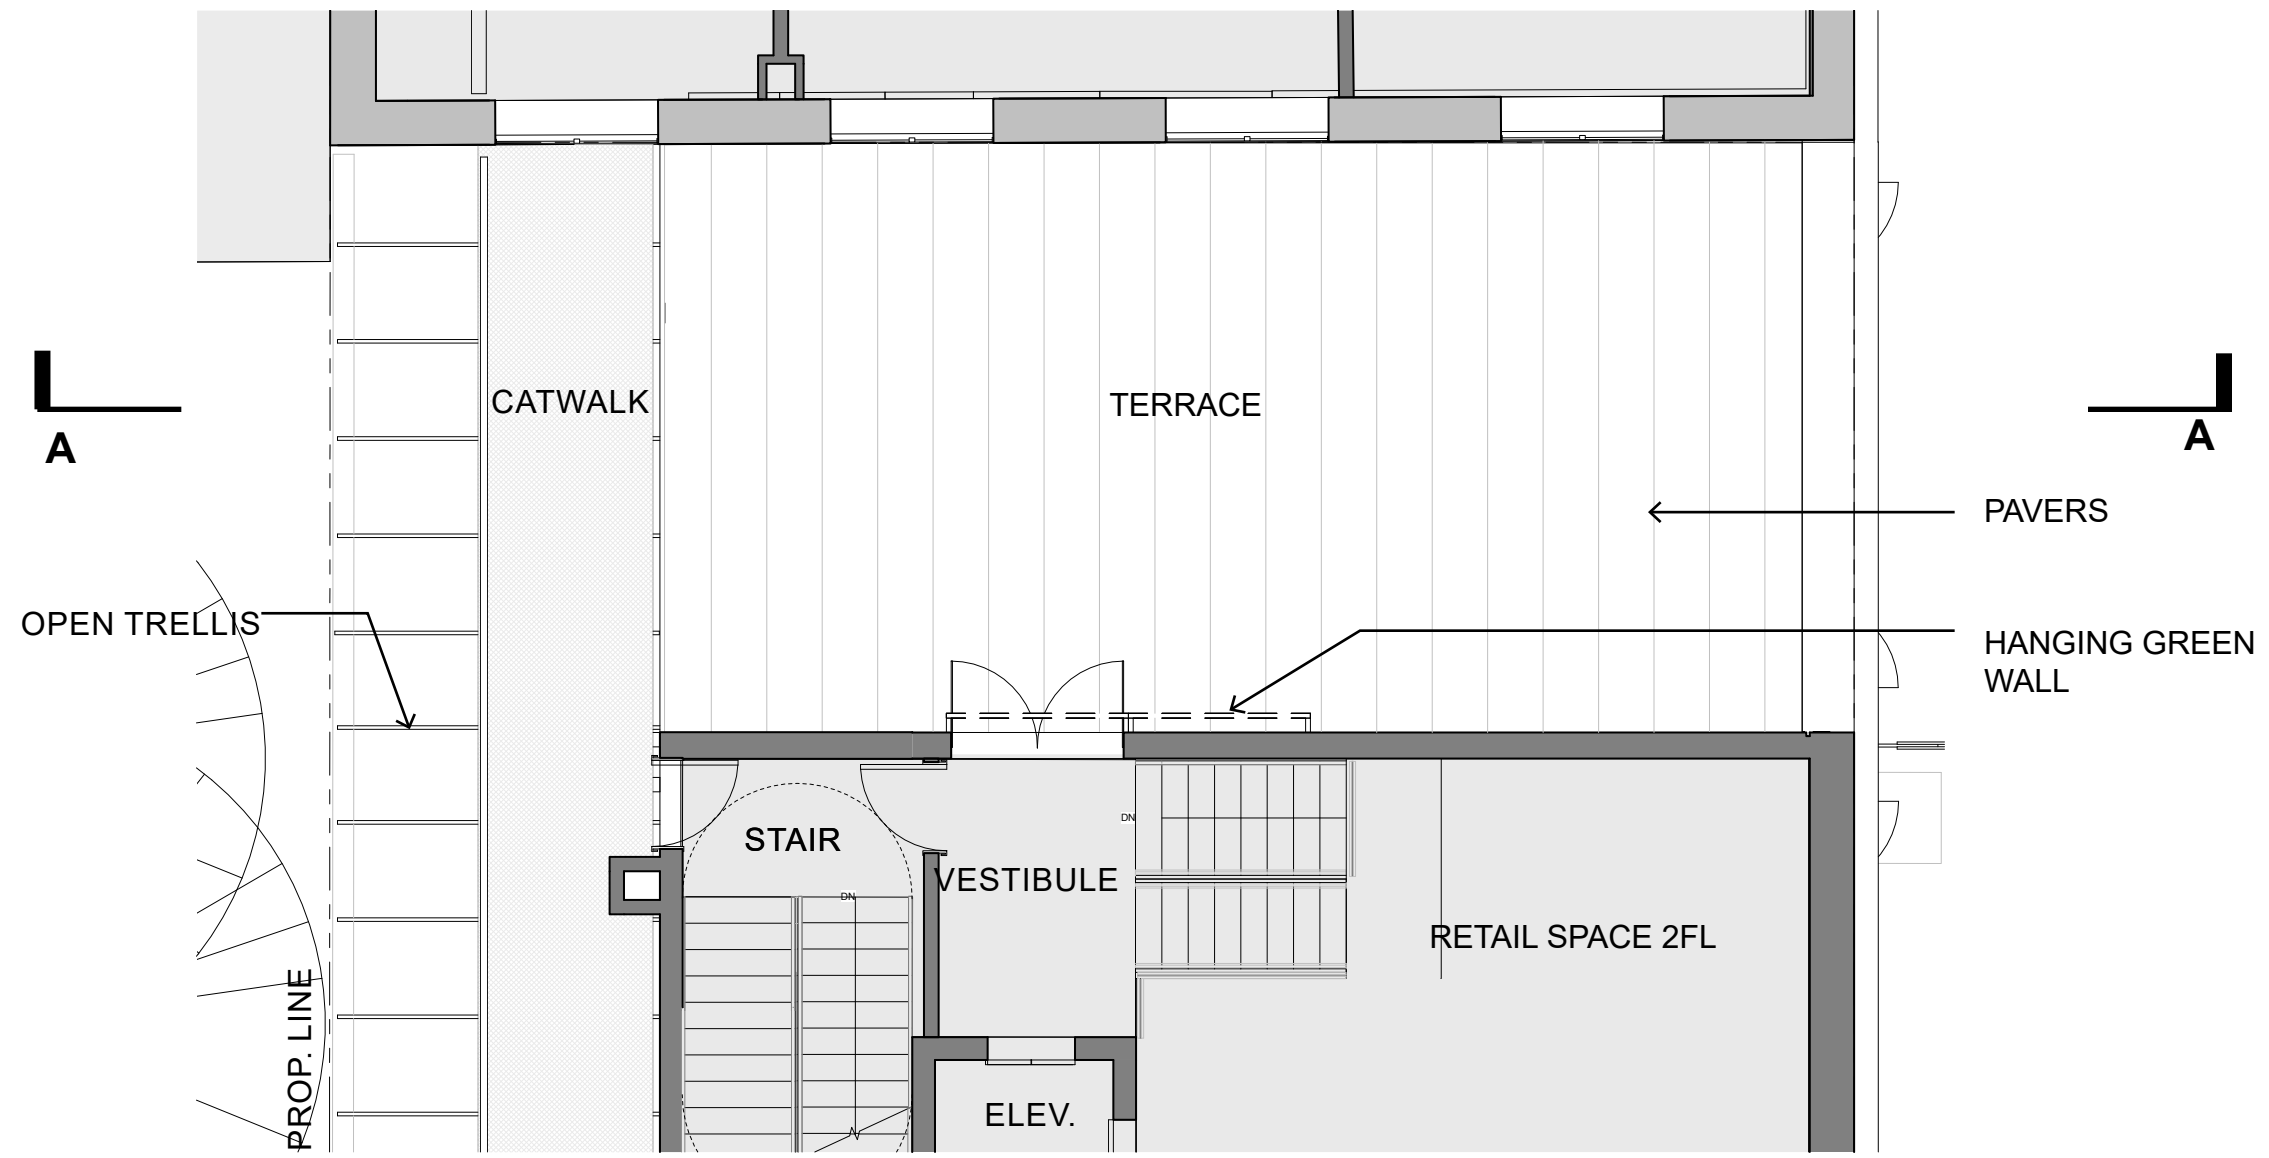
1 - ENLARGED TERRACE PLAN

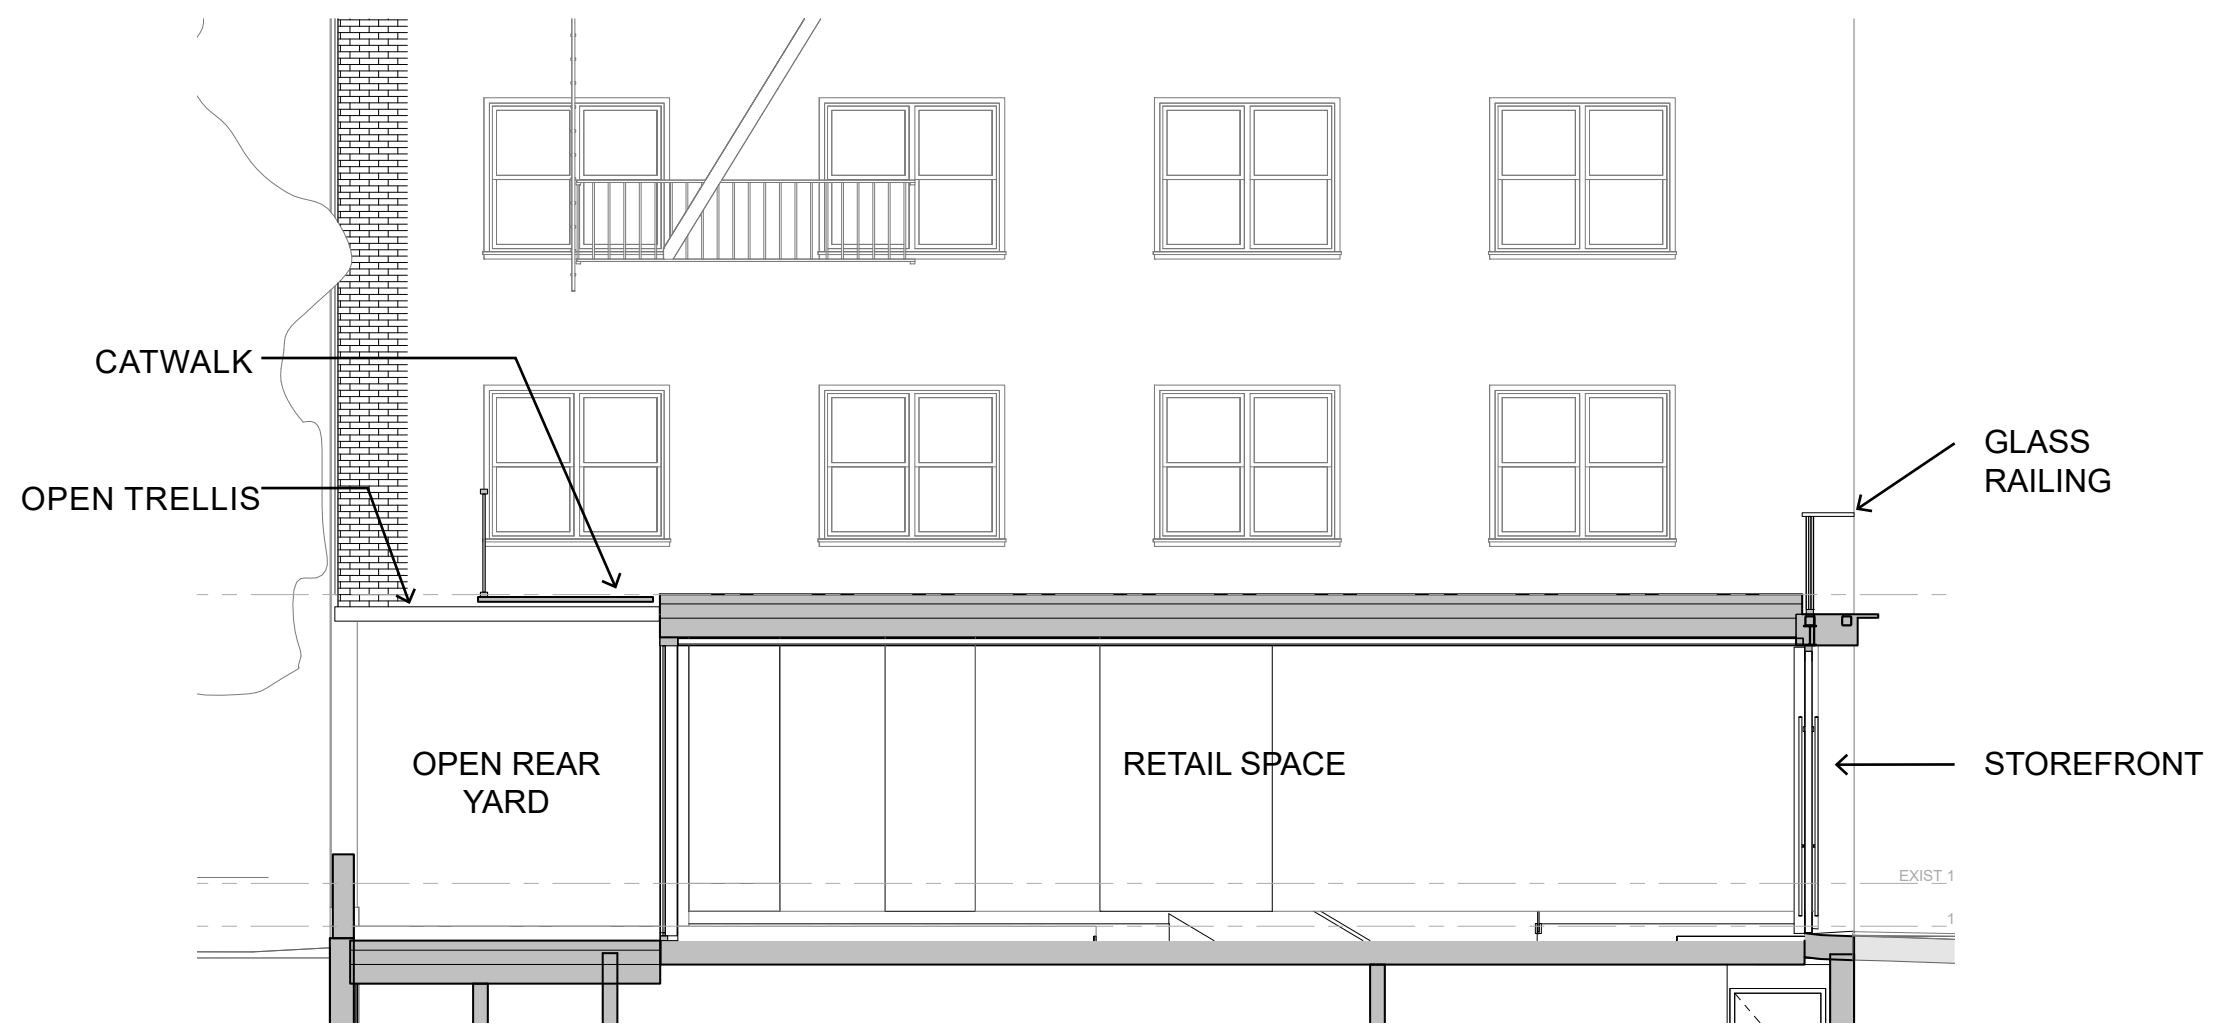
2 - TRANSVERSAL SECTION A

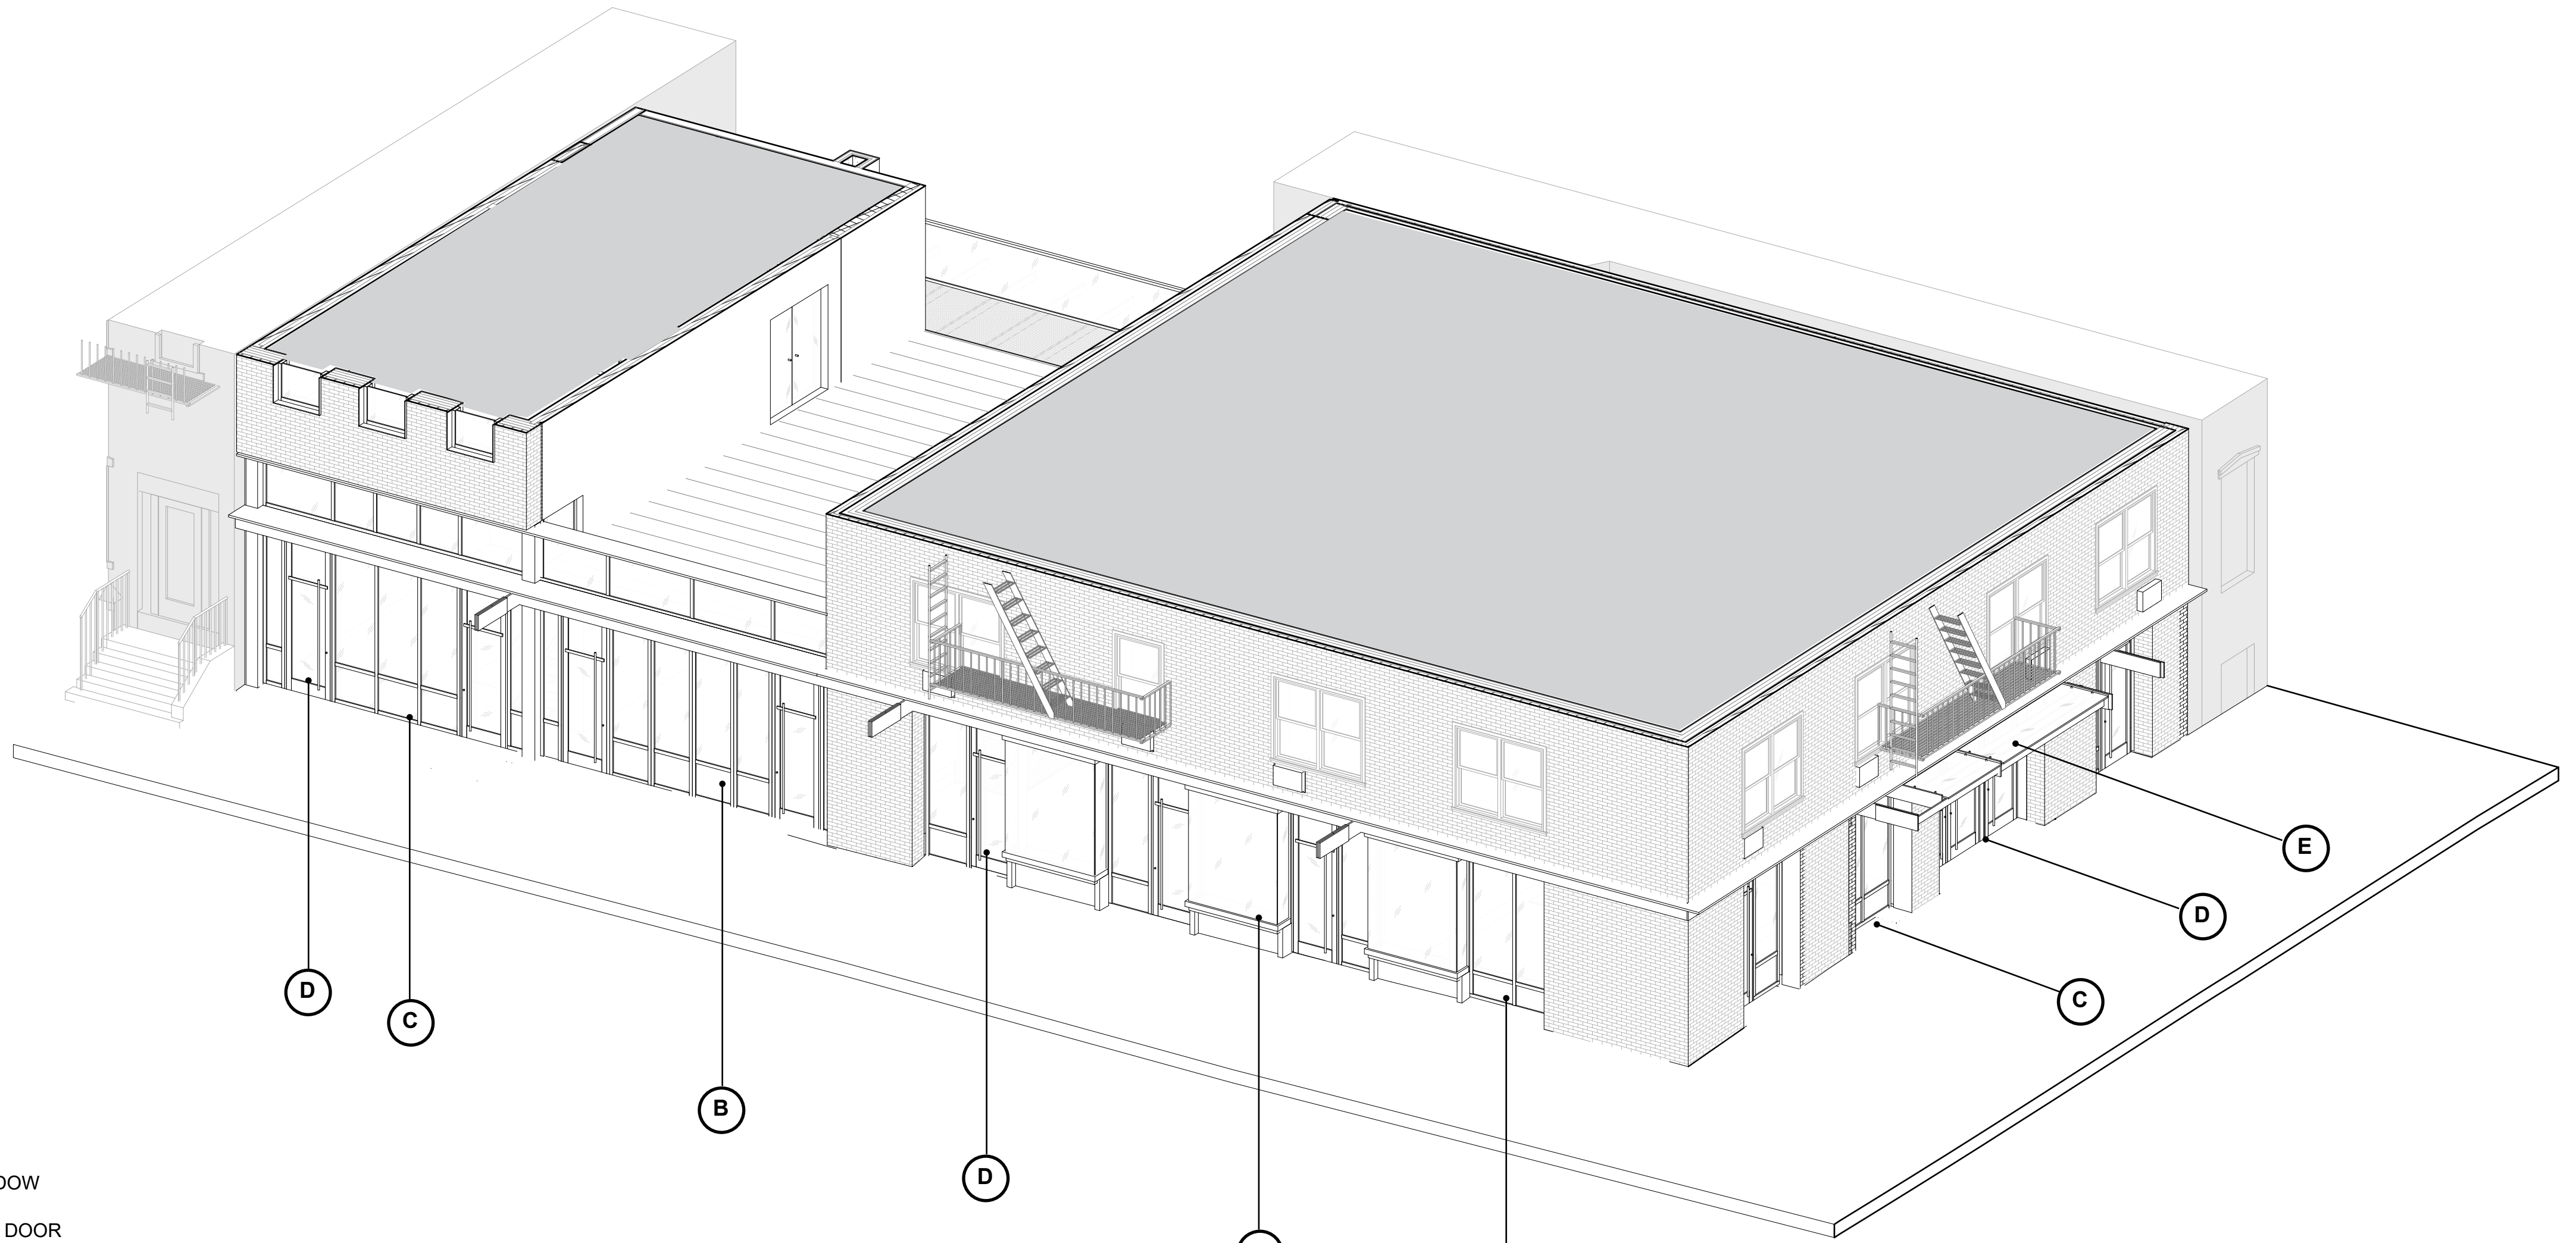
- (A)** BAY WINDOW
- (B)** FOLDING DOOR
(4X DOOR LEAFS)
- (C)** FIXED GLASS
- (D)** GLASS DOOR WITH METAL HANDLE
- (E)** GLASS AND METAL CANOPY

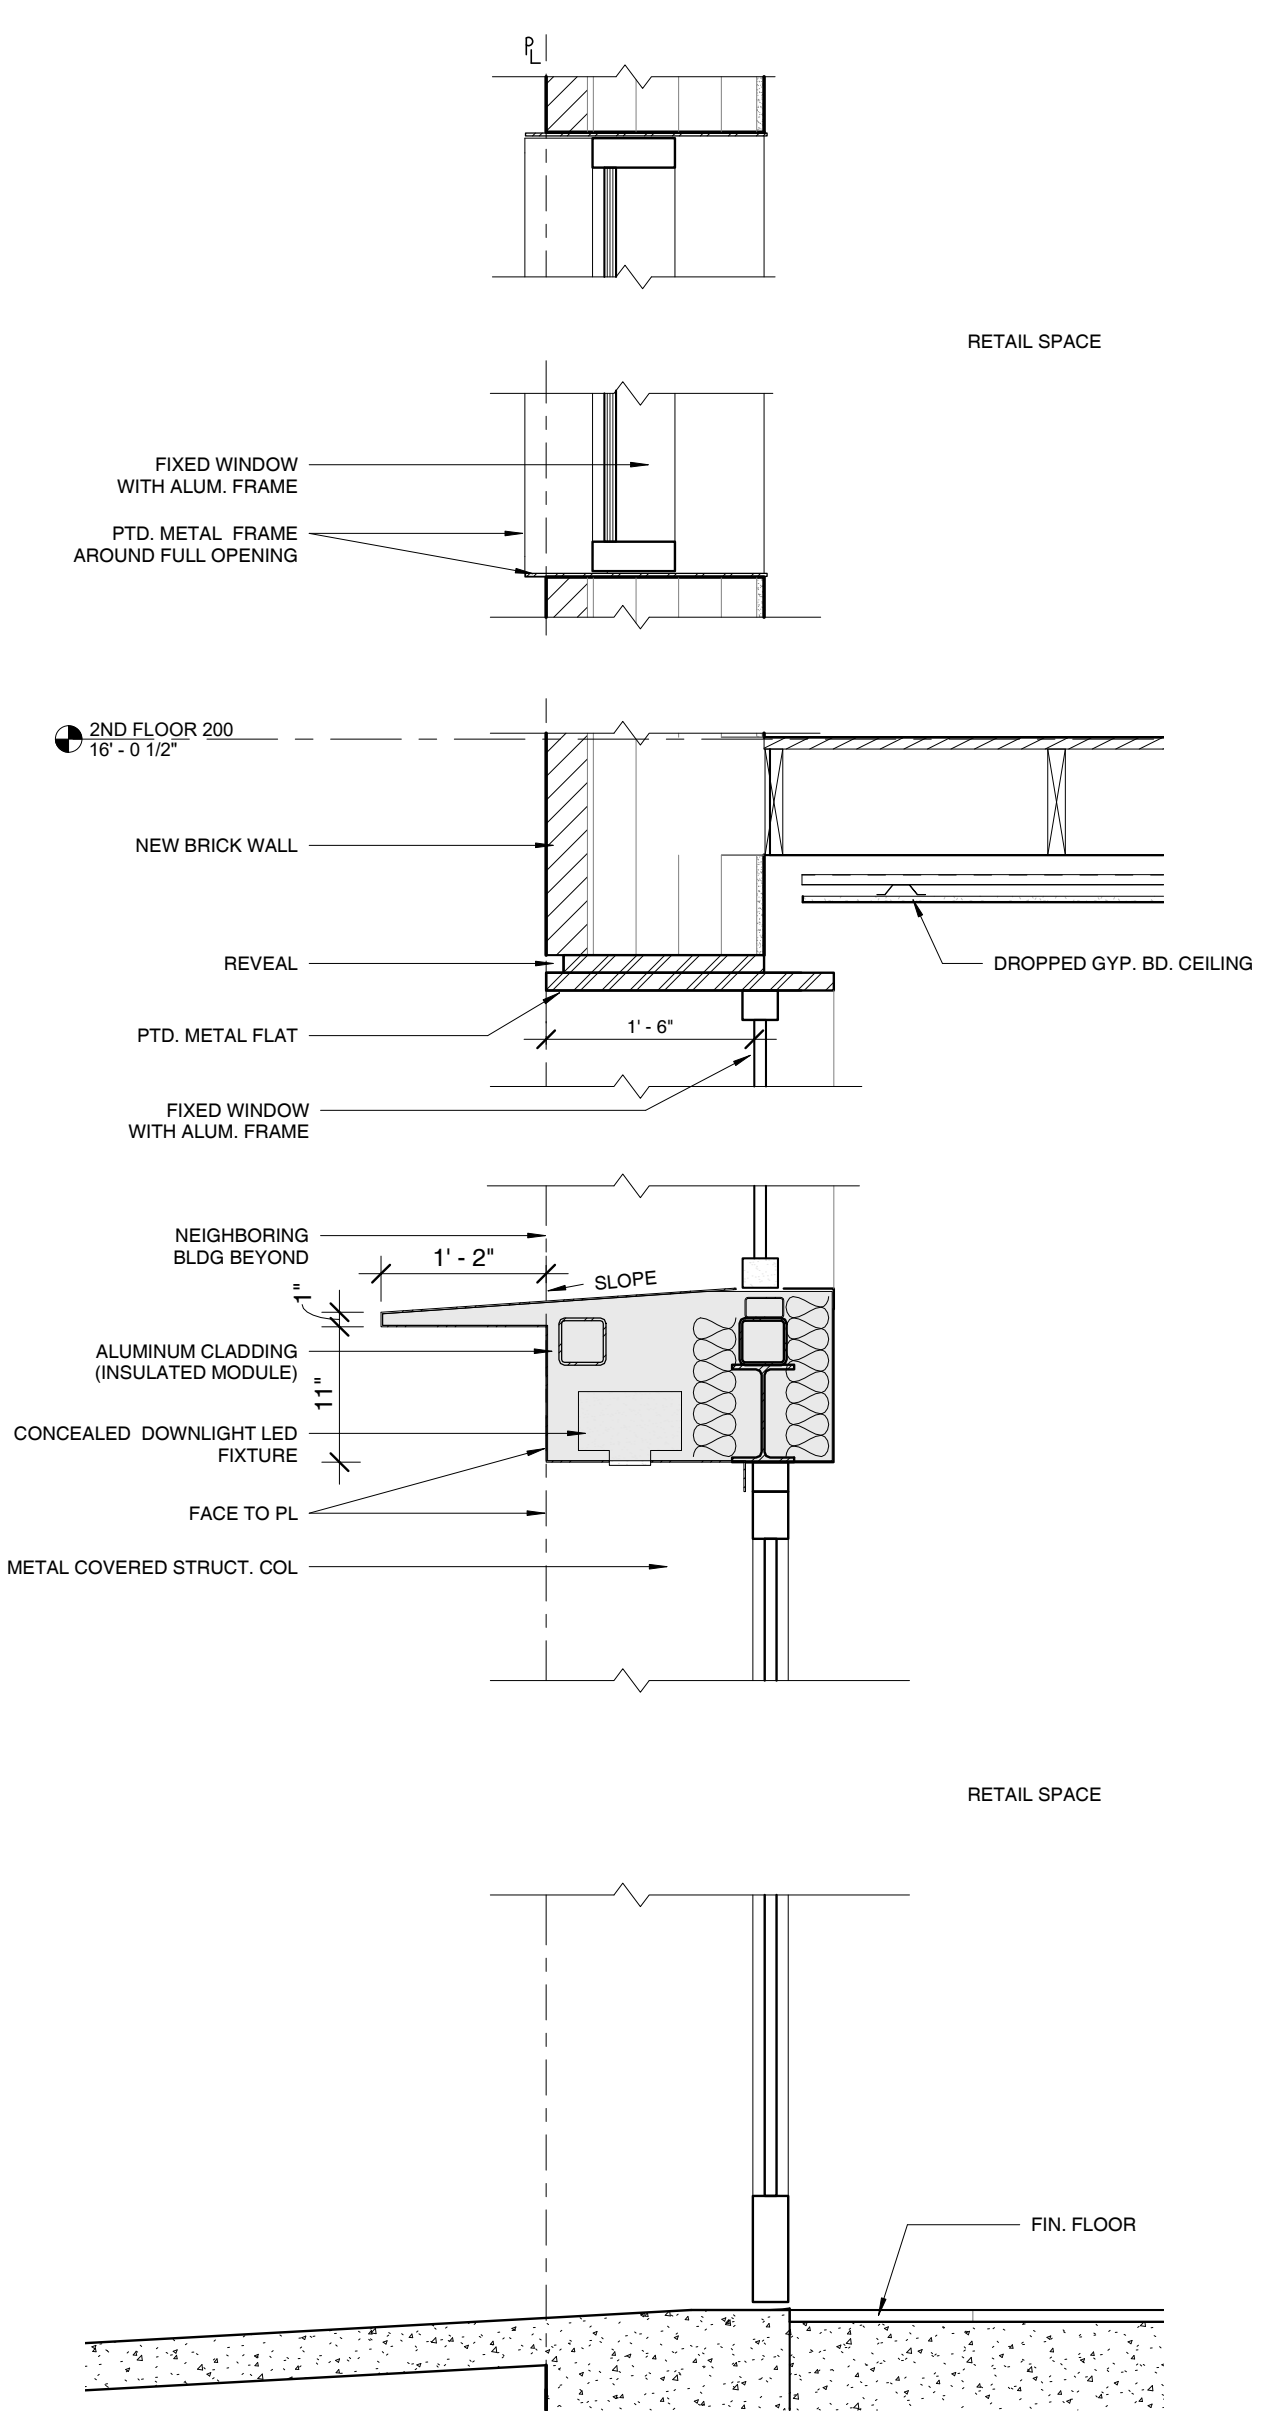
4 PROP. ENTRANCE SECTION 1
SCALE: 1" = 1'-0"

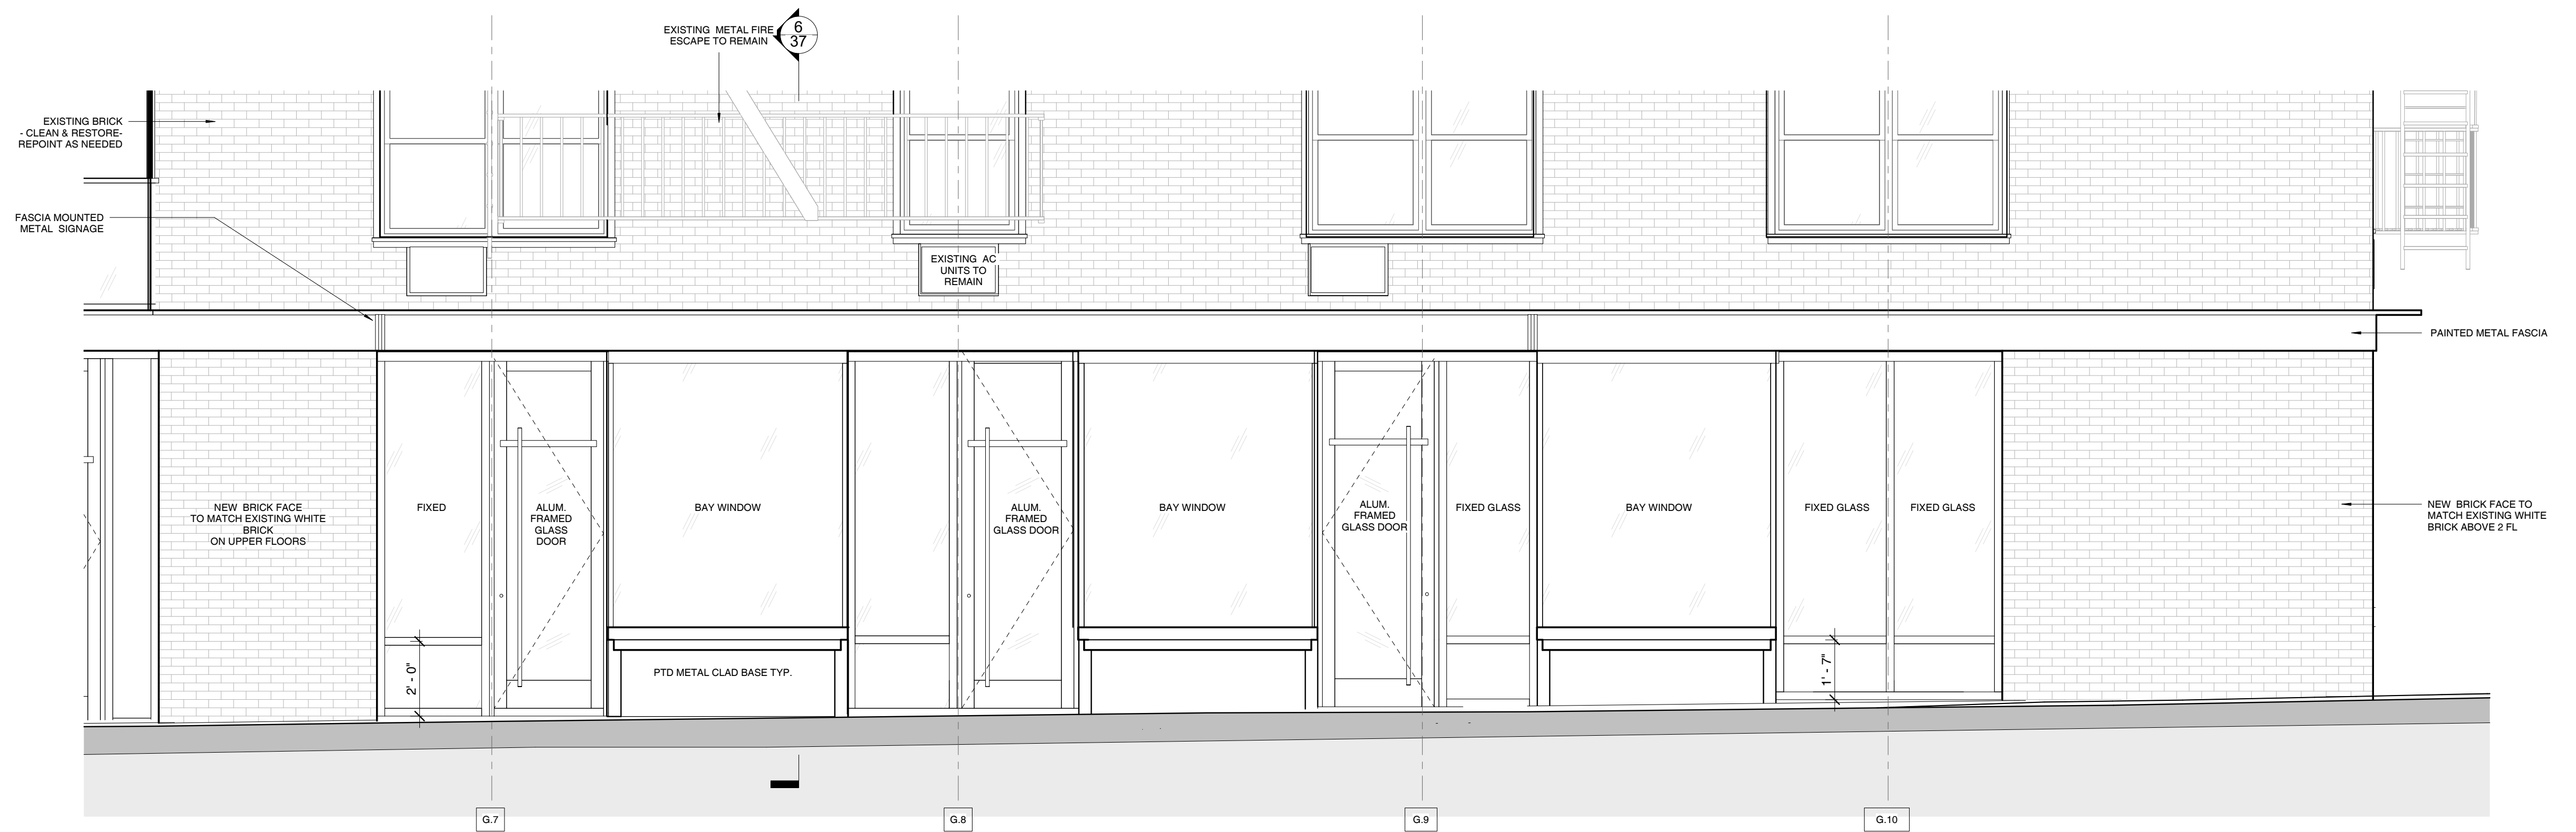
- ① RESTORED BRICK WALL.
CLEAN AND REGROUT AS NEEDED
- ② 1" CLEAR TEMPERED GLASS
- ③ PAINTED ALUMINUM DOORS AND
WINDOWS
- ④ BRUSHED STAINLESS STEEL
- ⑤ PAINTED METAL /PANELING/FLASHING
- ⑥ NEW BRICK FACE TO MATCH WHITE BRICK
ON 202 AVE OF THE AMERICAS

1 PROPOSED ENTRANCE- NORTH ENLARGED ELEVATION
SCALE: 1/2" = 1'-0"

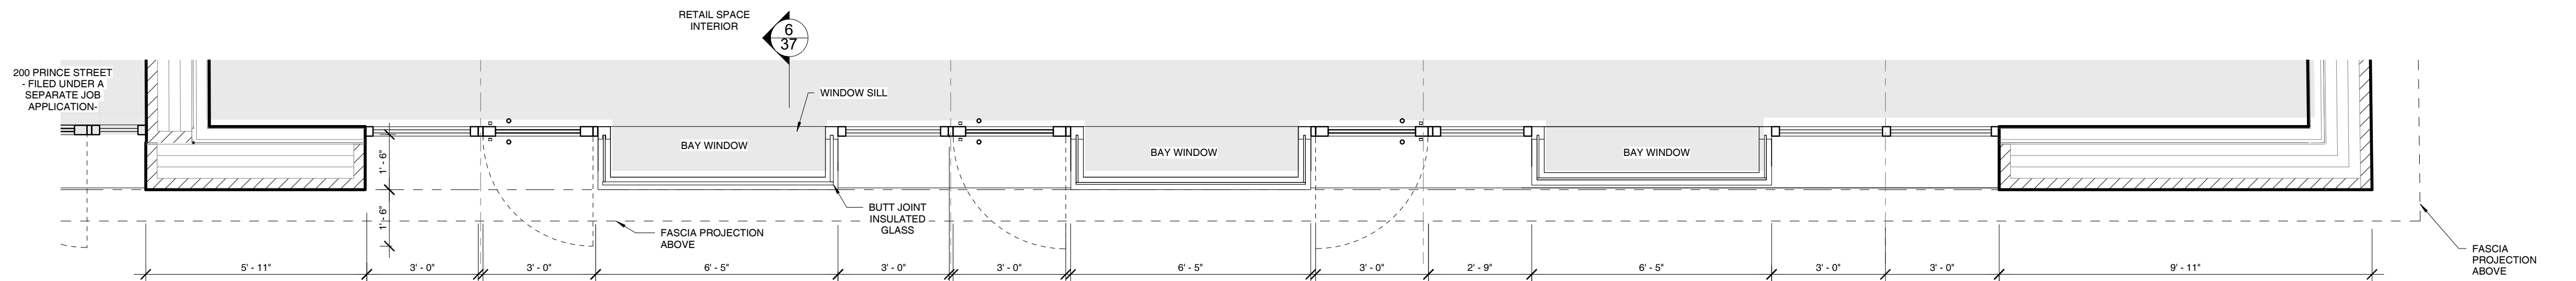
2 PROPOSED ENTRANCE- NORTH ENLARGED PLAN
SCALE: 1/2" = 1'-0"

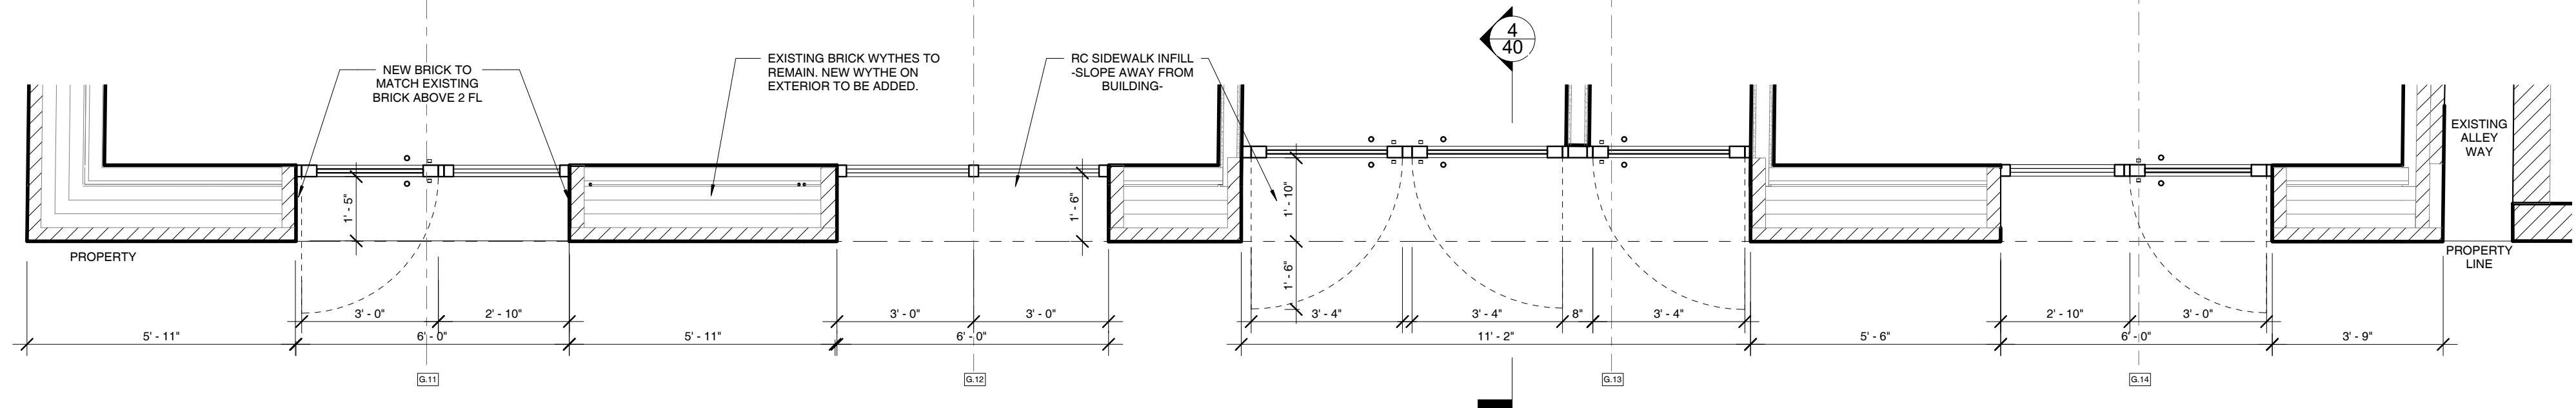
2 PROPOSED ENTRANCE- WEST ENLARGED PLAN
SCALE: 1/2" = 1'-0"

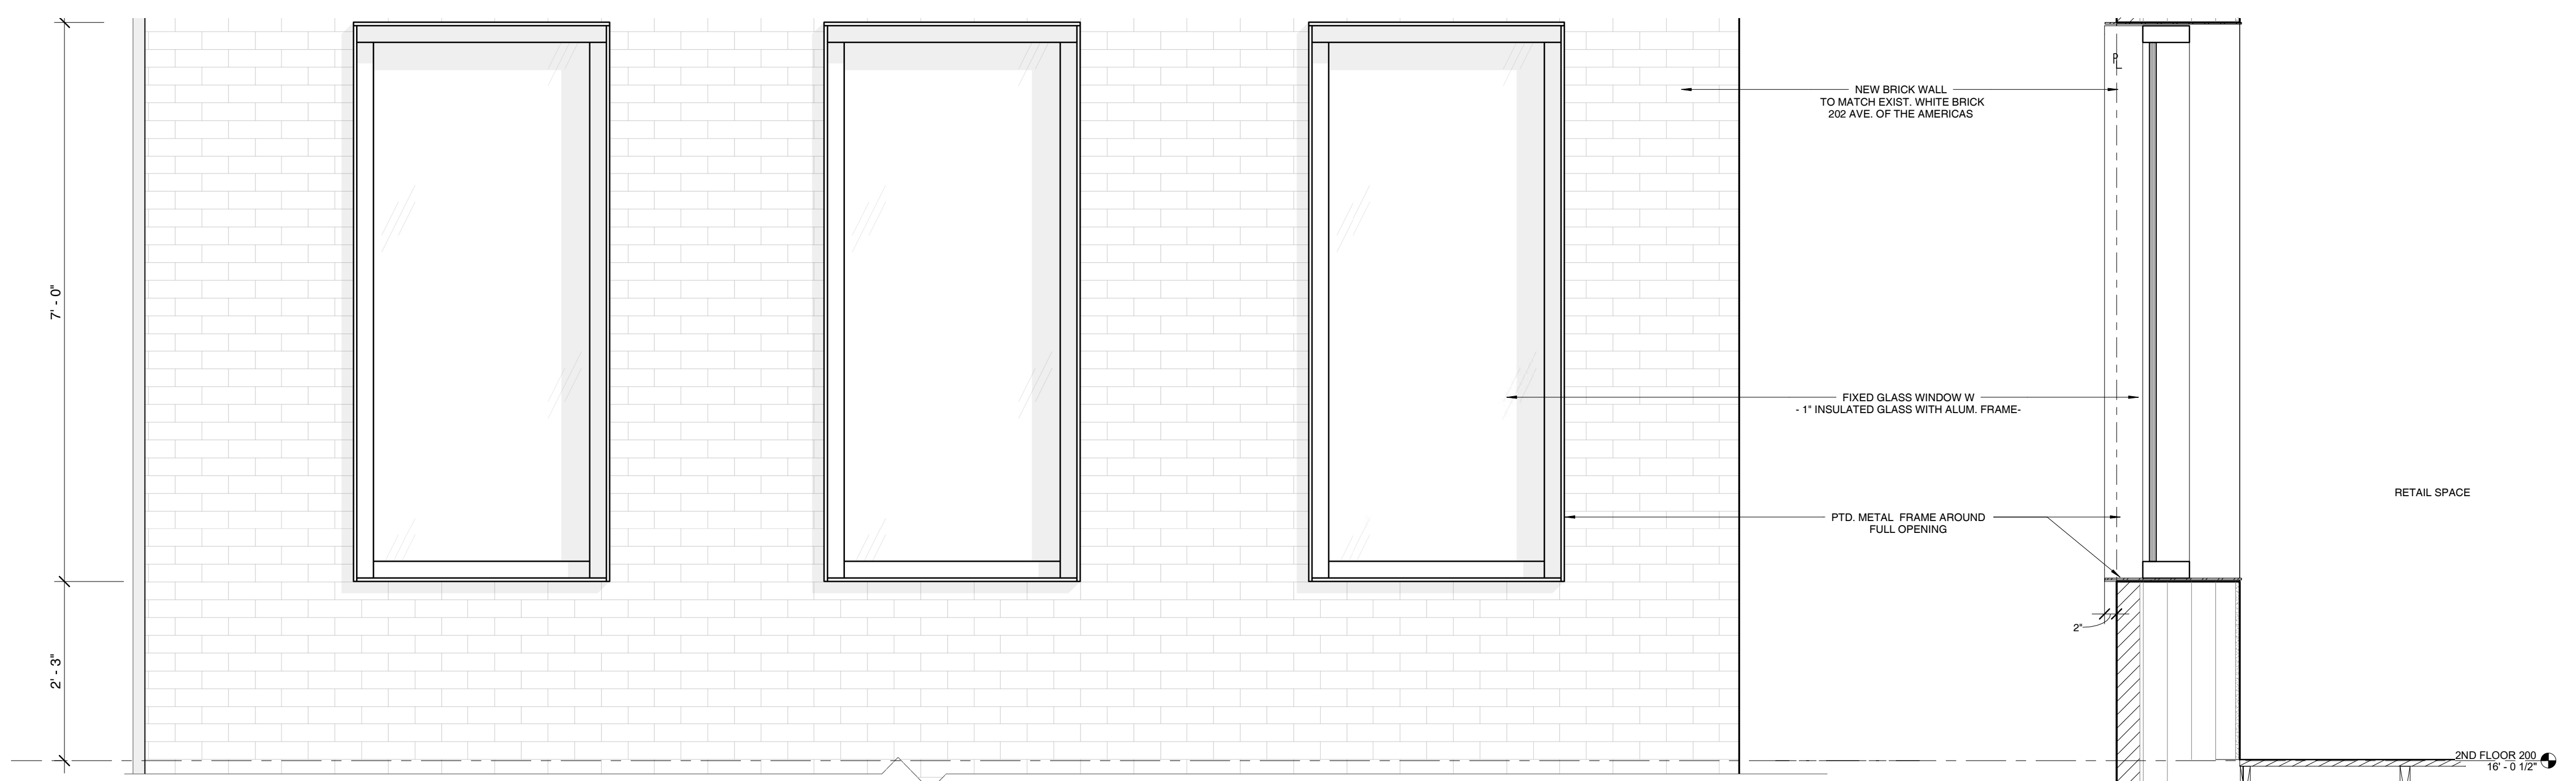
1 FIXED GLASS WINDOWS - ELEVATION
SCALE: 1" = 1'-0"

- MATERIAL KEY:
- ① RESTORED BRICK WALL. CLEAN AND REGROUT AS NEEDED.
 - ② 1" CLEAR TEMPERED GLASS
 - ③ PAINTED ALUMINUM DOORS AND WINDOWS
 - ④ BRUSHED STAINLESS STEEL
 - ⑤ PAINTED METAL/ PANELING/ FLASHING
 - ⑥ NEW BRICK FACE TO MATCH EXISTING BRICK OF 202 AVE. OF THE AMERICAS

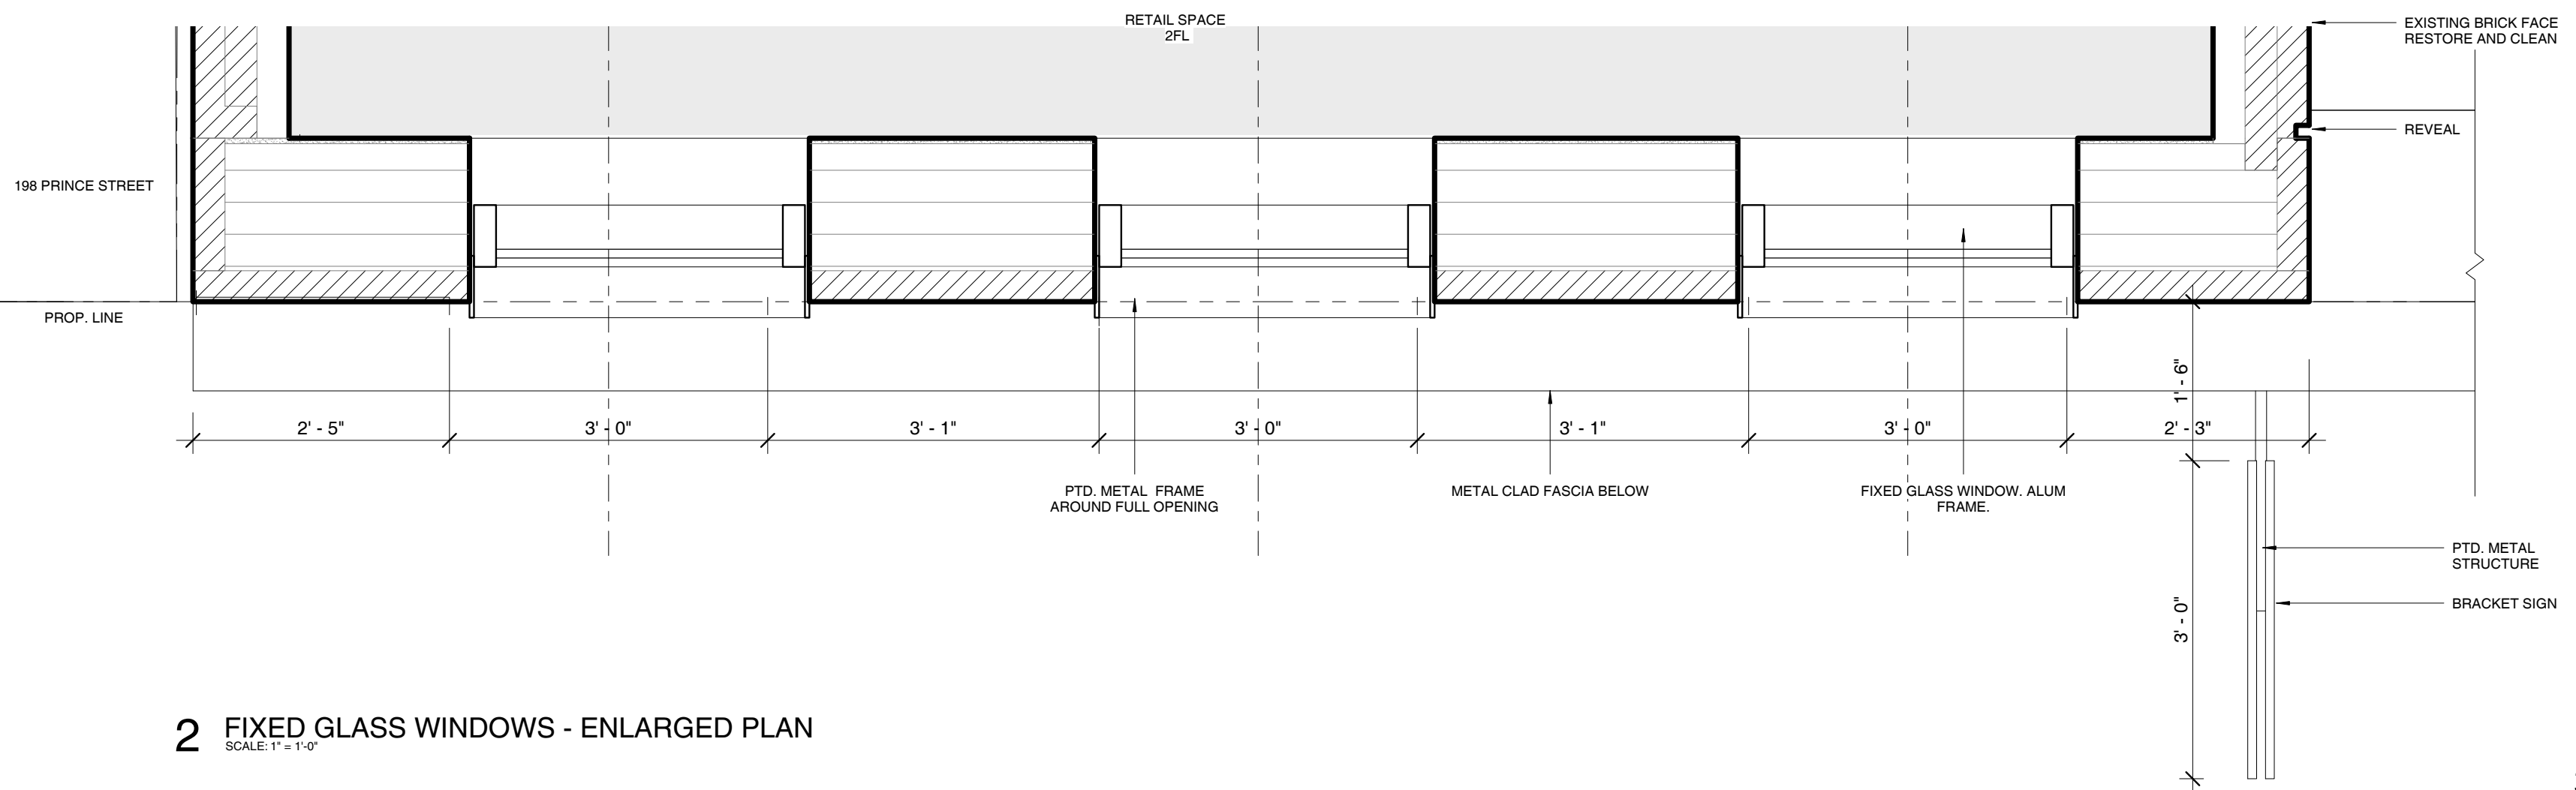
2 FIXED GLASS WINDOWS - ENLARGED PLAN
SCALE: 1" = 1'-0"

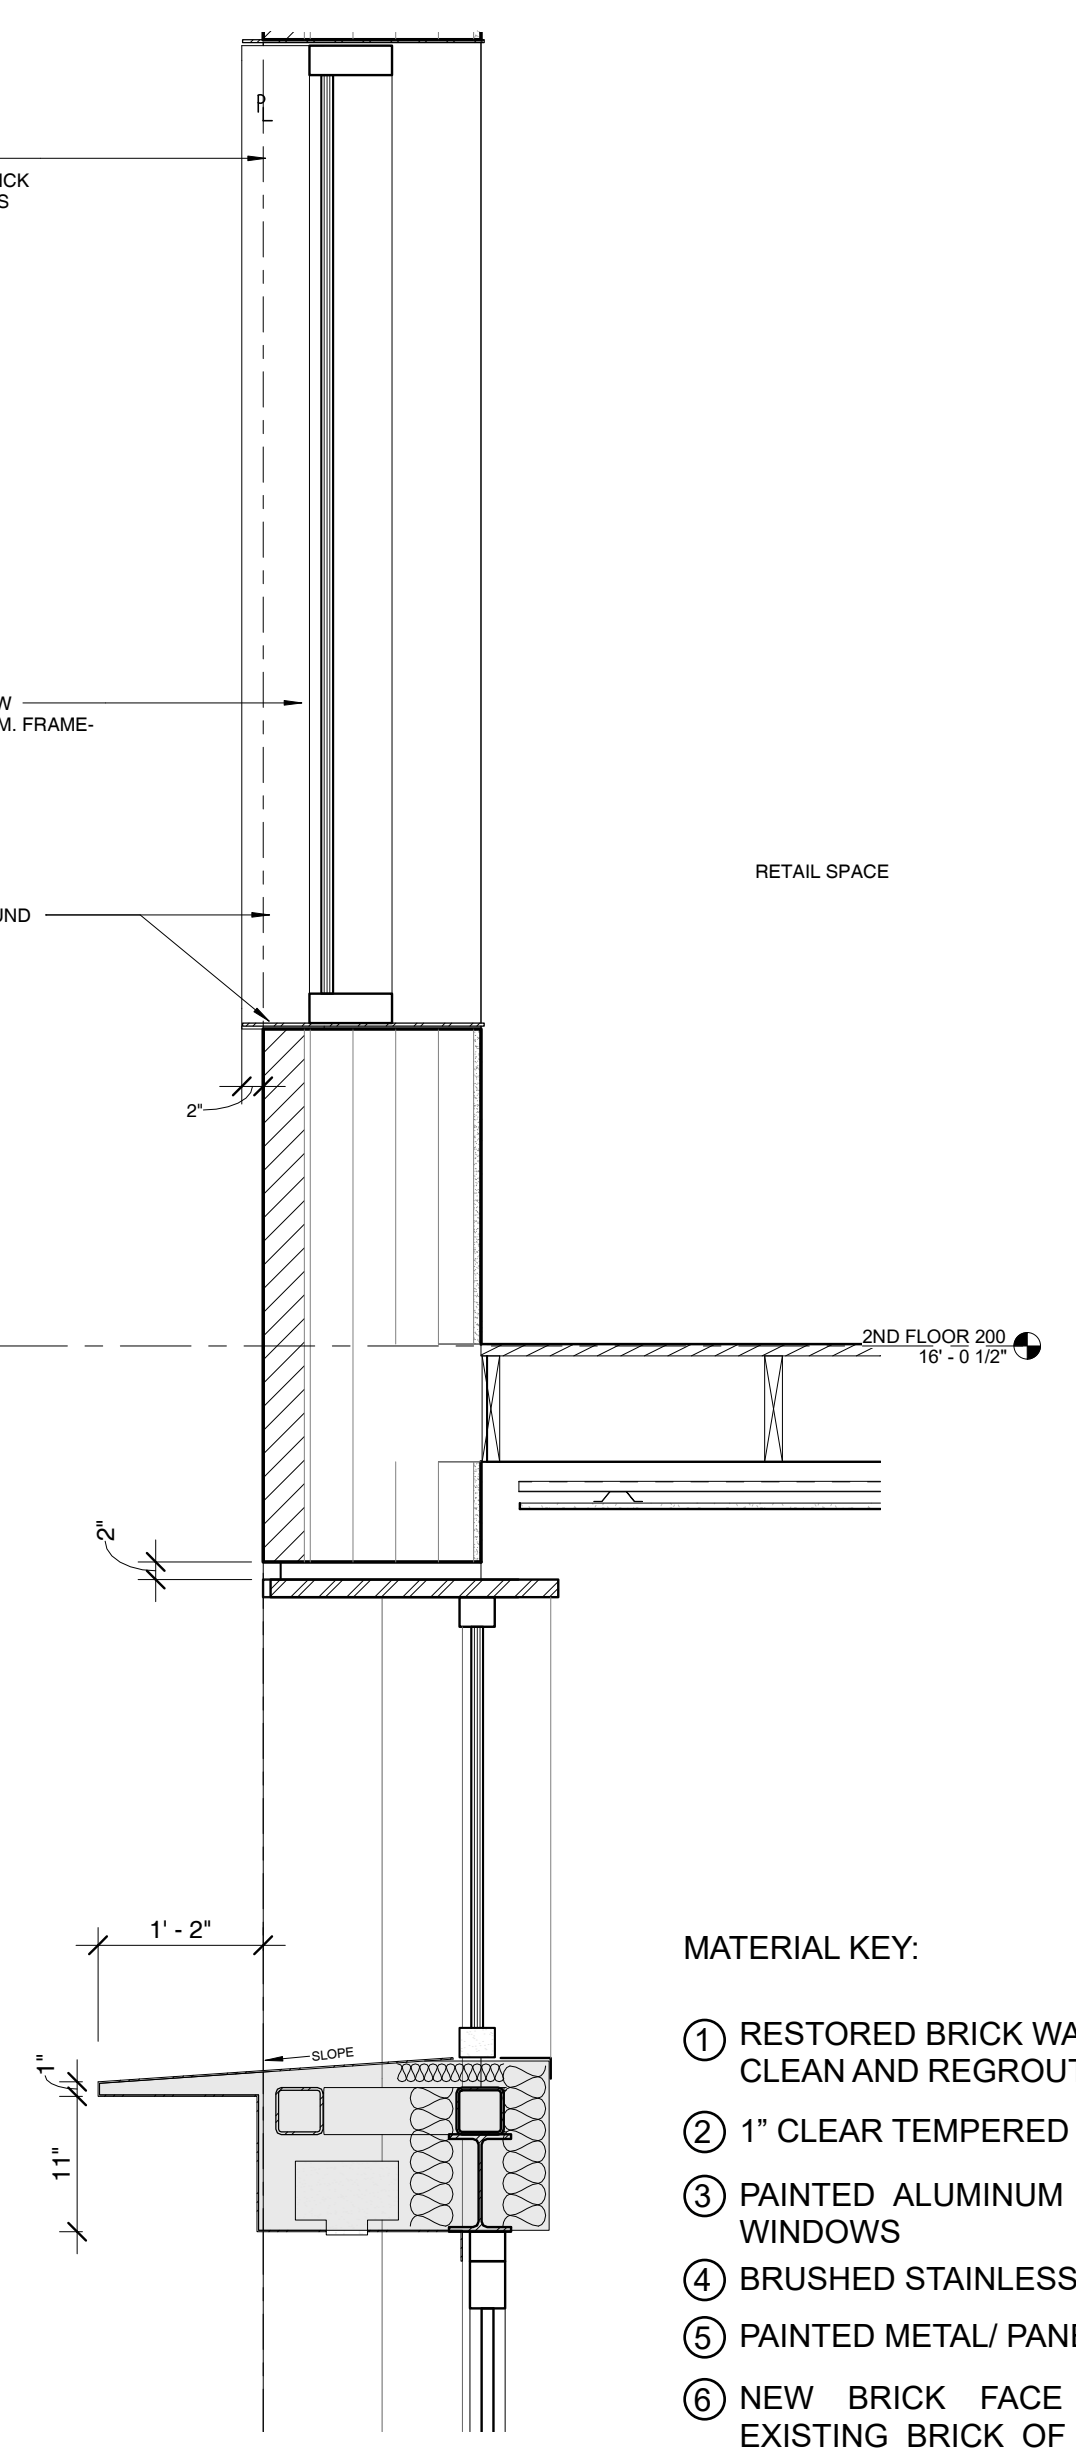
3 FIXED GLASS WINDOWS - SECTION
SCALE: 1" = 1'-0"
