200 PRINCE STREET AND 202 AVE. OF THE AMERICAS
NEW YORK, NY 10012

LANDMARKS PRESERVATION COMMISSION

12/14/2018

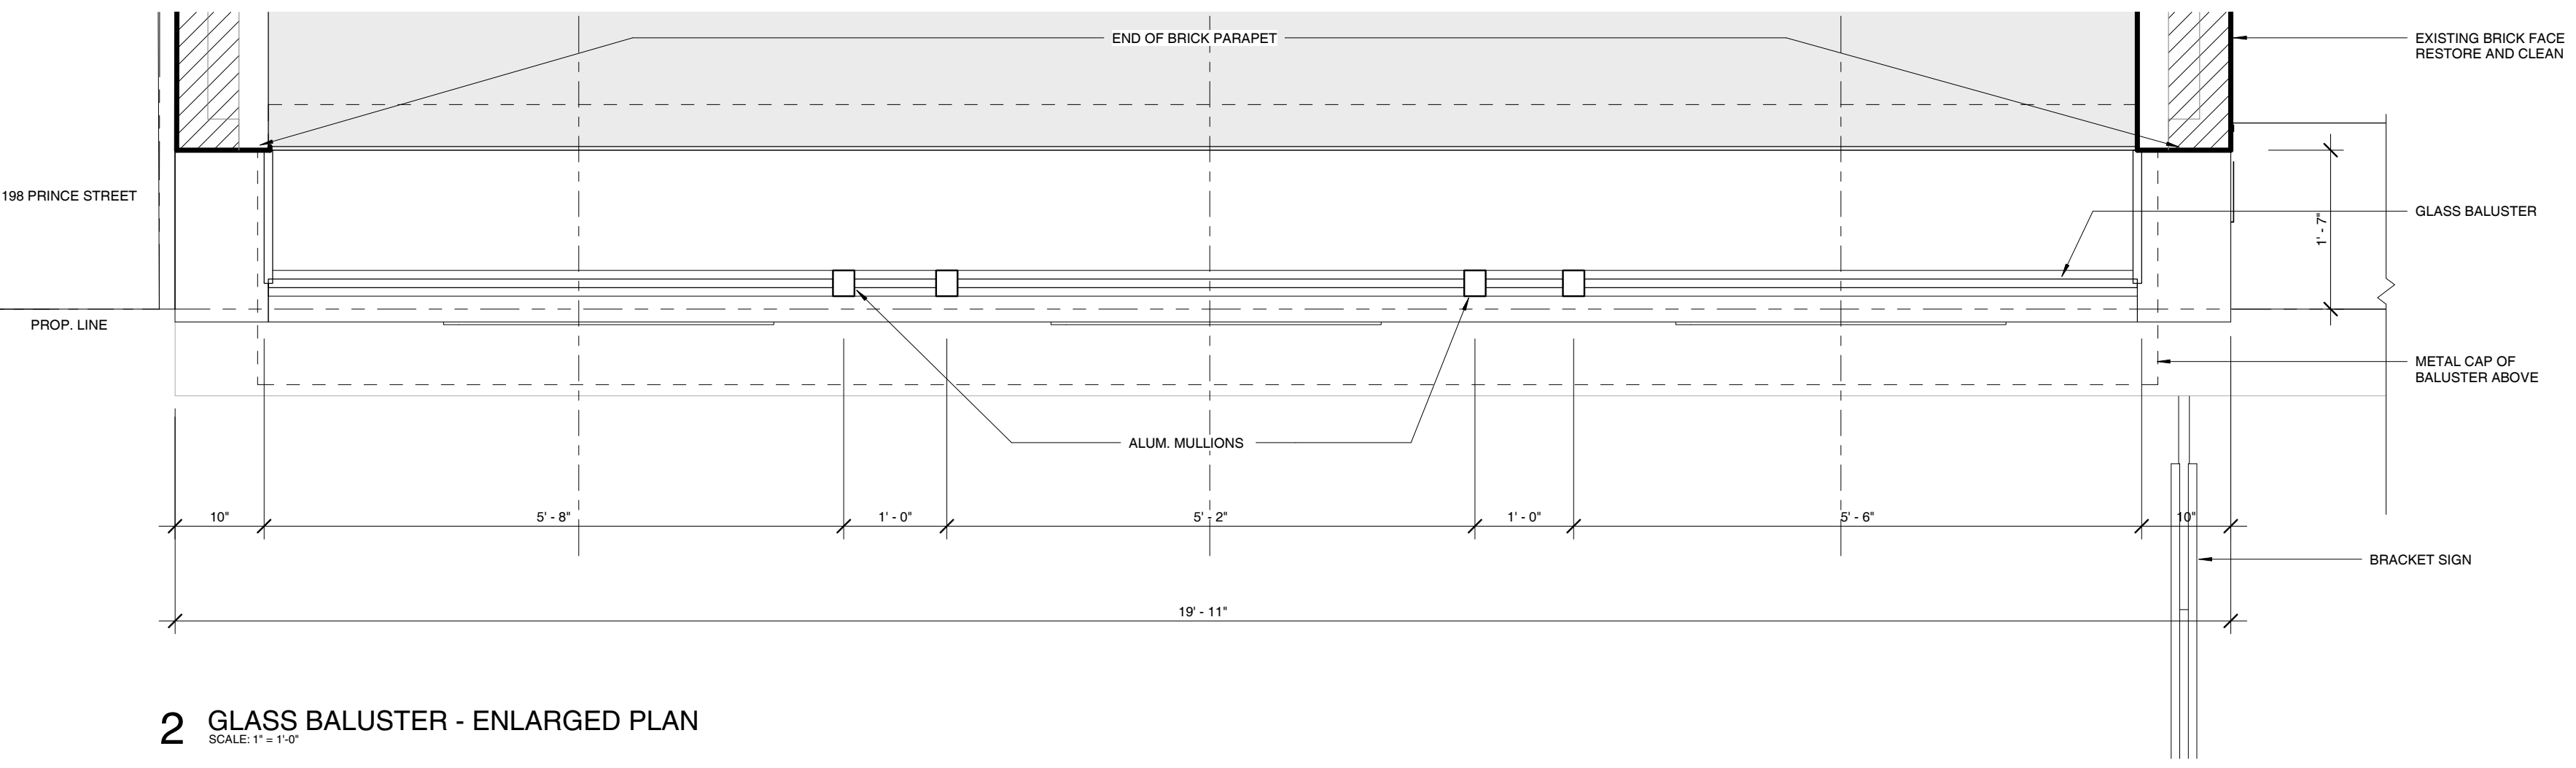
2 GLASS BALUSTER - ENLARGED PLAN
SCALE: 1" = 1'-0"

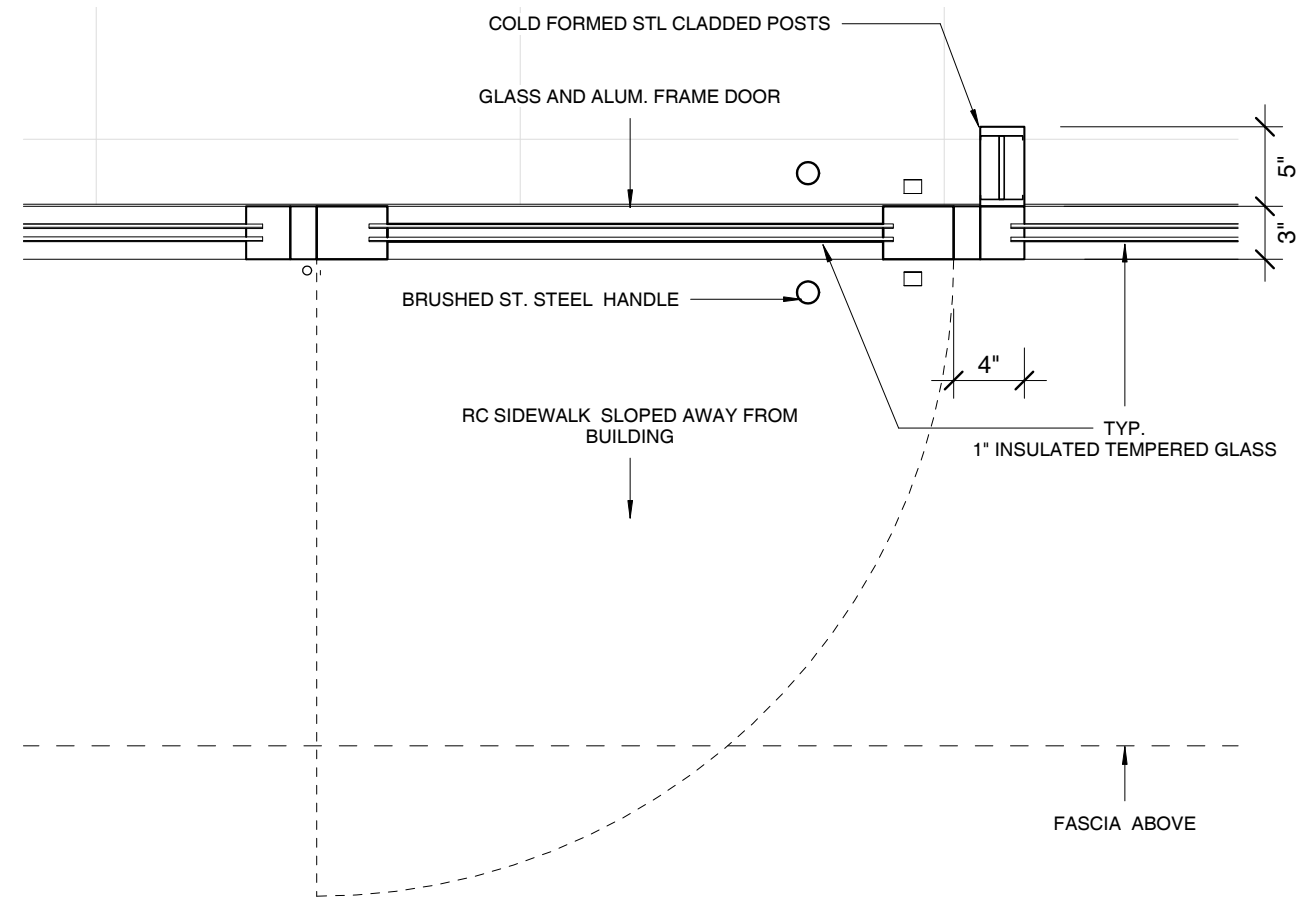
1 ENTRANCE DOOR- ENLARGED PLAN
SCALE: 1 1/2" = 1'-0"

- ① RESTORED BRICK WALL.
CLEAN AND REGROUT AS NEEDED.
- ② 1" CLEAR TEMPERED GLASS
- ③ PAINTED ALUMINUM DOORS AND
WINDOWS
- ④ BRUSHED STAINLESS STEEL
- ⑤ PAINTED METAL/PANELING/FLASHING

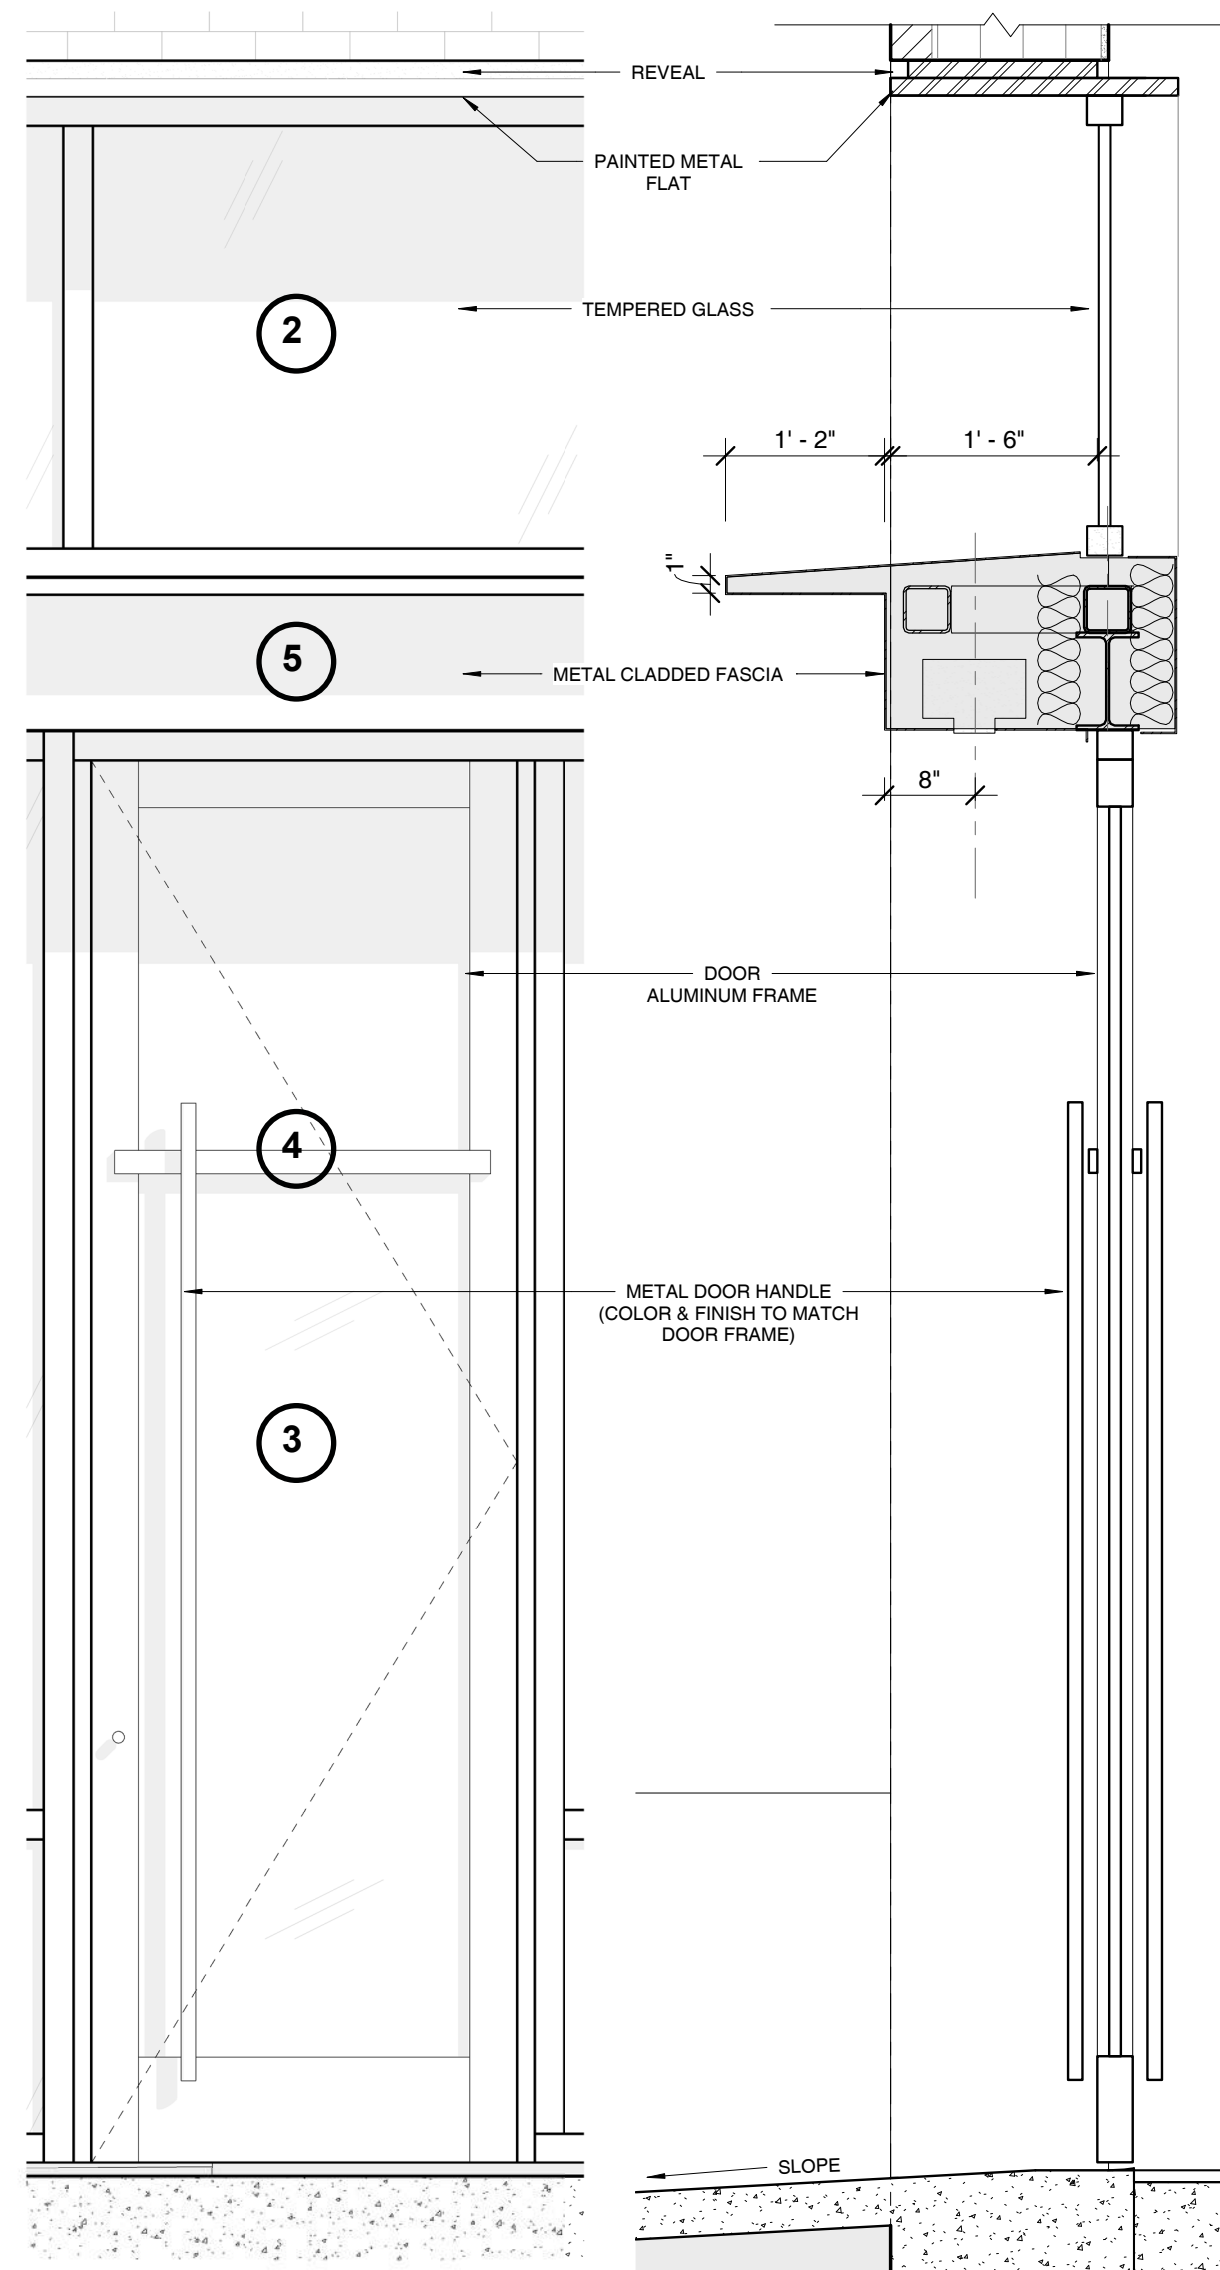
3 ENTRANCE DOOR - ELEVATION
SCALE: 1" = 1'-0"

4 ENTRANCE DOOR - SECTION
SCALE: 1" = 1'-0"

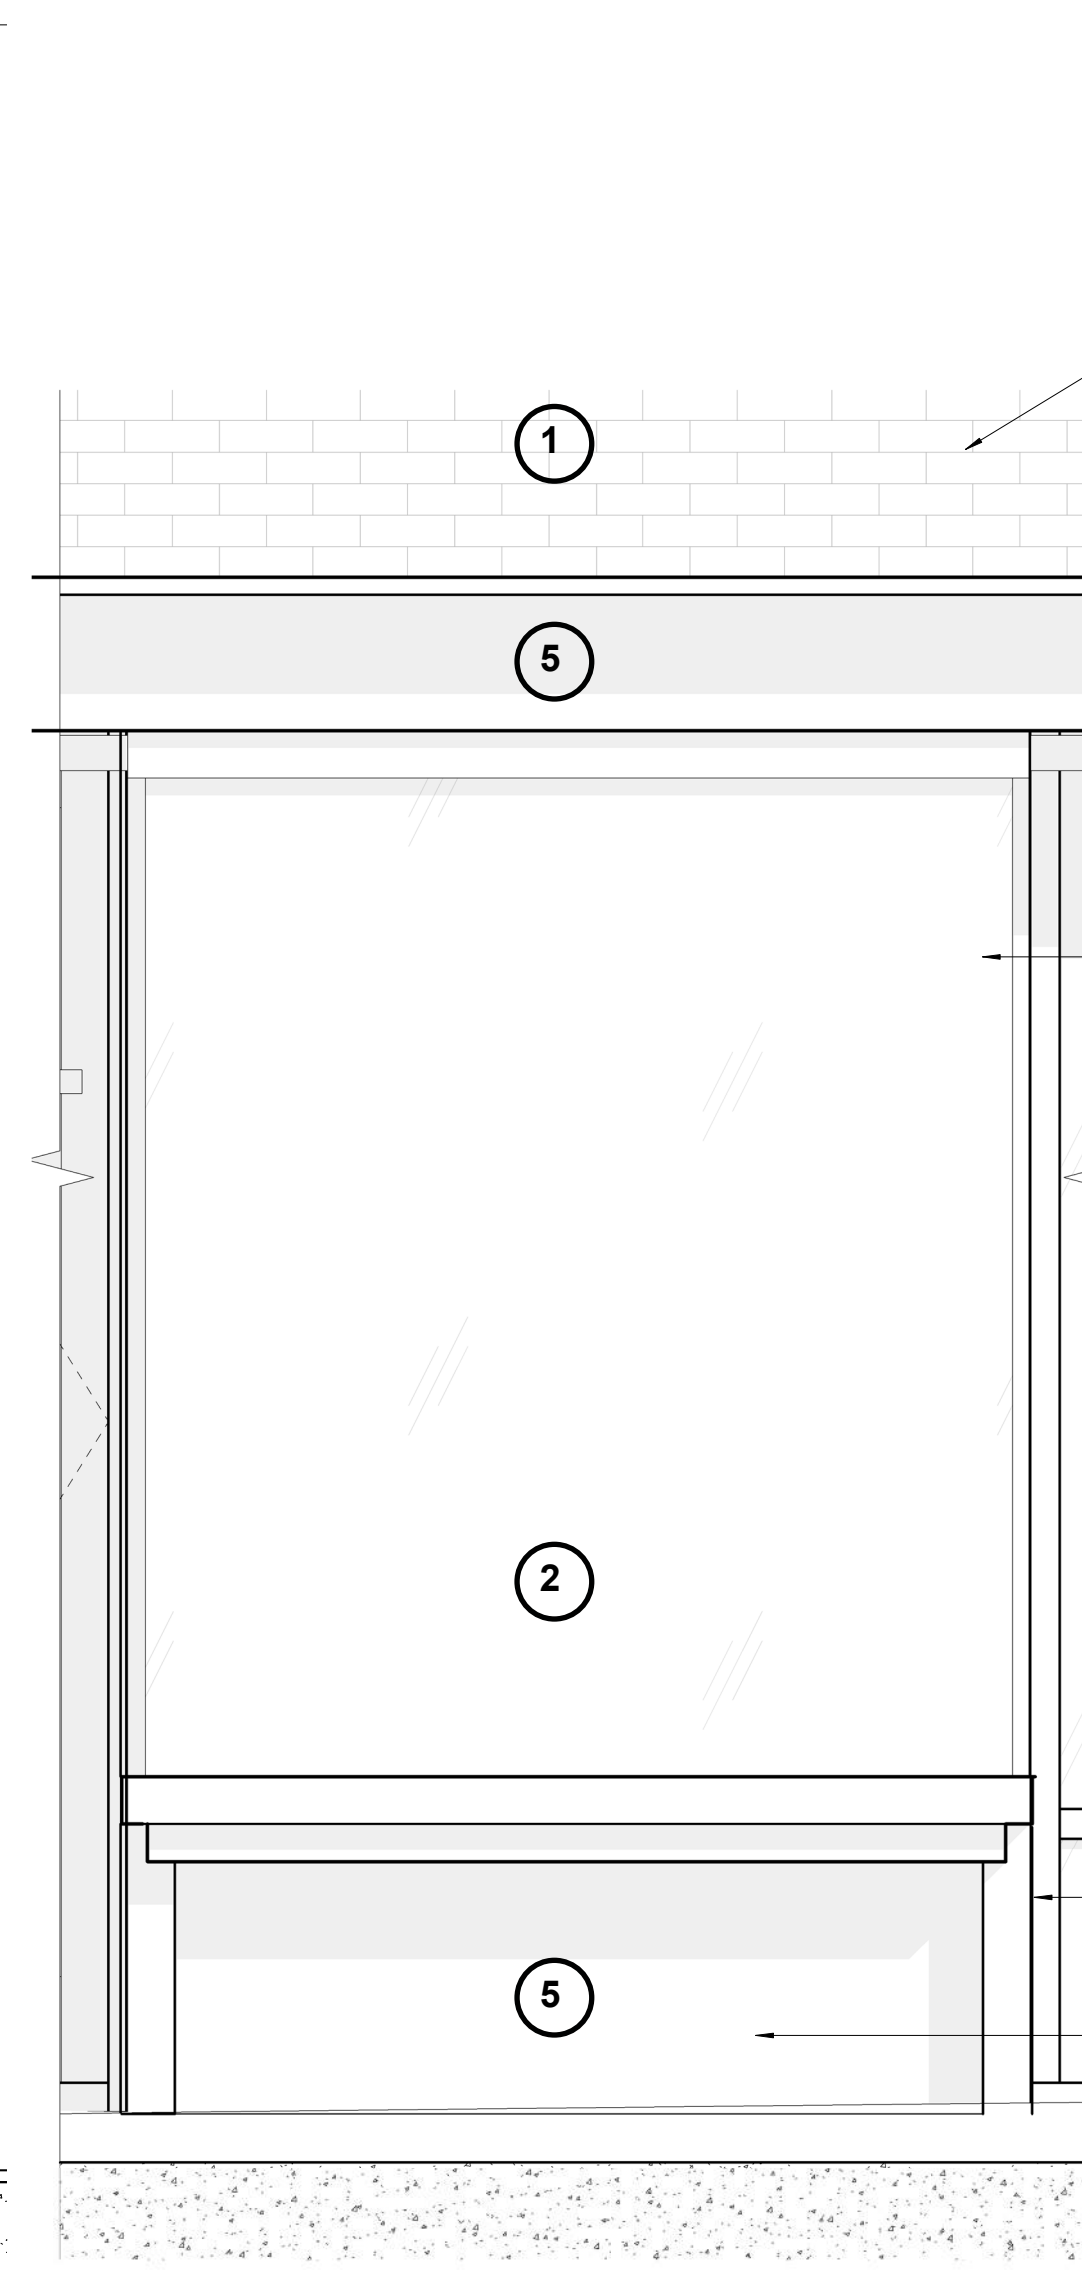
5 BAY WINDOW - ELEVATION
SCALE: 1" = 1'-0"

6 BAY WINDOW -SECTION
SCALE: 1" = 1'-0"

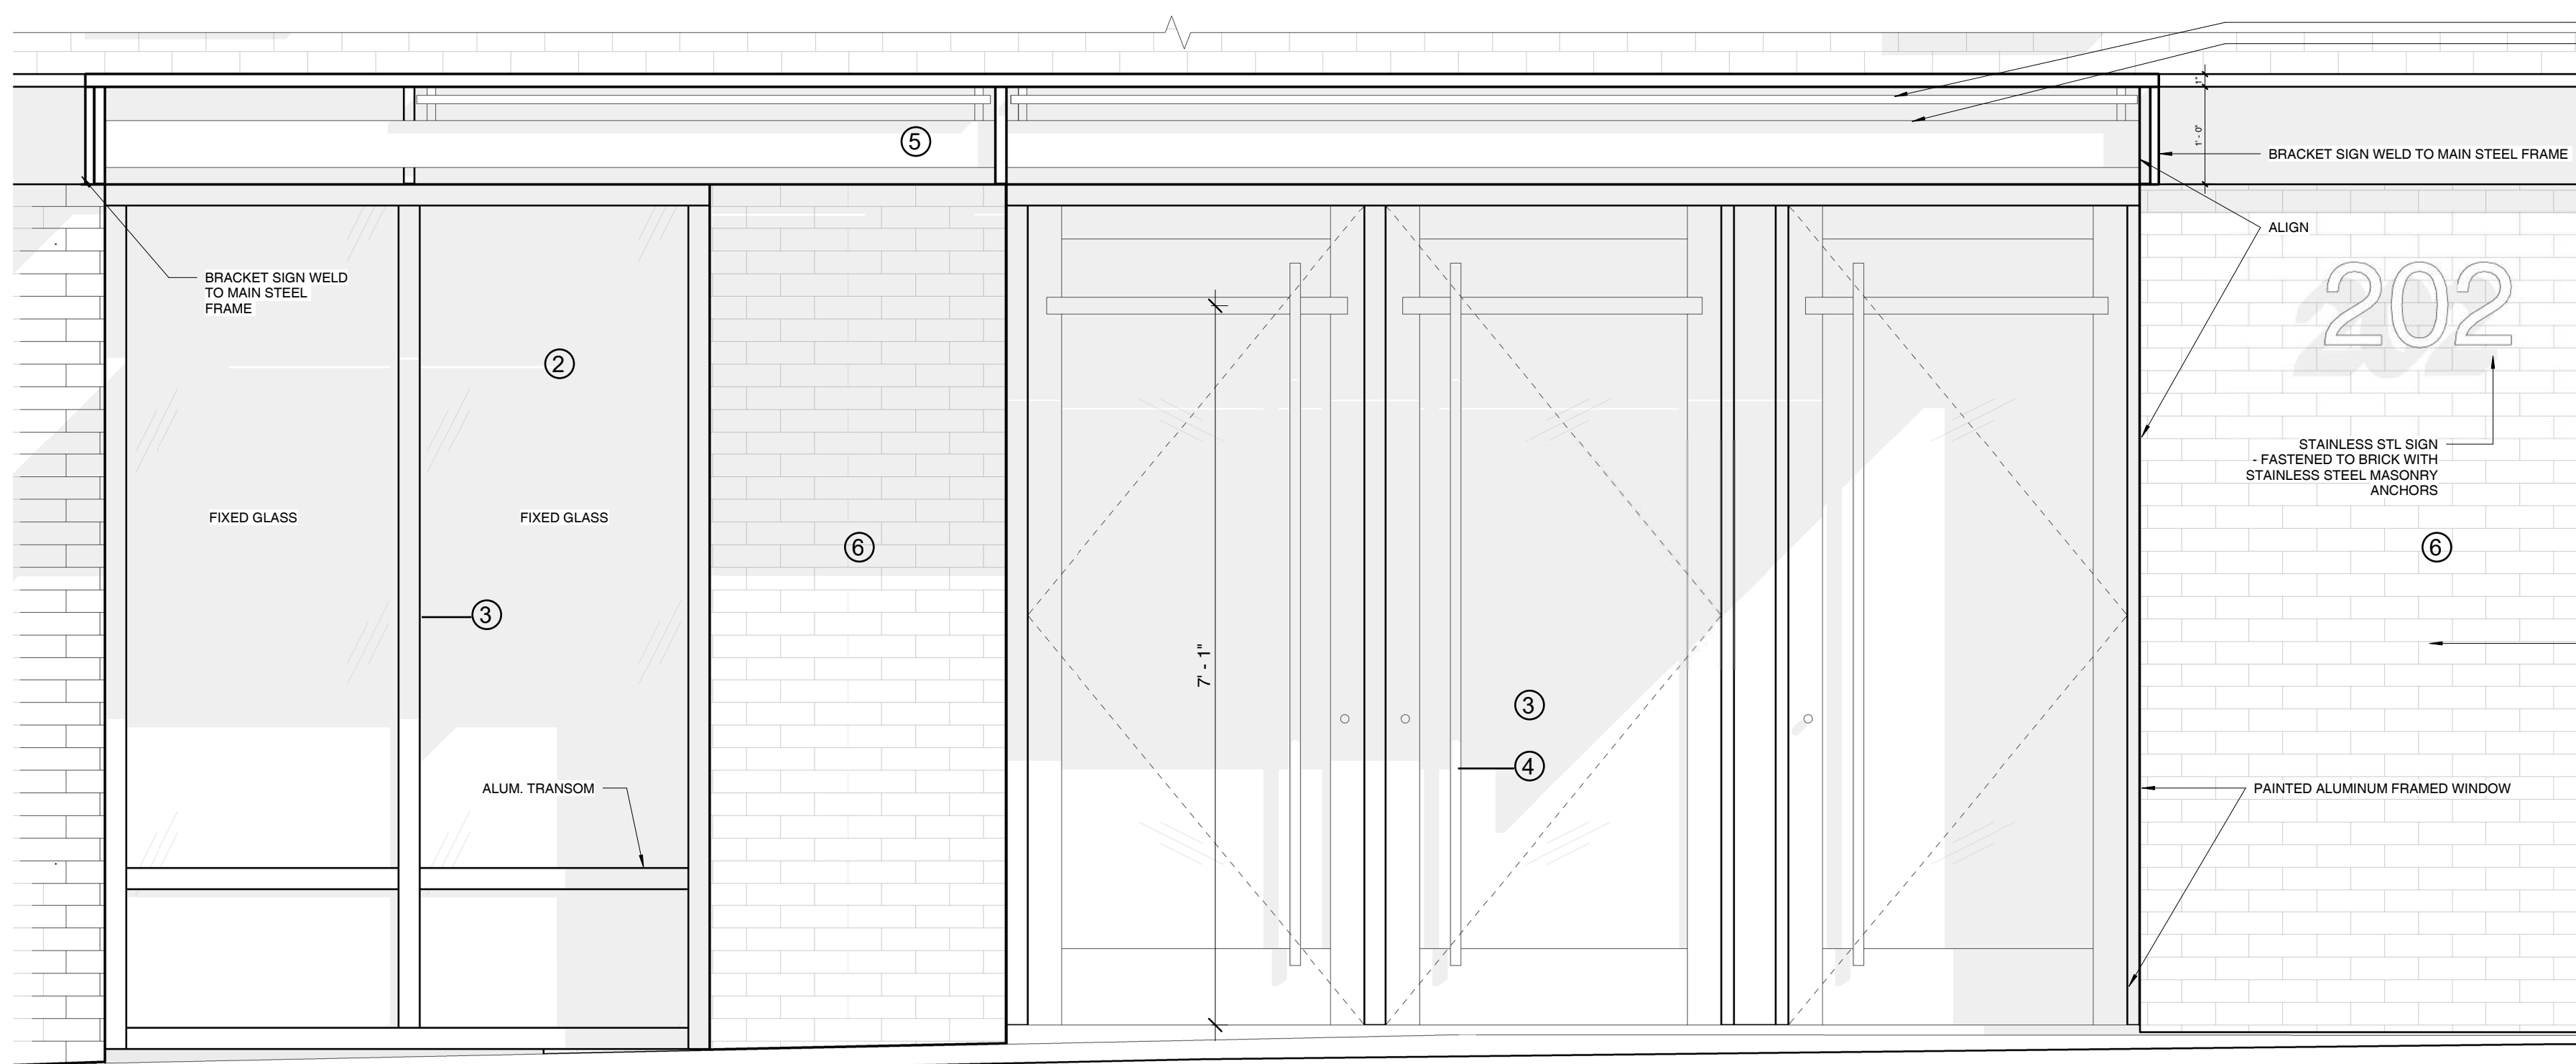
1 WEST ELEVATION - 6TH AVE
SCALE: 1" = 1'-0"

4 SECTION DOOR & CANOPY
SCALE: 1" = 1'-0"

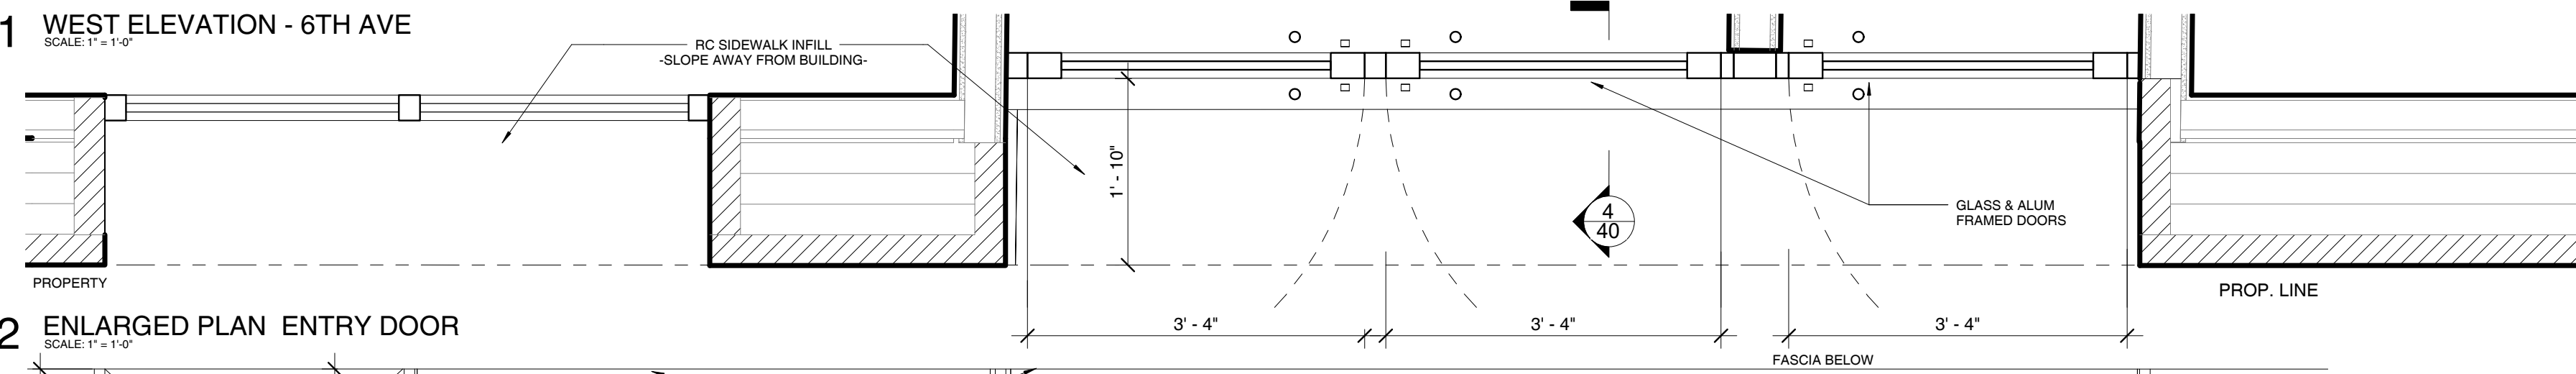
2 ENLARGED PLAN ENTRY DOOR
SCALE: 1" = 1'-0"

- MATERIAL KEY:**
- ① RESTORED BRICK WALL. CLEAN AND REGROUT AS NEEDED.
 - ② 1" CLEAR TEMPERED GLASS
 - ③ PAINTED ALUMINUM DOORS AND WINDOWS
 - ④ BRUSHED STAINLESS STEEL
 - ⑤ PAINTED METAL/PANELING/FLASHING
 - ⑥ NEW BRICK WYTHE TO MATCH EXISTING BRICK ON UPPER LEVELS
