66-68 West 10TH STREET NY, NY: TAX LOT PHOTO (1940)

MICHAEL SCHMITT ARCHITECT PC.

RESTORATION RECOMMENDATIONS

66 WEST 10TH ST NEW YORK, NY

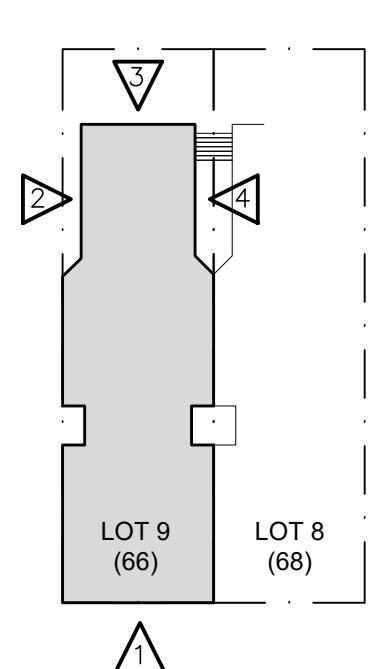
1 PLAN DIAGRAM 1/32" = 1'-0"

RESTORATION RECOMMENDATIONS FRONT FACADE

- (1) REPLACE FAILING PATCHES IN SHEET METAL CORNICE
- (2) PATCH SHEET METAL CORNICE IN KIND
- REMOVE ATMOSPHERIC SOILING WITH 3 APPROPRIATE CLEANER, TO BE TESTED
- (4) REPLACE DETERIORATED WOOD IN KIND
- (5) PATCH MASONRY SPALL/CRACK
- (6) REPOINT
- (7) REPAIR/PATCH PARGING
- (8) REPLACE RUSTED METAL COPING WITH BLUESTONE

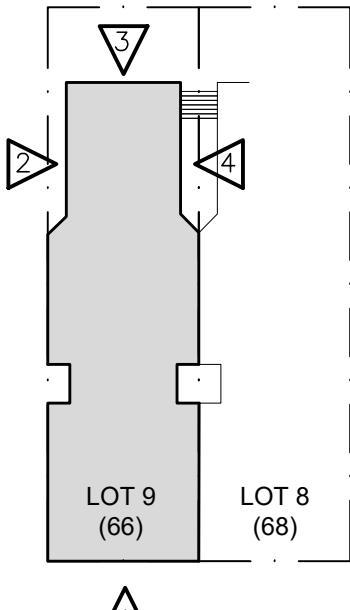
RESTORATION RECOMMENDATIONS SIDE FACADE

1) REPLACE FAILING PATCHES IN SHEET METAL CORNICE

(4) REPLACE DETERIORATED WOOD IN KIND

(5) PATCH MASONRY SPALL/CRACK

(7) REPAIR/PATCH PARGING

8 REPLACE RUSTED METAL COPING WITH BLUESTONE

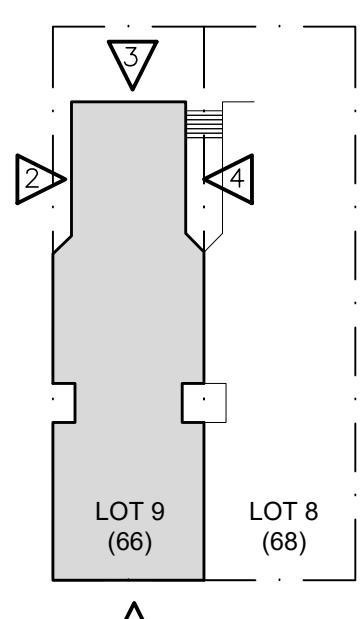
1 PLAN DIAGRAM 1/32" = 1'-0"

RESTORATION RECOMMENDATIONS REAR FACADE

- 1 REPLACE FAILING PATCHES IN SHEET METAL CORNICE
- (2) PATCH SHEET METAL CORNICE IN KIND
- (3) REMOVE ATMOSPHERIC SOILING WITH APPROPRIATE CLEANER, TO BE TESTED
- (4) REPLACE DETERIORATED WOOD IN KIND
- (5) PATCH MASONRY SPALL/CRACK
- 6 REPOINT
- (7) REPAIR/PATCH PARGING
- (8) REPLACE RUSTED METAL COPING WITH BLUESTONE

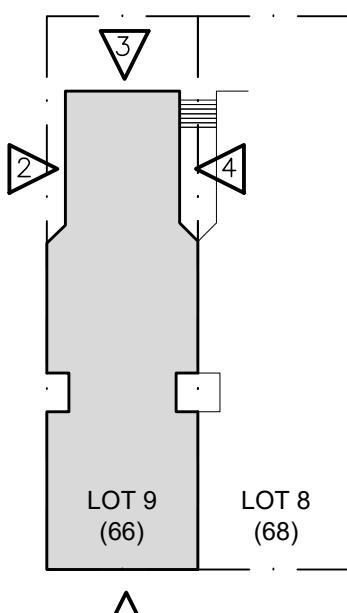
1 PLAN DIAGRAM 1/32" = 1'-0"

RESTORATION RECOMMENDATIONS SIDE FACADE

- 1 REPLACE FAILING PATCHES IN SHEET METAL CORNICE
- (2) PATCH SHEET METAL CORNICE IN KIND
- (3) REMOVE ATMOSPHERIC SOILING WITH APPROPRIATE CLEANER, TO BE TESTED
- (4) REPLACE DETERIORATED WOOD IN KIND
- (5) PATCH MASONRY SPALL/CRACK
- 6 REPOINT
- 7 REPAIR/PATCH PARGING
- (8) REPLACE RUSTED METAL COPING WITH BLUESTONE
